**This bulletin supersedes Technical Service Bulletin (TSB) 08-068-22, date of issue March 26, 2022, which should be removed from your files. All revisions are highlighted with **\*\*asterisks\*\*** and include an updated build date.**

Global Telematics Box Module (TBM2) Firmware Over The Air Software Version Updates

2022 (MP) Jeep Compass

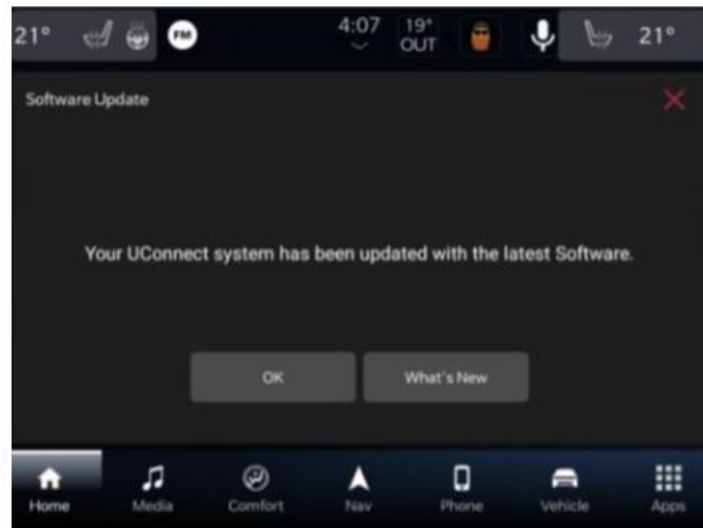
**Fig. 3**  
**Software Update Confirmation Screen**

3. Upon completion of update, the radio will display a confirmation message (Fig. 3) .
