# Preliminary Information

## PIP5495G Check Engine Light On With P0299 Or P0234

| Cause: | Misdiagnosis Leading to Returned Turbochargers with NTF |

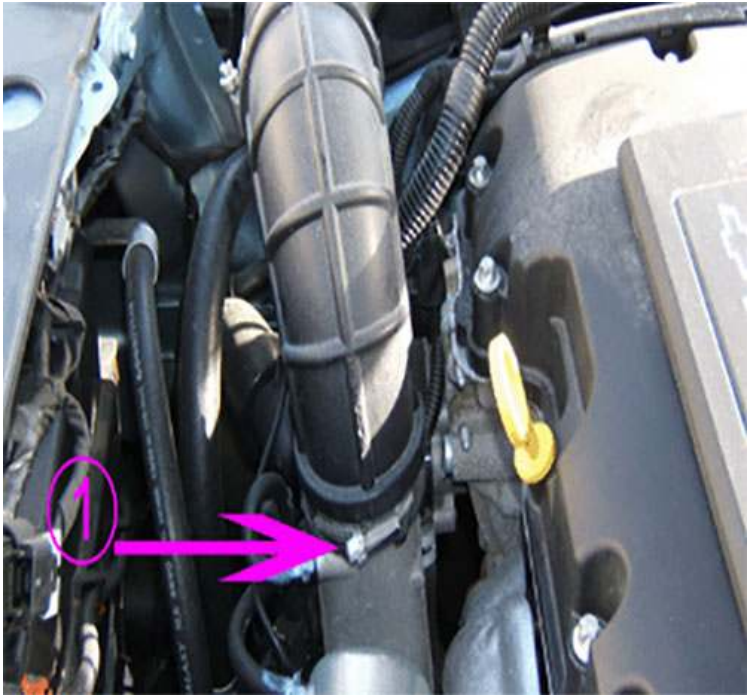
Notice: The view shown below indicates **NORMAL** oil staining in the turbocharger outside air inlet. This dry stain does not represent an oil leak.

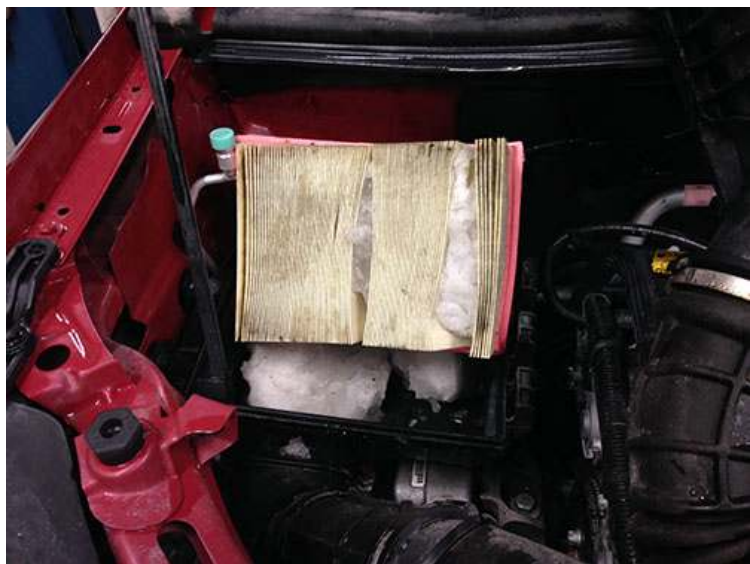
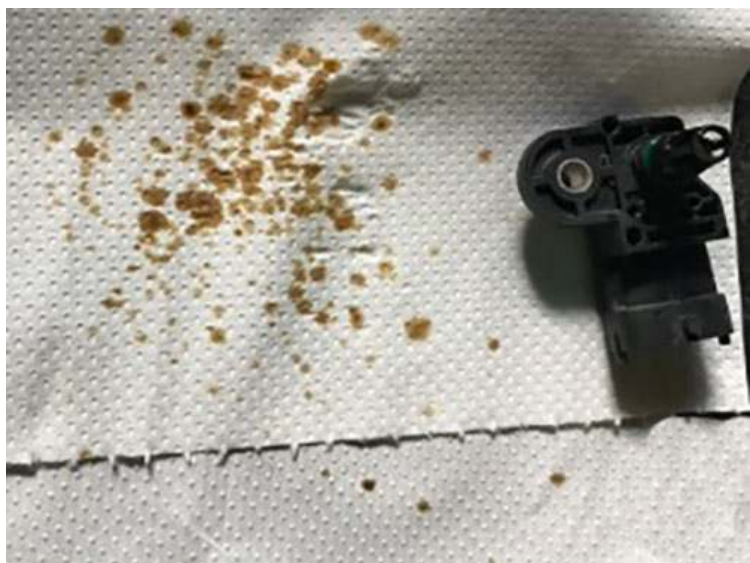
P0299 could set as a result of ice buildup in the Induction system, Charge Air Cooler (CAC) and/or the Boost Pressure sensor.

For Encore and Trax refer to the latest version of [16-NA-405](#): (Poor Engine Performance in Extremely Cold Weather Conditions, PCV Bypass Hose and Charge Air Cooler Icing - Malfunction Indicator Lamp (MIL) Illuminated, DTC P0299, P0236, P2227, and P00C7 Set)

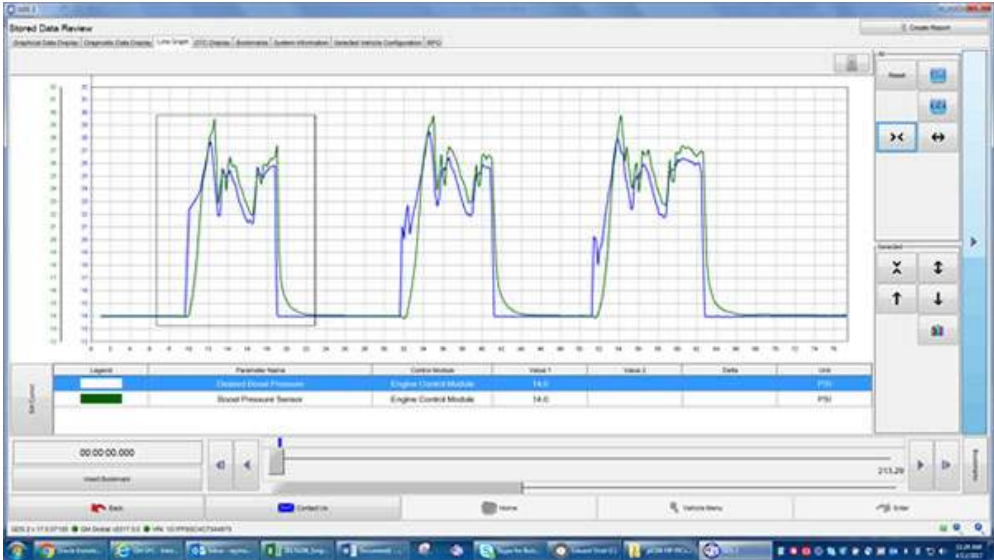
Example of normal turbocharger wastegate operation:  
In this example, notice that the measure window begins once the Boost Pressure Sensor reading (Green) meets the Desired Boost Pressure reading (Blue) and ends when the APP is released per the testing instructions.  
The Boost Pressure Sensor reading (Green) closely tracks the Desired Boost Pressure reading (Blue) indicating normal Turbocharger

operation.
