## SERVICE BULLETIN

**APPLICABILITY:** 2014-15MY XV Crosstrek Hybrid Electric Vehicle (HEV) **NUMBER:** 16-94-15R

**SUBJECT:** Diagnosis and Repair of DTCs P172A and P0B0B

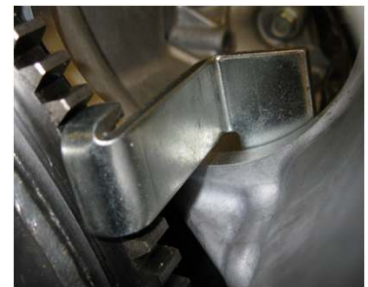
- The torque converter can also be left in place. Either support it from the underside after standing the unit up with a block of wood or use a retainer strap / bracket included with remanufactured and replacement transmission assemblies to keep the torque converter in place.
- It is **NOT** necessary to remove the internal parking pawl control rod or the inhibitor switch assembly to perform this repair.
- There are 14 bolts securing the drive motor case assembly to the CVT main case.
- Use extra caution during removal and installation of the electric oil pump wiring harness to avoid damaging it.
- Always utilize a helper when removing and installing the drive motor case assembly.
- The drive motor input shaft and coupling sleeve must be swapped over to the new Drive Motor Case assembly.
