# HYUNDAI

## Technical Service Bulletin

| GROUP<br><b>BODY ELECTRICAL</b> | NUMBER<br><b>19-BE-001</b> |

**SUBJECT:** HAPTIC STEERING CONTROLLER REPLACEMENT  
DTC CODE B247100

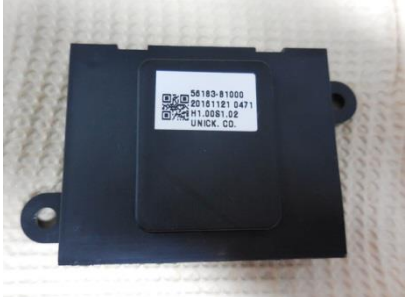
| PART NAME | BEFORE | AFTER | QTY |
|---|---|---|---|
| CONTROLLER ASSY –<br>S/WHL HAPTIC | | | 1EA |
| | 56183-B1000 | | |

Ensure replacement haptic controller has S1.02 software level.
