| | NUMBER<br><b>PI1803W/X (Rev 4, 04/10/2019)</b> | DATE<br><b>November 2018</b> |
| <b>PRODUCT IMPROVEMENT CAMPAIGN</b> | | |
| <b>SUBJECT:</b> ENGINE REPLACEMENT INSTRUCTIONS<br>FOR DTC P1326 (PI1803W/X) | | |

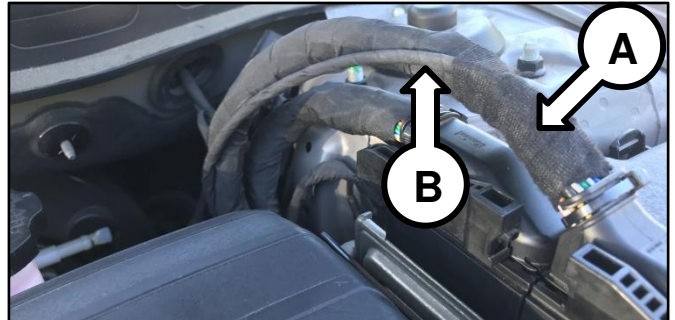
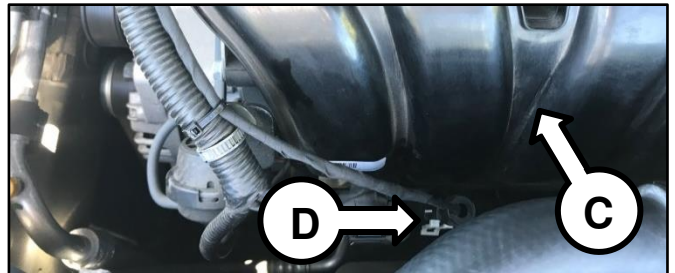
**NOTE:** To identify the extension harness (B), look for an external harness (B) which should be cable-tied to the existing wiring harness (A) leading by the intake manifold (C) to the knock sensor (D), as shown.

- If the extension harness (B) has been installed, open a Techline case online.
- If the extension harness (B) has not been installed, proceed to the next step.
