Preliminary Information

PIP5495J Check Engine Light On With P0299 Or P0234

| Cause: | Misdiagnosis Leading to Returned Turbochargers with NTF |

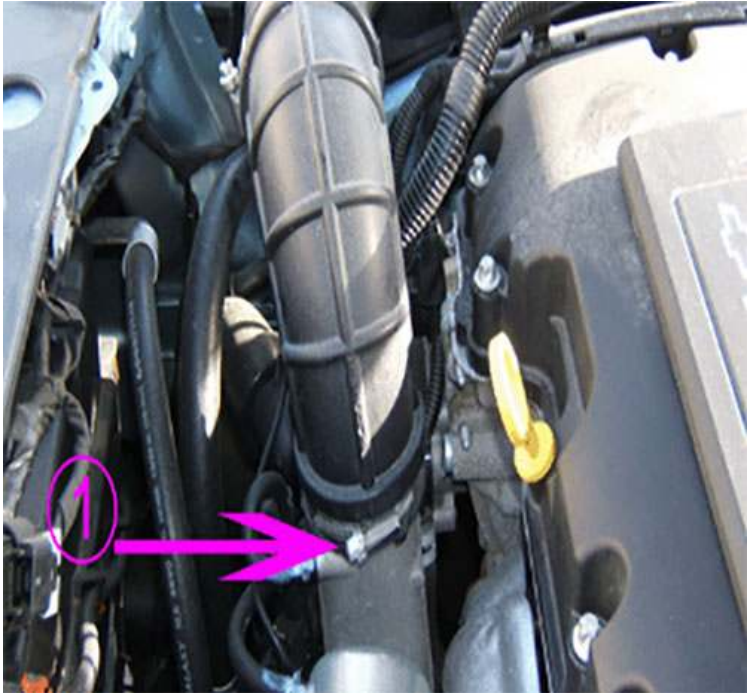
Notice: The view shown below indicates NORMAL oil staining in the turbocharger outside air inlet. This dry stain does not represent an oil leak.
