# Service Alert

**TURN ON/OFF LIGHTS MANUALLY WARNING MESSAGE AND DTC  
B10AD:09 STORED WHEN PARKED UNDER HOT WEATHER  
CONDITIONS**

**Service Alert No.:** SA-035/19

2019 Mazda3

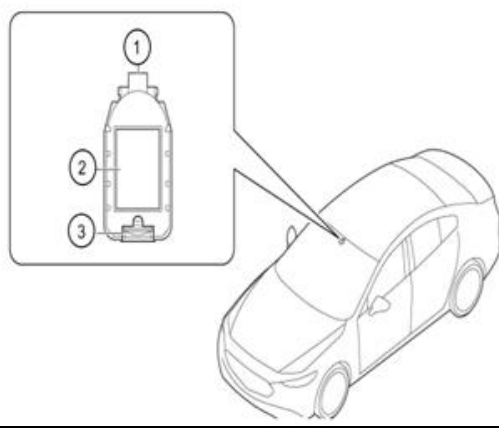
If the rain sensor detects temperature higher than the operation range, the auto light system temporarily stops and the exterior light warning indicator light turns ON.

The auto light system starts to operate normally after the interior temperature drops.

| 1 | Rain sensor, auto light sensor and humidity sensor | |
| 2 | Rain sensor detection area | |

3 Auto light detection area

If this condition occurs, use the climate control system to cool the interior. The auto light system will operate normally after the temperature around the rain sensor has dropped.  
No parts replacement is needed.
