| <b>HYUNDAI</b><br><b>Technical Service Bulletin</b> | GROUP<br><b>BODY ELECTRICAL</b> | NUMBER<br><b>19-BE-016H</b> |
| | DATE<br><b>OCTOBER 2019</b> | MODEL(S)<br><b>ELANTRA (ADa)</b> |
| <b>SUBJECT:</b> BLIND-SPOT RADAR REPLACEMENT, AND MOUNTING ANGLE VALIDATION | | |

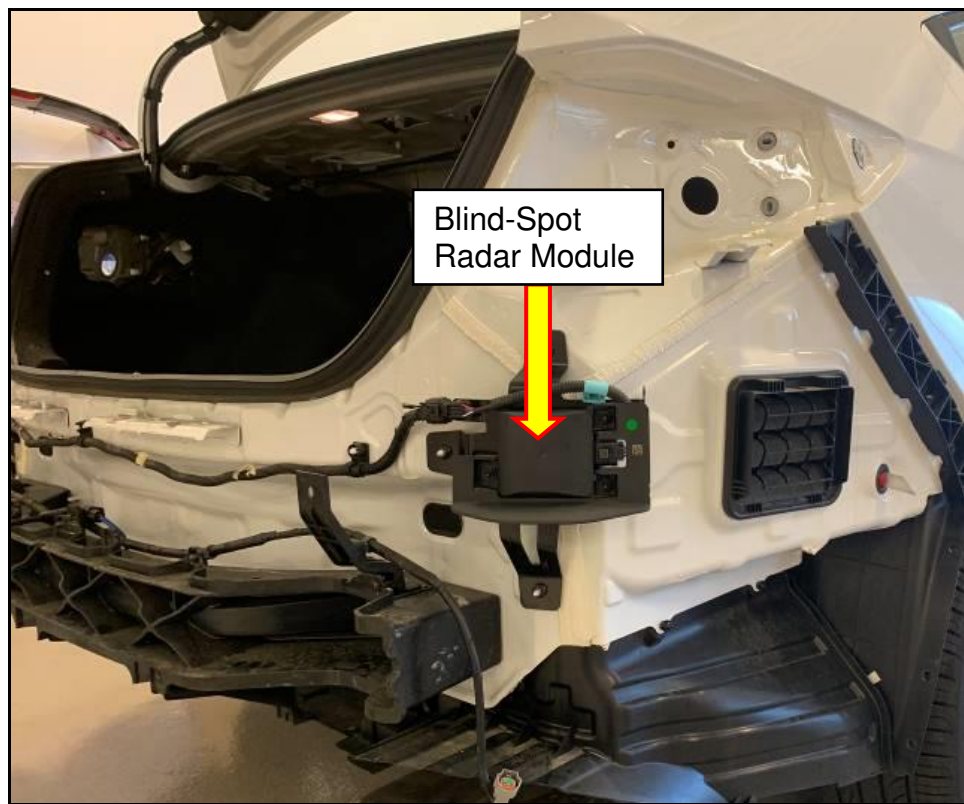
**Description:** Certain 2019 MY Elantra (ADa) vehicles may experience the Blind-Spot Collision Warning (BCW) light displayed on the instrument cluster. In some cases one and/or two of the following DTCs can be set:

- C2702 – Control Module Missing Calibration
- C2703 – Control Module Slave Missing Calibration

This bulletin provides the service procedure to replace the left and right Blind-Spot radar modules.
