## SERVICE BULLETIN

| EC18-005 | NTB18-020 | March 6, 2018 |

### 2018 FRONTIER; MIL ON WITH DTC P00D2 AND/OR P00D4

**APPLIED VEHICLES:** 2018 Frontier (D40)  
**APPLIED ENGINE:** VQ40DE

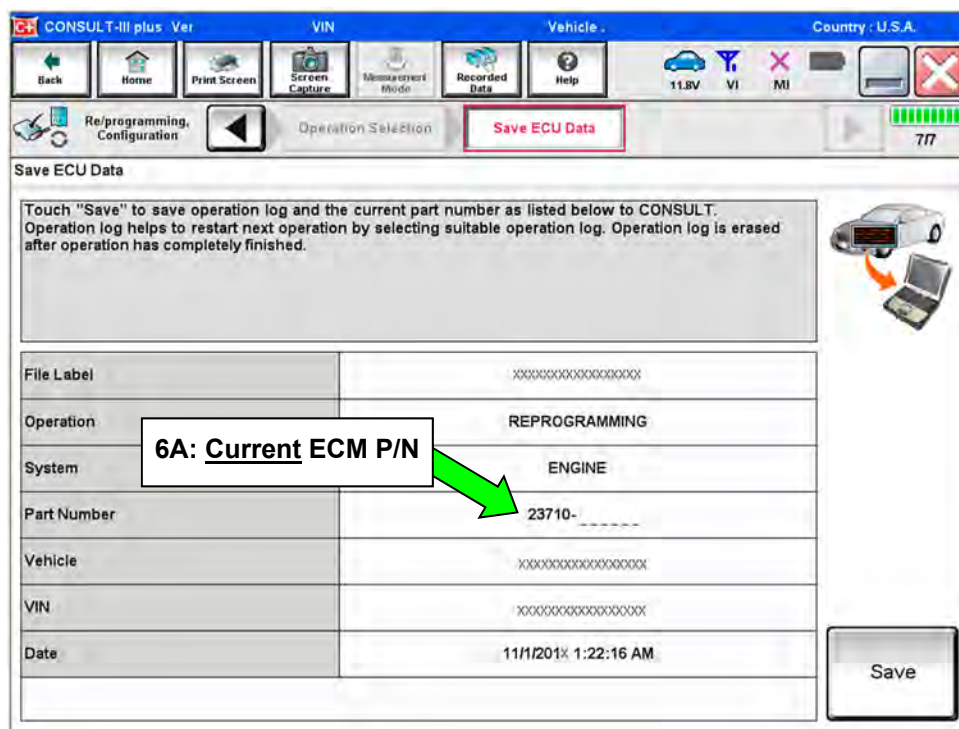
Figure 2

6. When you get to the screen shown in Figure 2, confirm this bulletin applies as follows.

A. Find the ECM **Part Number** and write it on the repair order.

**NOTE:** This is the current ECM Part Number (P/N).

B. Compare the P/N you wrote down to the numbers in the **Current ECM Part Number** column in **Table A**, below.

- If there is a match, this bulletin applies. Continue with the reprogramming procedure.
- If there is not a match reprogramming does not apply. Refer to ASIST for further diagnostic information.

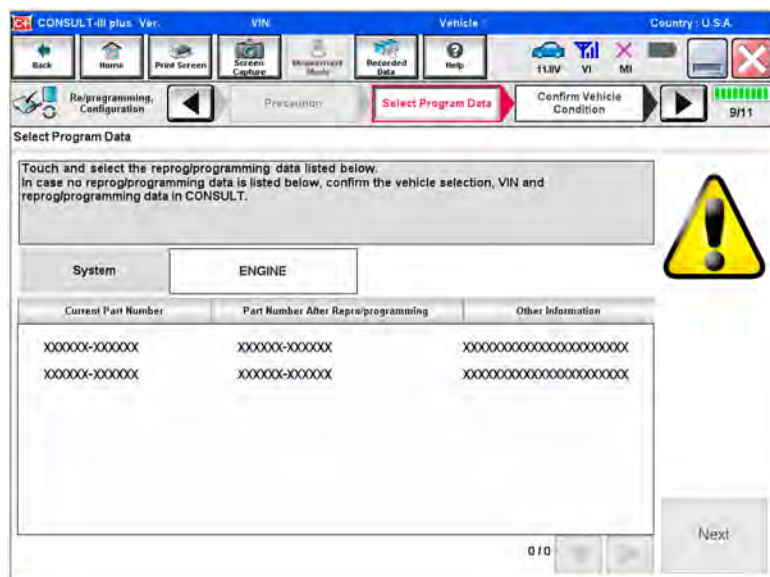
- In some cases, more than one new P/N for reprogramming is available.
  - In this case, the screen in Figure 3 displays.
  - Select and use the reprogramming option that **does not** have the message “Caution! Use ONLY with NTBXX-XXX”.
- If you get this screen and it is blank (no reprogramming listed), it means there is no reprogramming available for this vehicle. Close C-III plus and refer back to ASIST for further diagnosis.

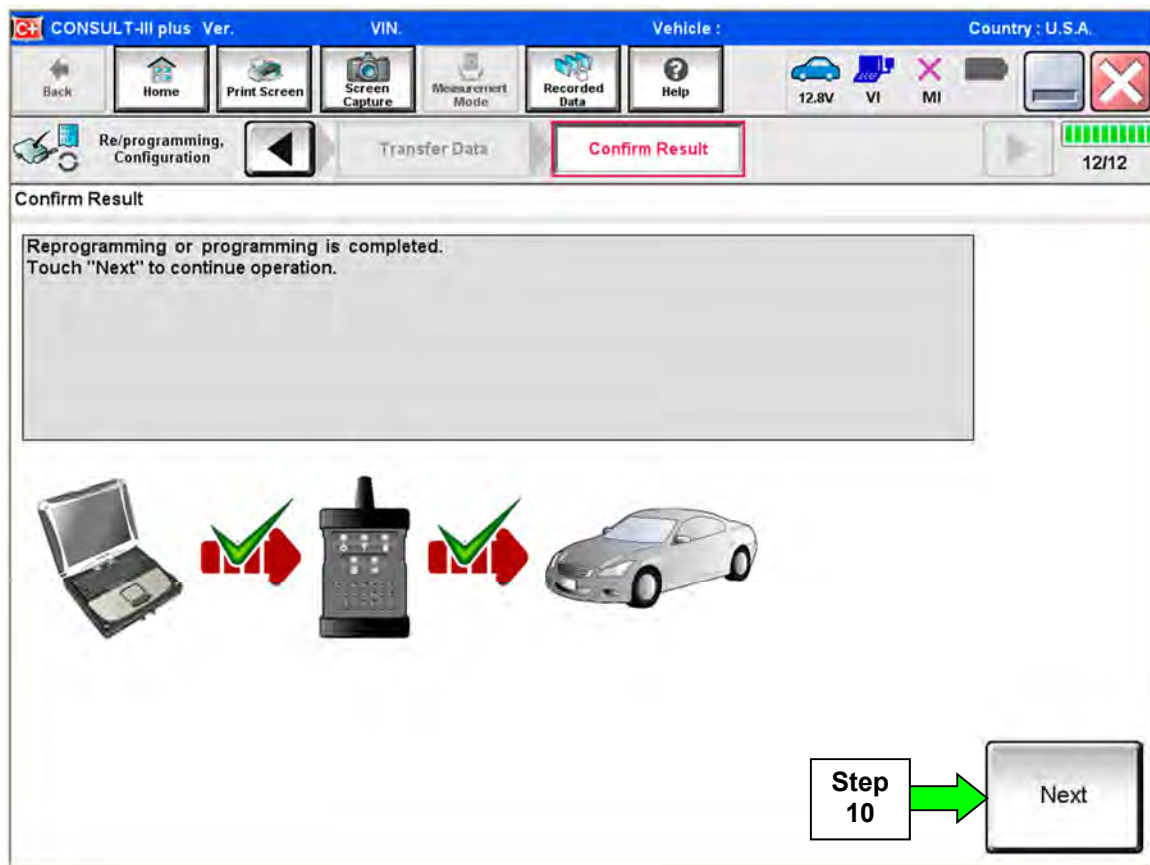
8. When the screen in Figure 5 displays, reprogramming is complete.

**NOTE:** If the screen in Figure 5 does not display (reprogramming does not complete), refer to the information on page 7.

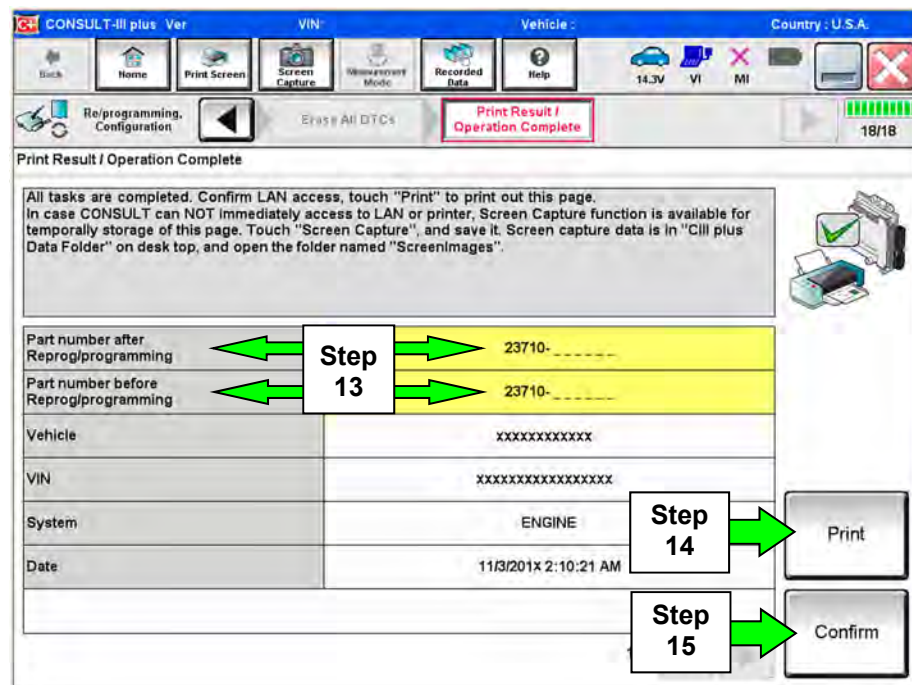
12. When the entire reprogramming process is complete, the screen Figure 8 will display.
13. Verify the before and after part numbers are different.
14. Print a copy of this screen (Figure 8) and attach it to the repair order for warranty documentation.
15. Select **Confirm**.
