## Technical Service Bulletin

| GROUP<br><b>CAMPAIGN</b> | NUMBER<br><b>18-01-017</b> |
| DATE<br><b>APRIL, 2018</b> | MODEL<br><b>ACCENT (HC)</b> |

**SUBJECT:** HC ACCENT SPARK PLUG REPLACEMENT  
(SERVICE CAMPAIGN T2X)

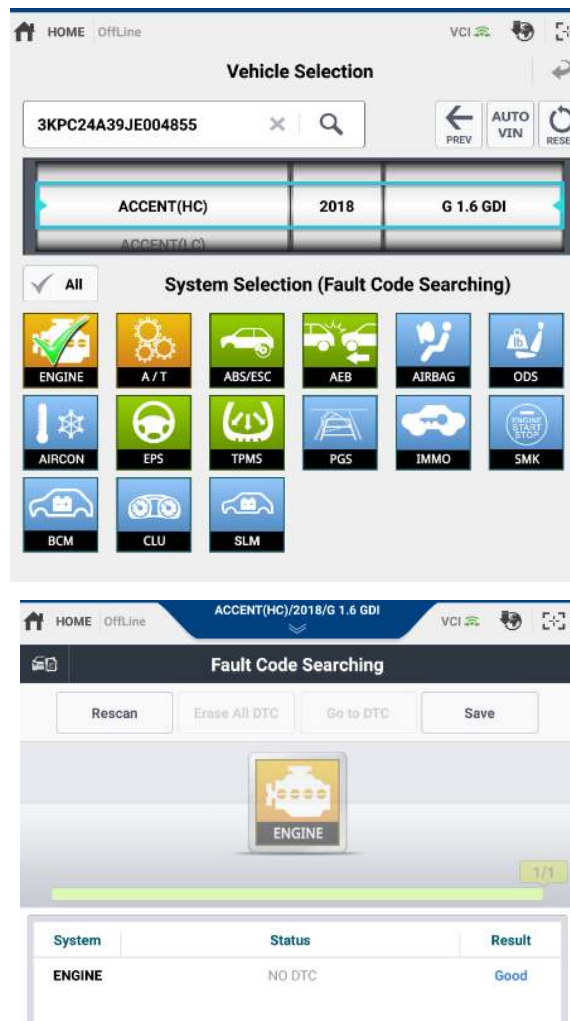
- DTC P0300 / P0301 / P0302 / P0303 / P0304 Random/Multiple Misfire.
- Engine runs rough.

9. Reinstall the ignition coils, ignition coil connectors, and engine cover in reverse order of removal.
10. Attach a GDS to perform **Fault Code Searching** of the **Engine** System to check for any DTC P0300-P0304 and select **Erase All DTC** if any are found.
