## SERVICE BULLETIN

**APPLICABILITY:** 2014-15MY XV Crosstrek Hybrid Electric Vehicle (HEV) **NUMBER:** 16-94-15R

**SUBJECT:** Diagnosis and Repair of DTCs P172A and P0B0B

**DATE:** 07/30/15

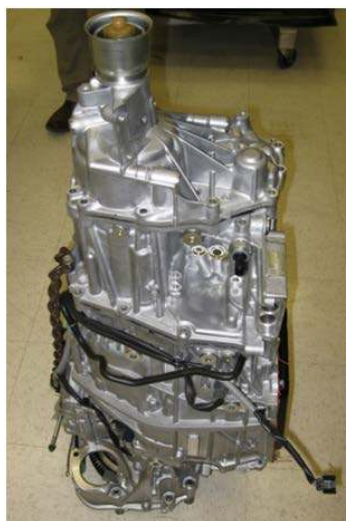
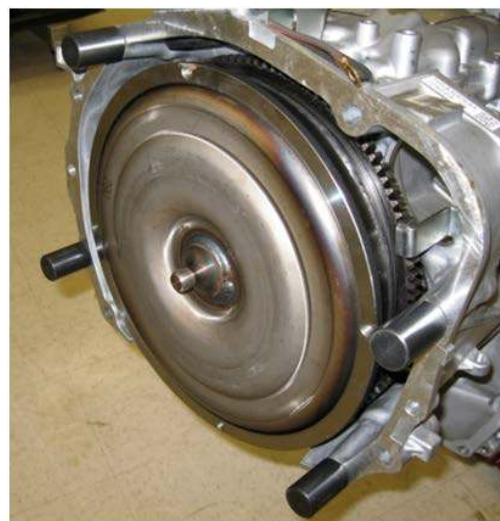
The bulk of this procedure is best performed with the transmission assembly standing vertically. Use the 4- 6M/T stands (S/T# 18632AA000) pictured below for support.

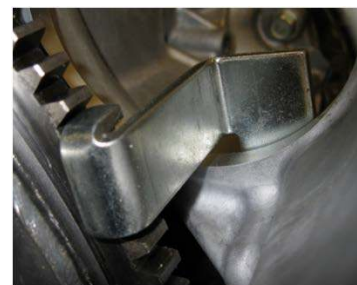
- The torque converter can also be left in place. Either support it from the underside after standing the unit up with a block of wood or use a retainer strap / bracket included with remanufactured and replacement transmission assemblies to keep the torque converter in place.
