# Preliminary Information

## PIP5584 Dynamic Fuel System DTC

| Brand: | Model: | Model Years: | VIN: | | Engine: | Transmissions: |
|---|---|---|---|---|---|---|
| Chevrolet | Silverado 1500 (new Model) | 2019 | All | All | 5.3L 6.2L, L84, L87 | All |
| GMC | Sierra 1500 (new Model) | 2019 | All | All | 5.3L 6.2L, L84, L87 | All |

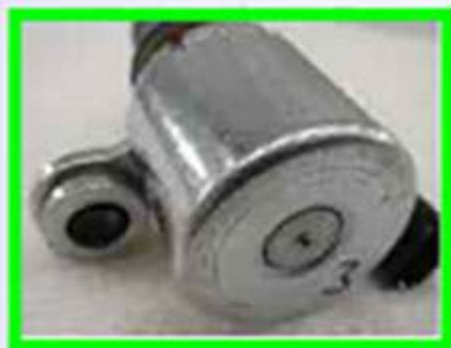
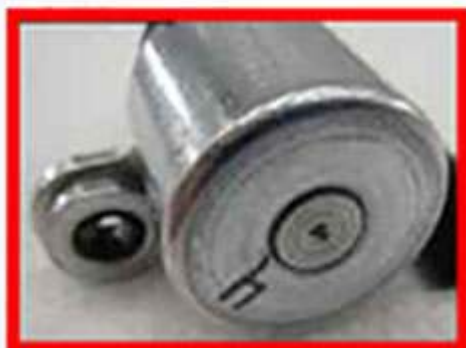
Inspect the rest of the solenoids for pole piece standing proud as seen below.

If the pole piece is sticking out (above the surface) the solenoid will also need to be replaced.

> 0.4mm = Good

< 0.4mm = NOK

3 Images above show measuring the plunger of the OCV. (It should be checked in the vehicle)

Replace the OCV for the cylinder with the concern.
