# Service Alert

INFOTAINMENT CENTER DISPLAY AND CONNECTED VEHICLE  
IMPROPER OPERATION

Service Alert No.: SA-015/26

2026 CX-5

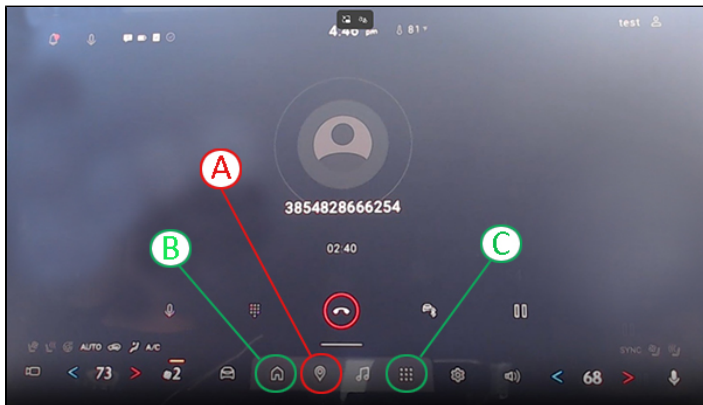
10. During a Bluetooth® phone call, tapping the navigation icon (A) does not launch Google Maps.

- This is normal system operation.
  - Google Maps is available during a Bluetooth® phone call:
    - Tap the [HOME] button (B) on the navigation bar, then tap the [Map Widget].
    - Tap the [All Apps] button (C) on the navigation bar, then select [Google Maps].
