| <b>HYUNDAI</b><br><b>Technical Service Bulletin</b> | | GROUP<br><b>AUTOMATIC<br/>TRANSMISSION</b> | NUMBER<br><b>17-AT-005</b> |
| <b>SUBJECT:</b> | <b>AUTOMATIC TRANSAXLE DIAGNOSIS (6-SPEED)<br/>INHIBITOR SWITCH DTC P0705, P0706, P0707 &amp; P0708</b> | | |

***This TSB supersedes TSB 15-AT-001 to update the Service Procedure and applicable vehicles.***

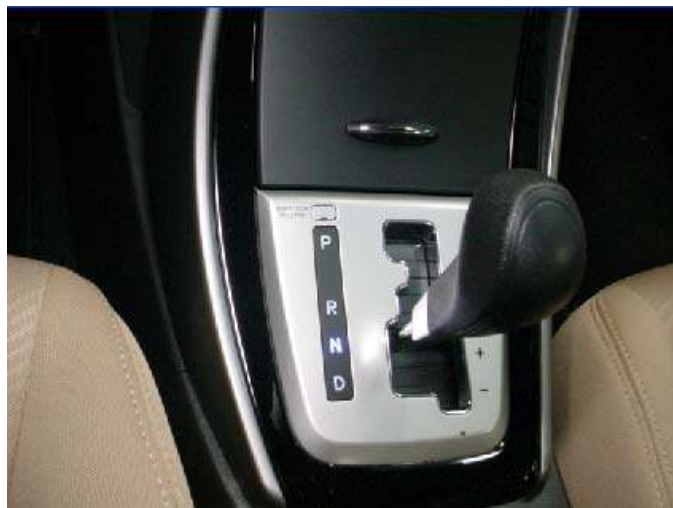
9. Apply the parking brake. Move the shift lever to the “N” position.

Turn the ignition switch to the OFF position.

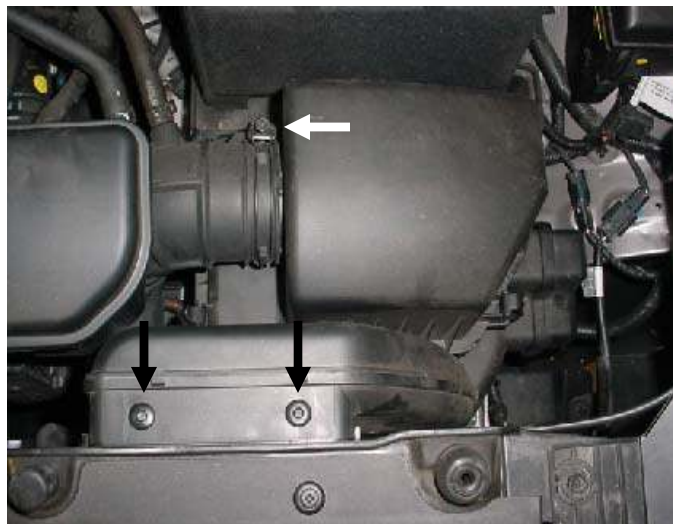
10. Remove the air duct and air cleaner, if needed, to access the inhibitor switch.

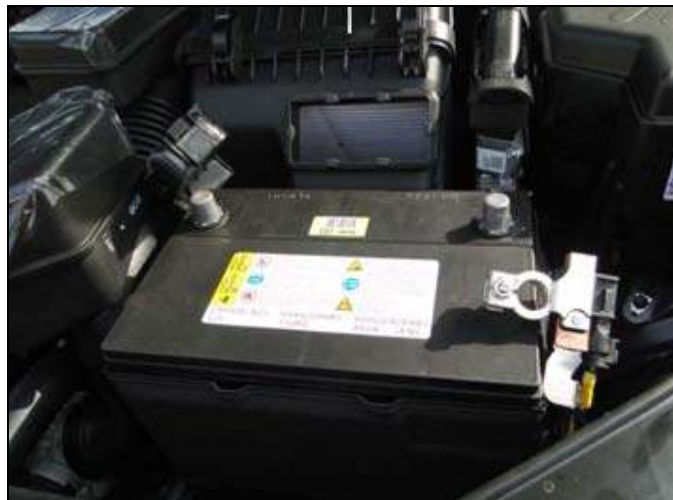
11. Remove the battery, if needed, to access the inhibitor switch.

Record the preset radio stations and reset after repairs are completed.

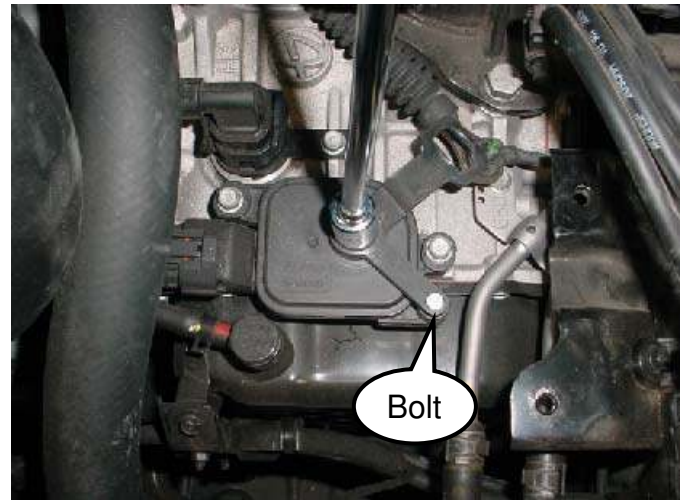
15. Install the manual control lever, washer and nut to the new inhibitor switch and tighten the nut.

**Torque: 13~18 lb-ft (1.8~2.5kgf.m)**

Insert **09480-A3800** guide pin or **5mm** bolt in the alignment hole before tightening the nut.

SST 09480-A3800, Inhibitor Switch Guide Pin

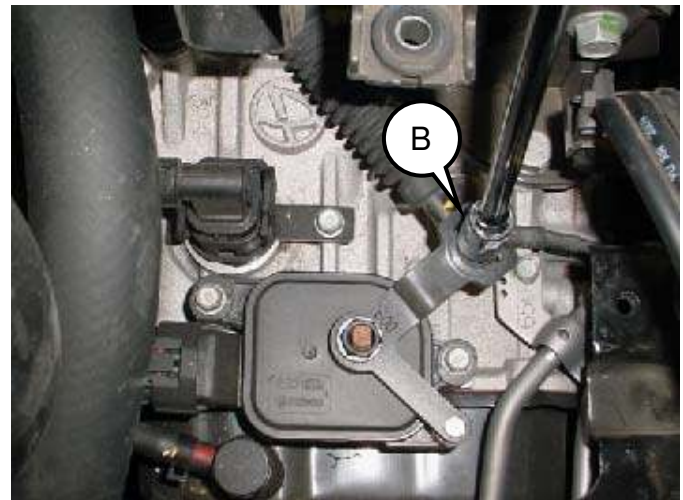
16. Install the shift cable nut (B) and tighten the nut to specification.

**Torque: 6~9 lb-ft (0.8 ~ 1.2 kgf.m)**

Remove the bolt or SST from the alignment hole.
