ATS 171102 Version 1

## MIL On with DTC P0035?

2017 Civic Type R

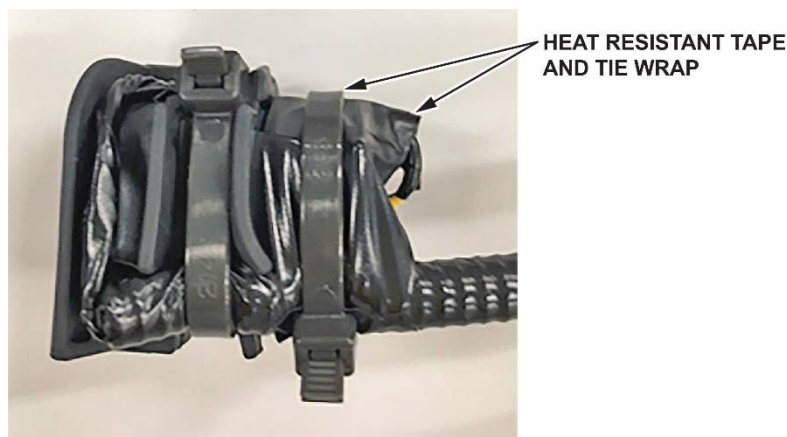
We found that when the connector matches a natural engine frequency, it starts to oscillate. Over time, this can cause one or both of the connector wires to break, resulting in a short. And if they do break, you might not even notice it if the insulation remains intact.

If this is the case, **don't** try repairing the broken connector wire(s). Even if you manage to, they're still prone to oscillation, and you could wind up with a comeback.

Instead, replace the engine wire harness with **P/N 32110-5BF-A02**. This replacement harness has a more robust turbocharger bypass control solenoid valve connector. So far, we haven't seen any reports of comebacks from using this harness.
