## SERVICE BULLETIN

**APPLICABILITY:** All Models Equipped with CVT Transmissions

**NUMBER:** 16-102-16

**SUBJECT:** DTC P0841 Diagnostics

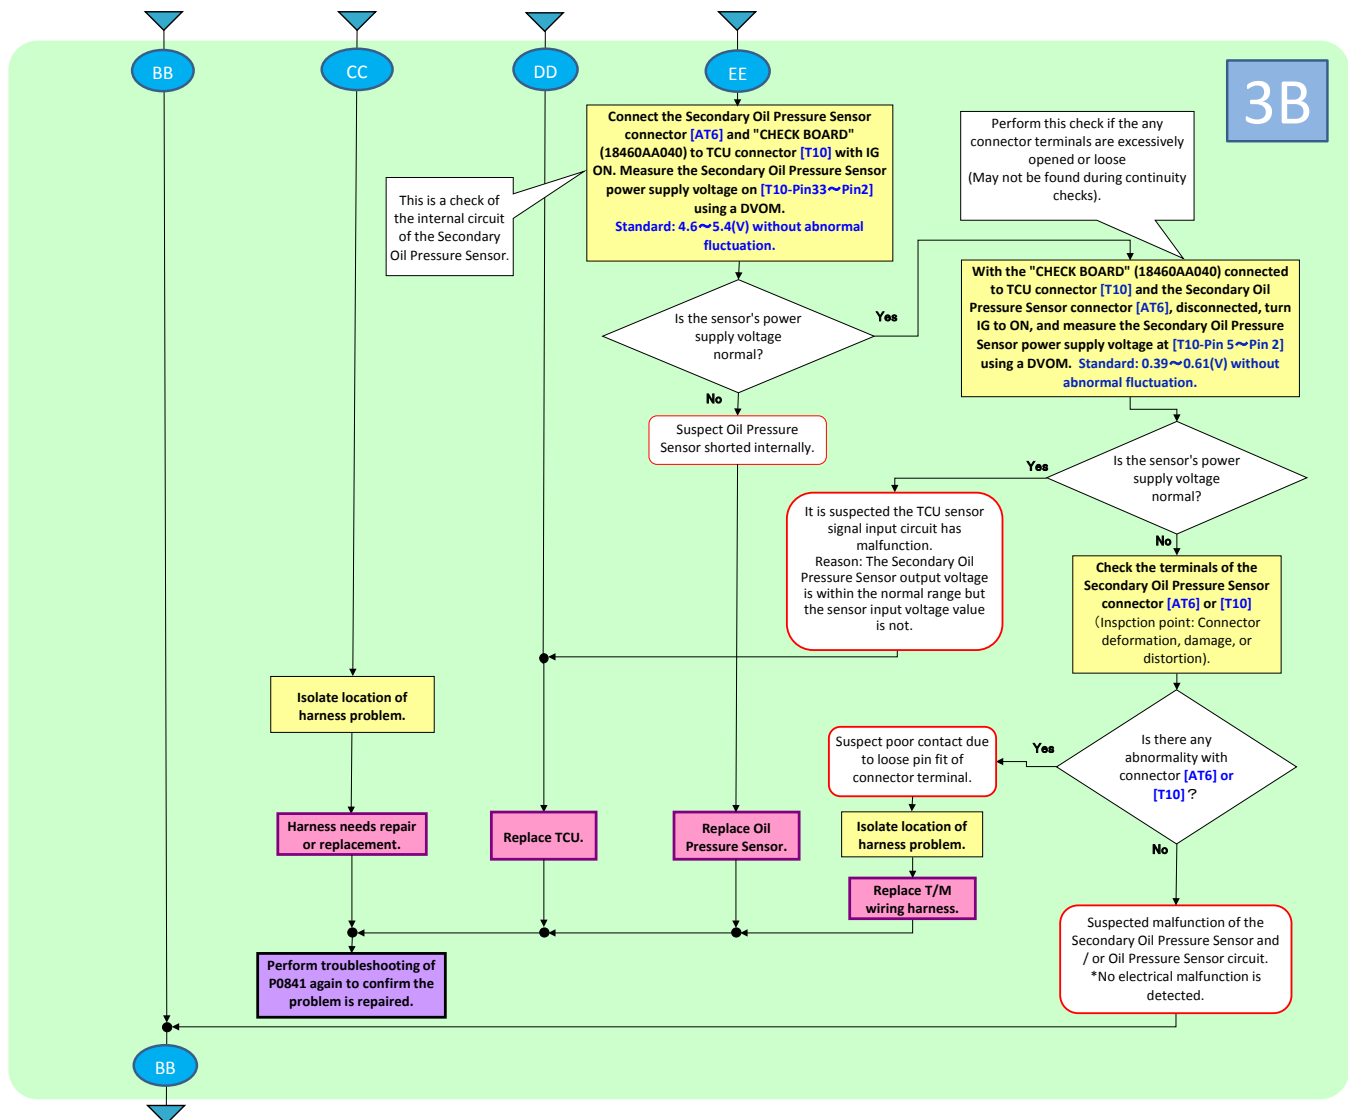
## STEP 3B:

(1) Contacts between broken wiring and the transmission case are the most common. However, small scrapes or abrasions to the wiring insulation can also cause short circuits to ground.

(2) The wiring and pins are bound inside the connector. If the binding is too tight, it can cause small scrapes or abrasions to the wiring insulation resulting in a short circuit between wires. Please check wiring inside the connectors also.
