EC17-031

ITB17-050

## 2016-2017 Q50 AND 2017 Q60; MIL IS ON WITH DTC STORED

APPLIED VEHICLES: 2016-2017 Q50 (V37)  
2017 Q60 (V37)  
APPLIED ENGINE: VR30DDTT

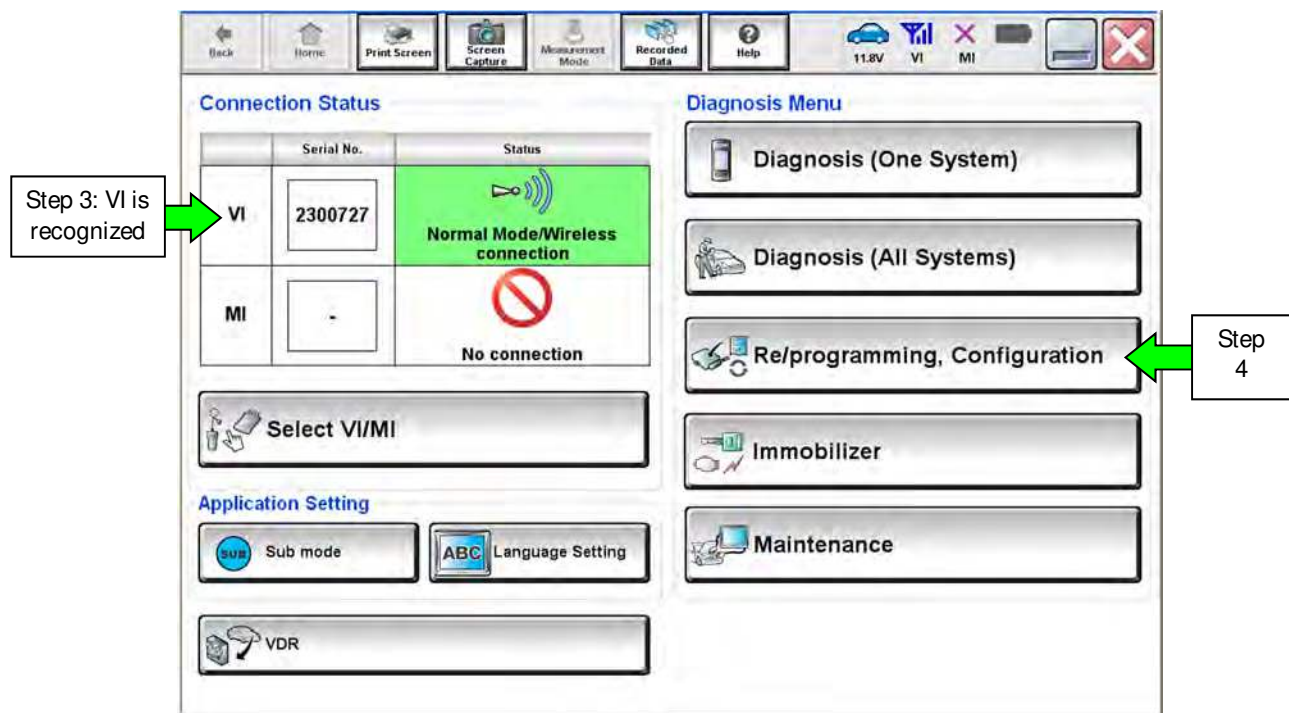
Figure 1

1. Connect the CONSULT PC to the vehicle to begin the reprogramming procedure.
2. Open ASIST on the CONSULT PC and start C-III plus.
3. Wait for the plus VI to be recognized / connected.
  - Serial number will display when the plus VI is recognized / connected.
4. Select Re/programming, Configuration.

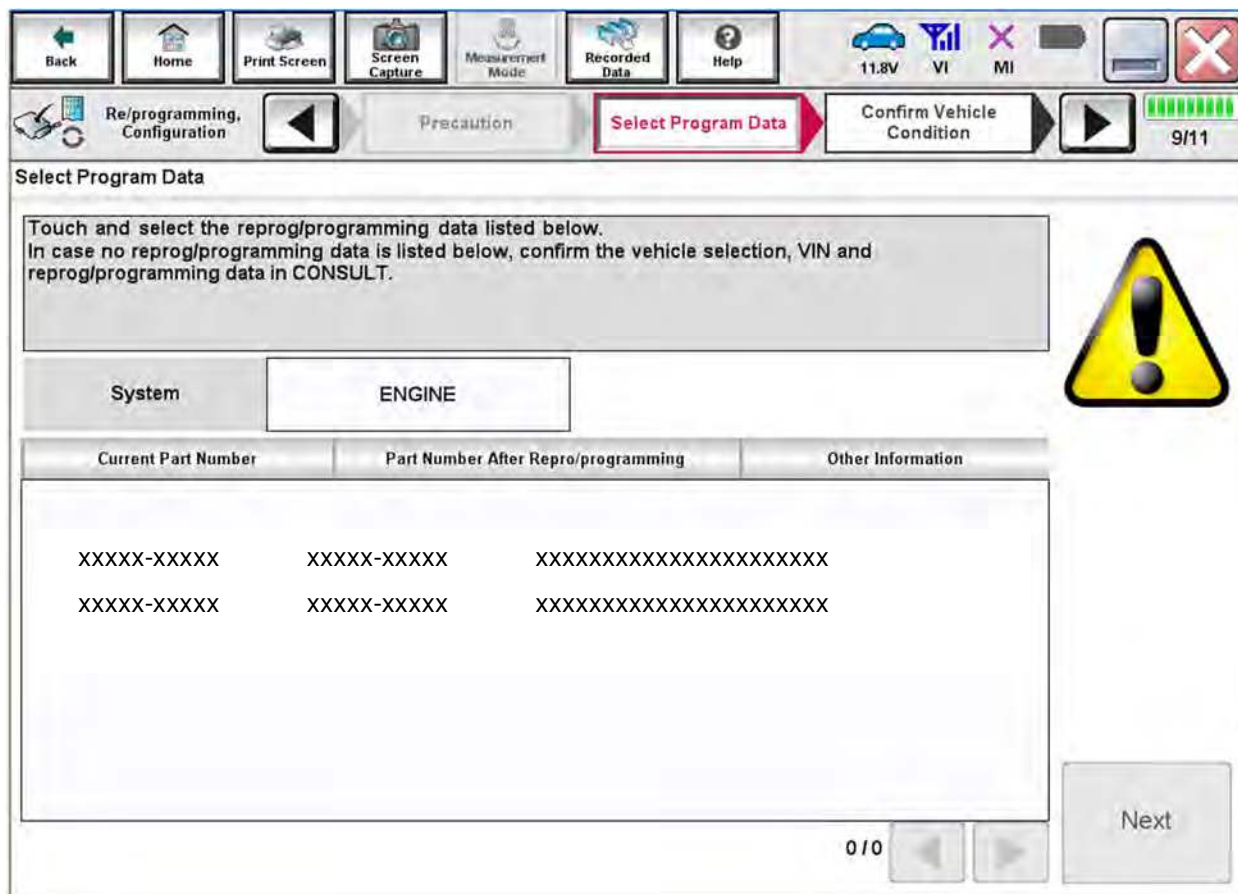
- In some cases, more than one new P/N for reprogramming is available.
  - In this case, the screen in Figure 3 displays.
  - Select and use the reprogramming option that does not have the message “Caution! Use ONLY with ITBXX-XXX”.
- If you get this screen and it is blank (no reprogramming listed), it means there is no reprogramming available for this vehicle. Close C-III plus and disconnect from the vehicle.

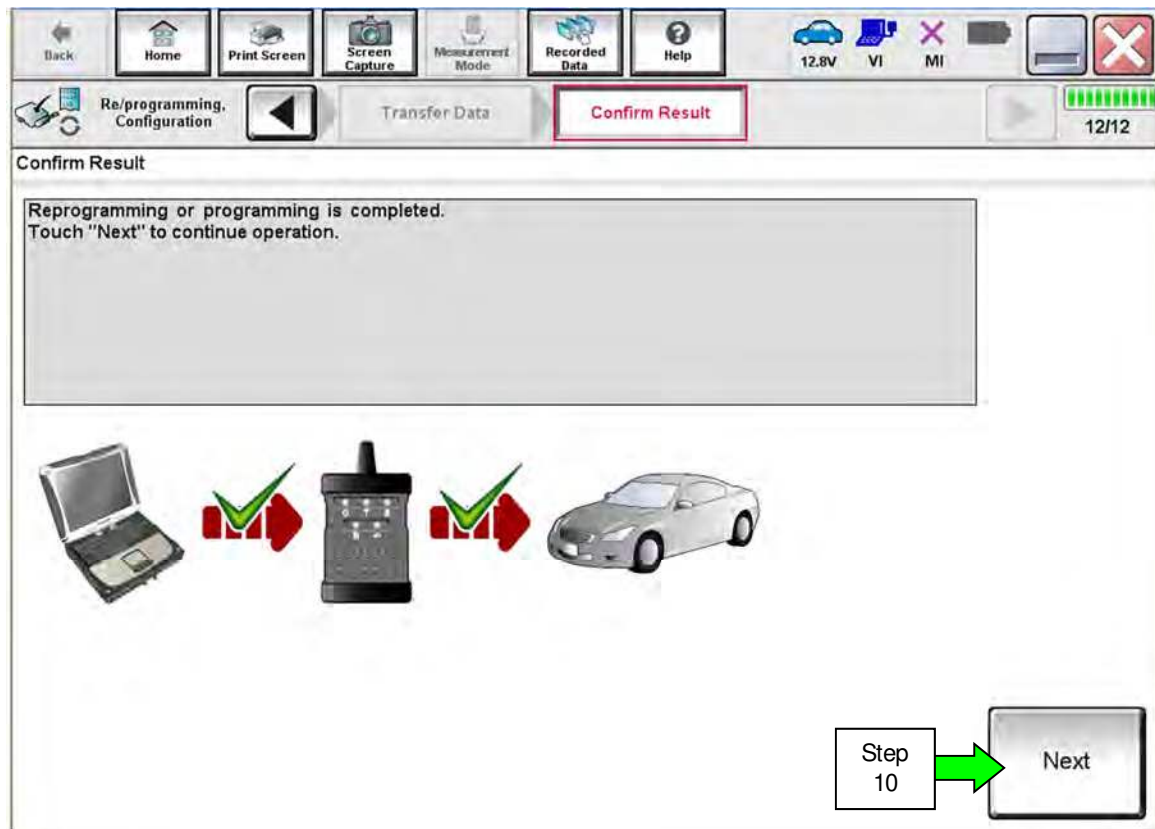
8. When the screen in Figure 4 displays, reprogramming is complete.

NOTE: If the screen in Figure 4 does not display (reprogramming does not complete), refer to the information on the next page.

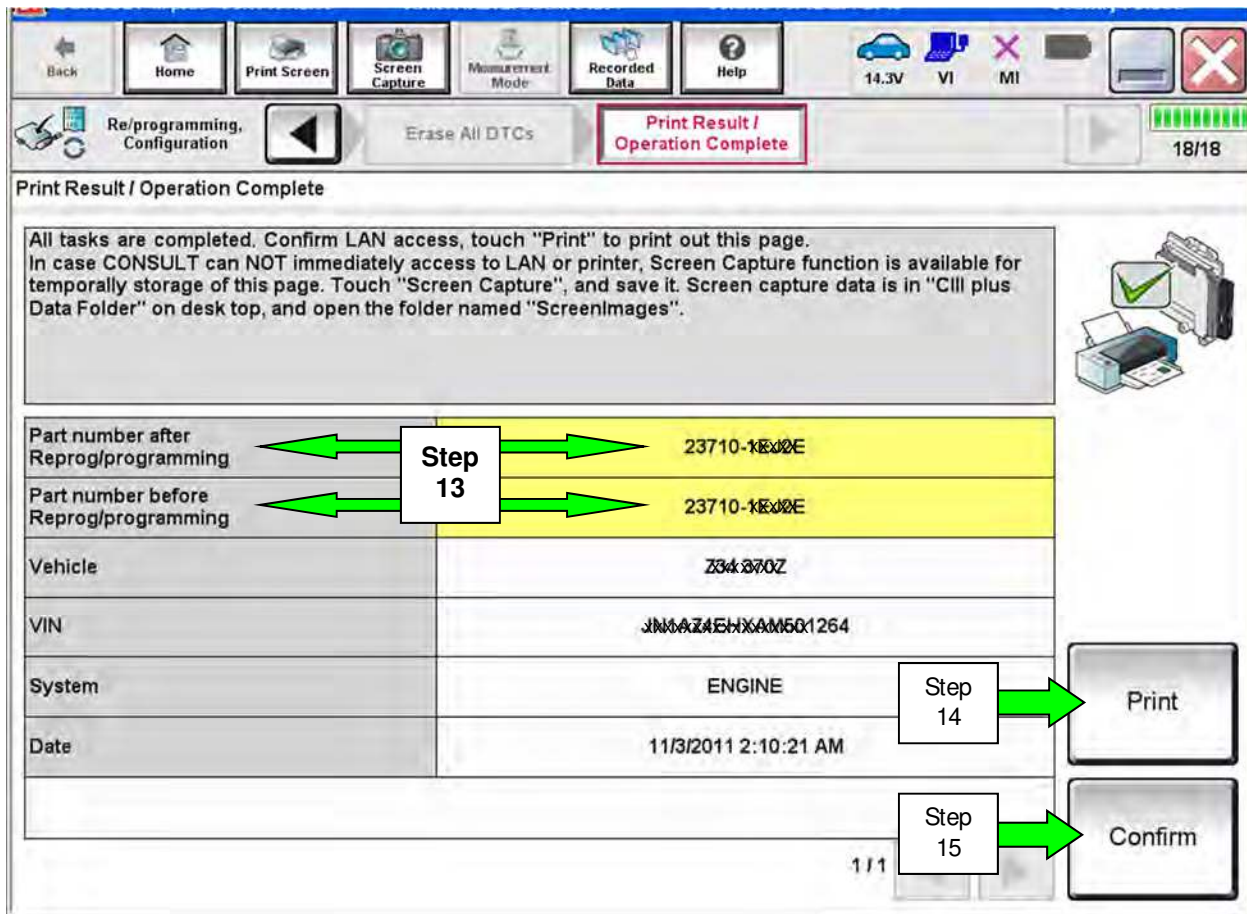
12. When the entire reprogramming process is complete, the screen in Figure 7 will display.
13. Verify the before and after part numbers are different.
14. Print a copy of this screen (Figure 7) and attach it to the repair order for warranty documentation.
15. Select Confirm.
