2021-2023MY  
Sorento (MQ4a)

257

## TECHNICAL SERVICE BULLETIN

ITM REPLACEMENT AND ECM & TCM  
LOGIC IMPROVEMENT (CA2508)

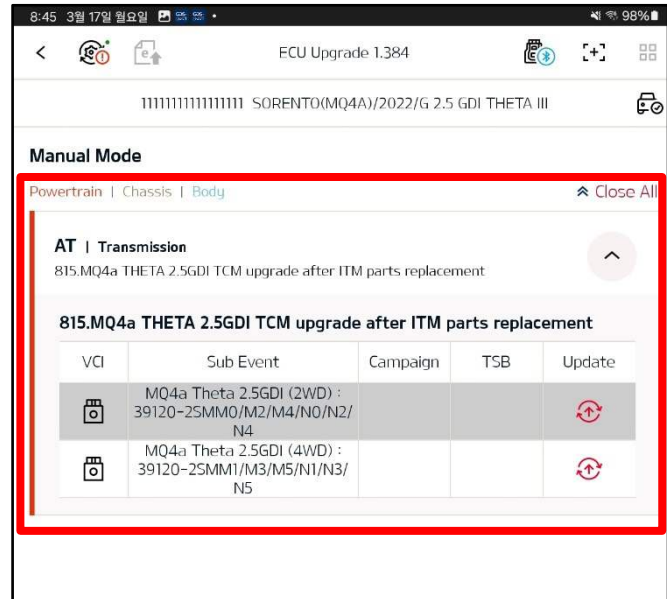
- **815. MQ4a THETA 2.5GDI TCM Upgrade After ITM Parts Replacement**

Verify the affected vehicle Calibration Identification of the applicable ECU ROM ID and reference the Information Table on pages 5 - 10 as necessary.

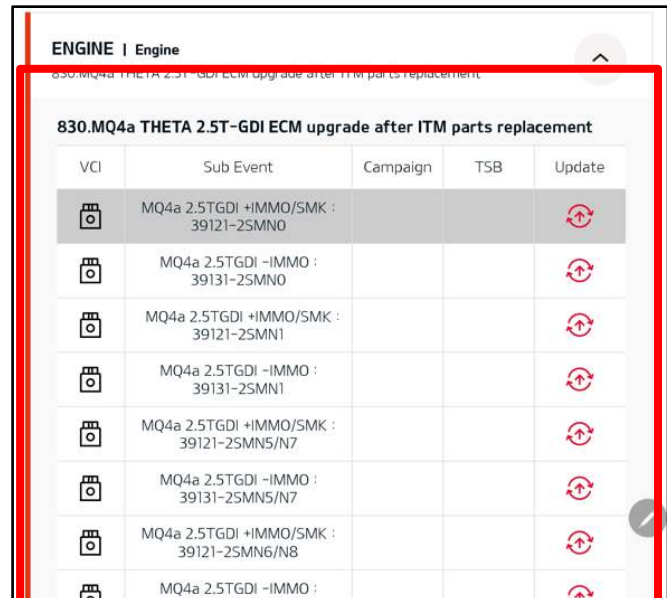
- **830. MQ4a THETA 2.5T-GDI ECM Upgrade After ITM Parts Replacement**

Verify the affected vehicle Calibration Identification of the applicable ECU ROM ID and reference the Information Table on pages 5 - 10 as necessary.

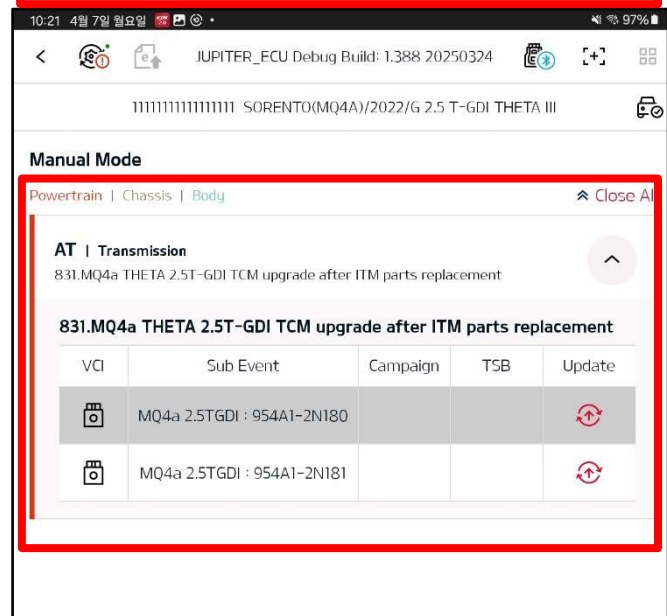
- **831. MQ4a THETA 2.5T-GDI TCM Upgrade After ITM Parts Replacement**

Verify the affected vehicle Calibration Identification of the applicable ECU ROM ID and reference the Information Table on pages 5 - 10 as necessary.

**After SW #831 Upgrade is Completed:**

**Perform Air Bleeding and Transmission Learning procedure using KDS.**
