## Technical Service Bulletin

**25-EM-007H**

**ITM THERMOSTAT SPRING INSTALLATION &  
ECU SOFTWARE UPDATE – DTC P218100**

**Description:** Some Elantra (CN7, CN7A), Kona (OS, SX2), and Sonata Hybrid (DN8 HEV) vehicles equipped with 2.0L engines may illuminate a warning lamp for DTC P218100 (Cooling System Performance) related to the Integrated Thermal-Management Module (ITM).

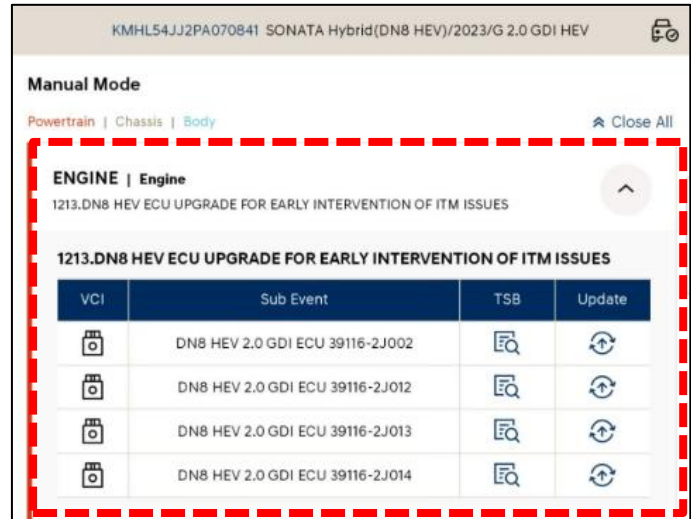
3. After the ECU update process shows 100% complete, follow the prompts on the screen to cycle the ignition **OFF** for at least **10 seconds** to reset the control unit (certain models may take up to **30 seconds**).

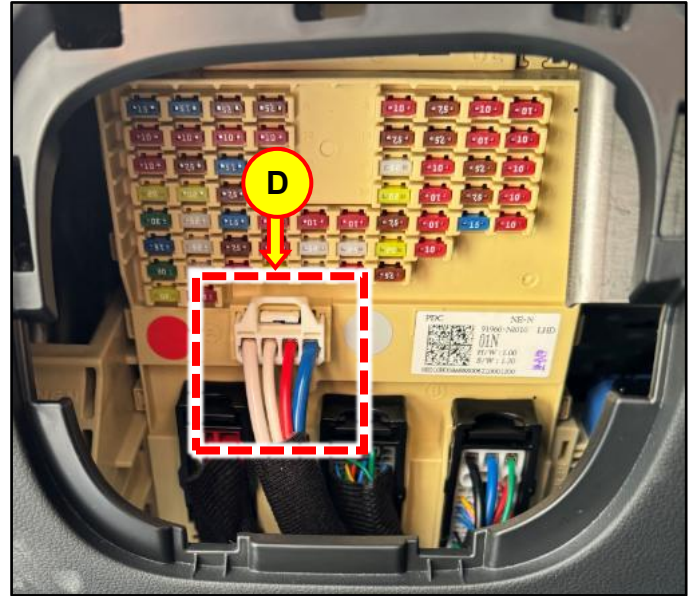
8. Start the engine OR place in **Ready** mode to confirm proper operation of the vehicle.
9. Perform the ITM Coolant Filling Method to fully bleed the cooling system using GDS to enter the **Integrated Thermal Module Coolant Filling Mode**.
