# Technical Service Bulletin

| <b>Topic</b> | Window Drop Glass Operation Continental GT/GTC 19-24MY |
| <b>Transaction No.</b> | 2080375/1 |
| <b>Release date</b> | Jan 20, 2026 |

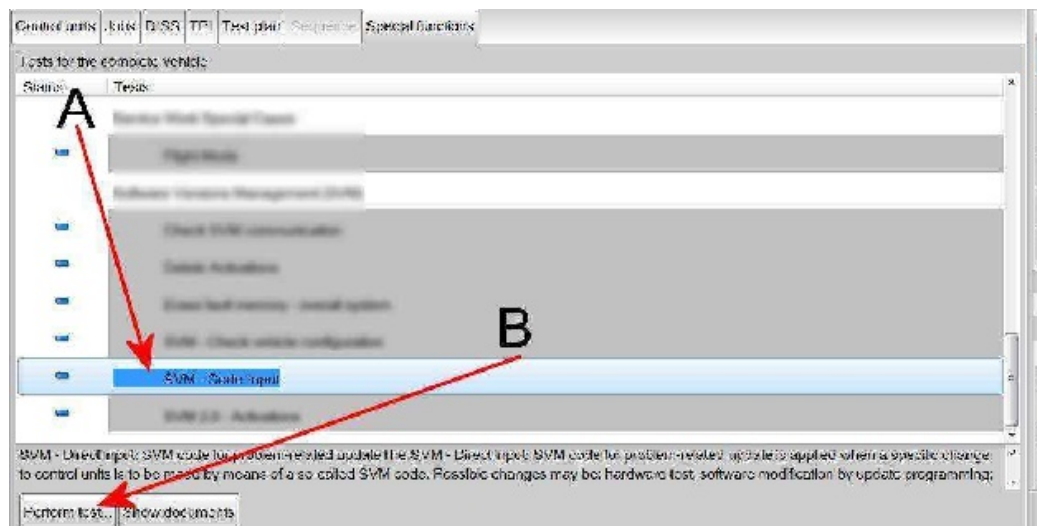
4. Referring to Figure 1 - Within the Special functions tab - Select SVM - Code Input (Point A)

- Select Perform test (Point B)

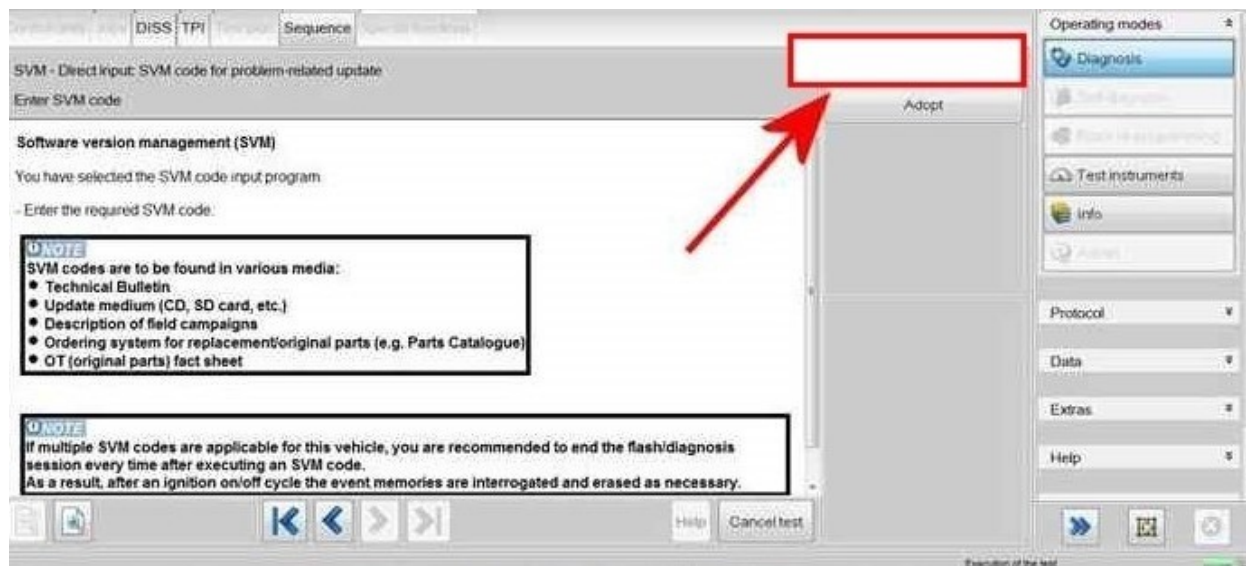
5. Referring to Figure 2 - Enter SVM code **370FTM01**

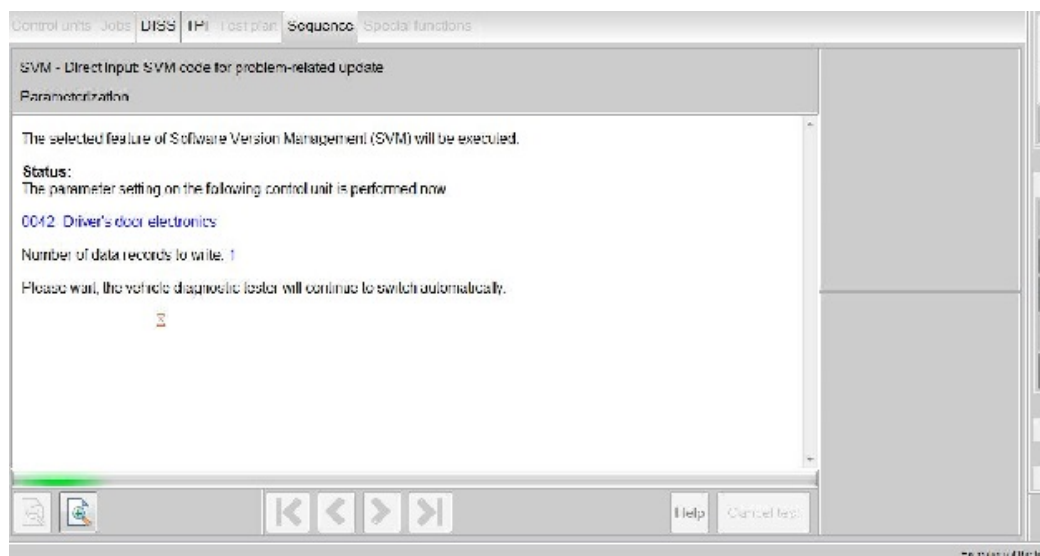
Figure 3

6. The required control modules will be automatically updated one by one, starting with 0042 – Door electronics Drivers side (Figure 3)

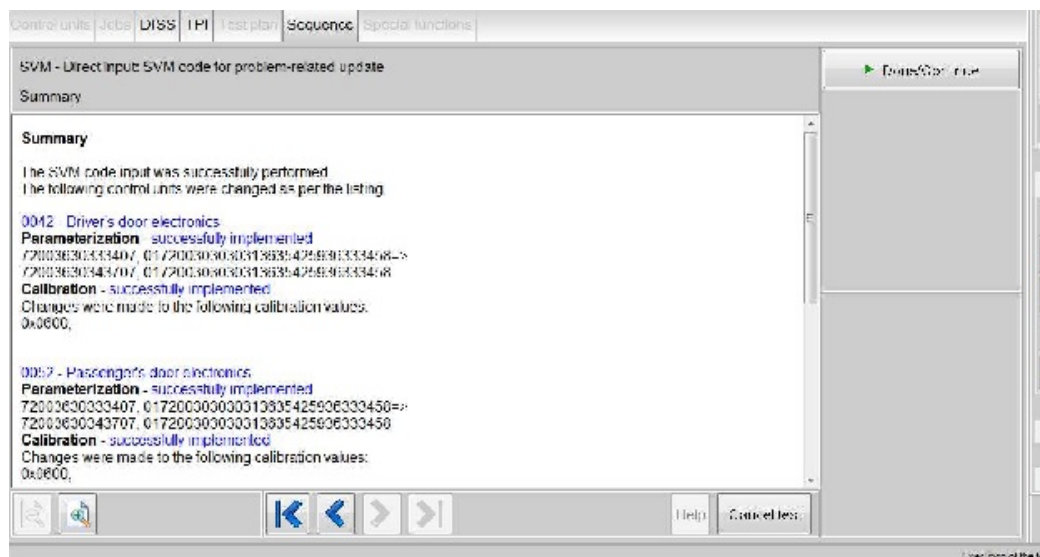
Figure 4

7. Once the update is complete the summary screen will be shown in Figure 4, this confirms completion of the required updates

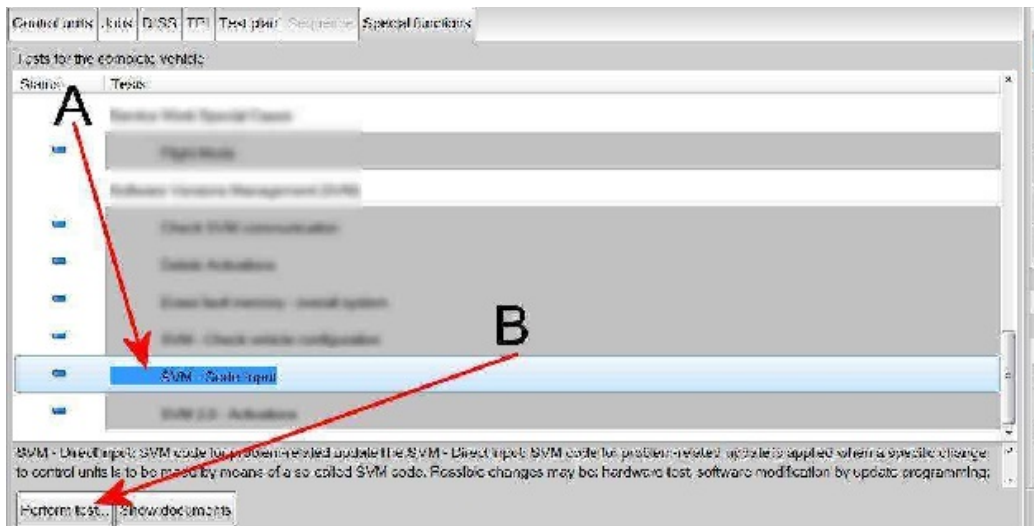
9. Referring to Figure 5 - Within the Special functions tab - Select SVM - Code Input (Point A)

- Select Perform test (Point B)

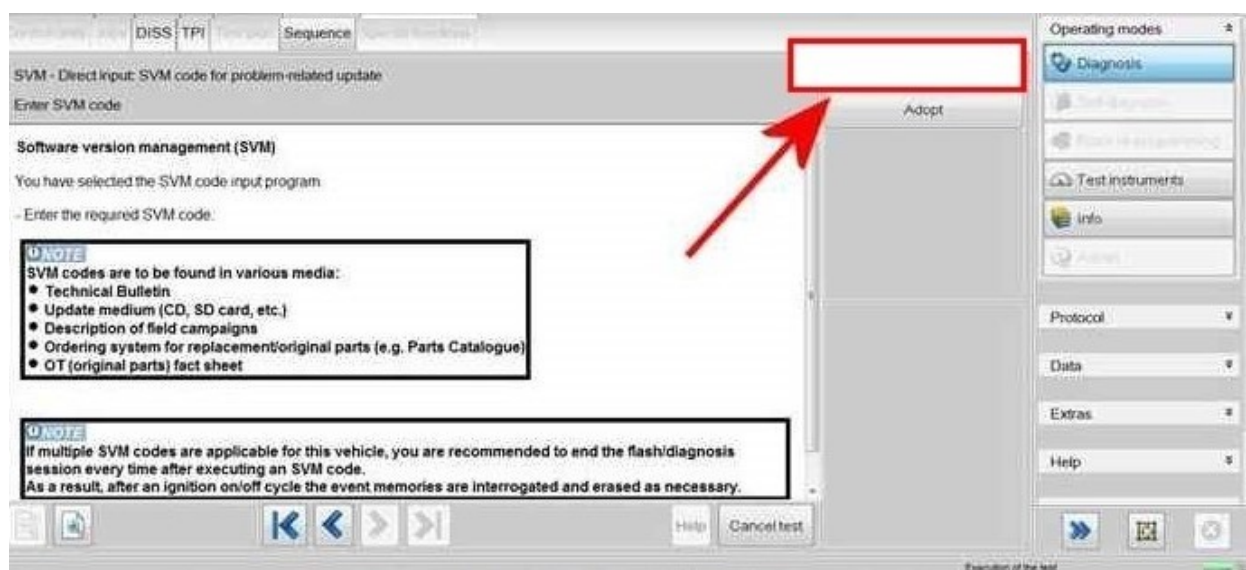
#### 10. Referring to Figure 6 - Enter the SVM code **370WAD01**

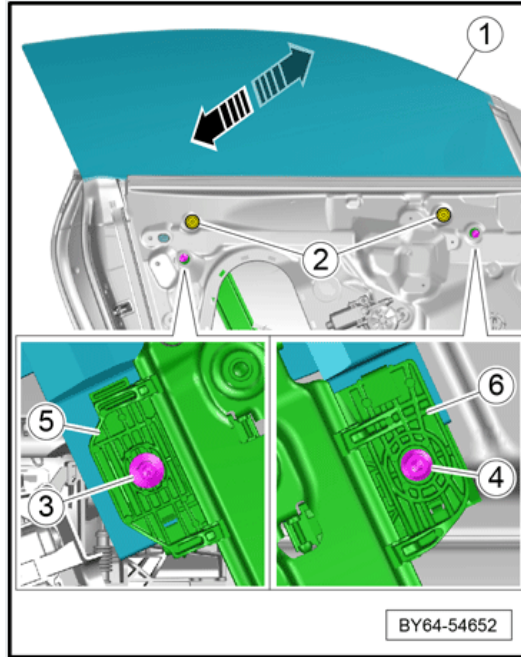
Figure 3

If the specifications for interlock points 2, 3 or 4 cannot be achieved through normal adjustment, insert the ratchet as shown in figure 4 and unwind both screws two full turns counterclockwise.

Then loosen the two purple bolts (-3- & -4-) in figure 3, raise the glass evenly as required, and re-secure the two purple bolts. Finally, return to the allen key (ratchet) adjustment to set interlock points 2, 3 and 4 to specification. Check the 971mm measurement has not altered, if so, re-adjust as required.

Loosen bolts -3- & -4- to ensure the glass sits in mounting position in its lowest position. Then resecure the bolts.

**NOTE:** If the 971 mm  $\pm$  1mm specification shown on the previous slide is incorrect, these bolts must be loosened to adjust the glass forward or backward as needed to meet the correct specification.

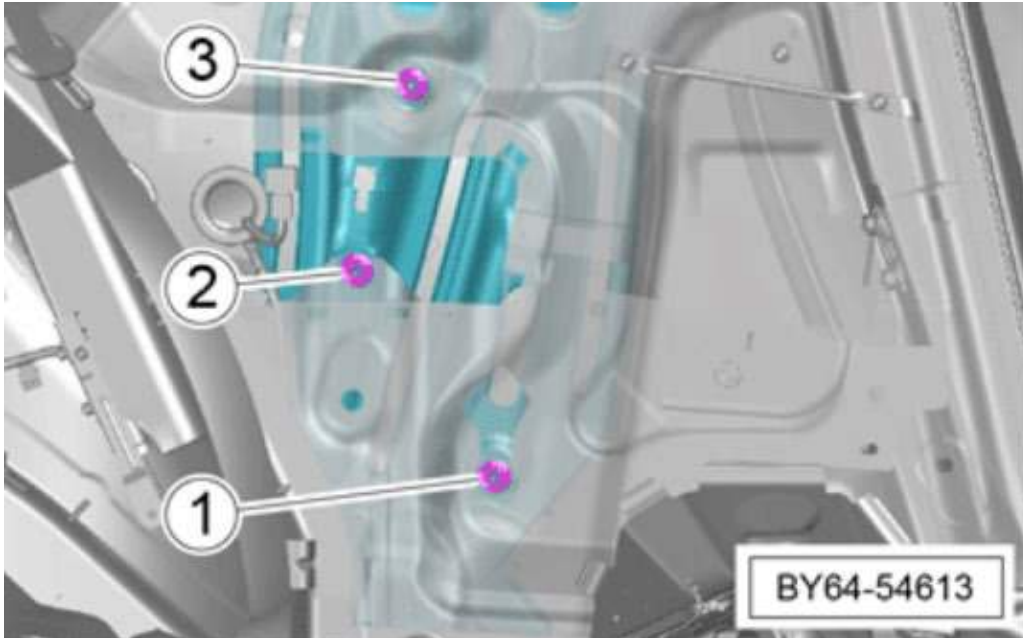
Figure 7

In some cases, since not all adjusters are visible, there is a possibility that the adjusters can be set to their maximum inboard/outboard and induce excess tension in the regulators and affect the angle the windows enter the seals. There is free play built into the front and rear regulators, therefore as the windows are being held in place by the cant rail/convertible roof seals when closed, this may not be apparent when measuring. However, these extreme adjustments can cause issues with how the windows enter the cant rail/convertible roof seals or how the front and rear glasses interlock with each other, in some cases this can cause the seals to pinch and cause an anti-trap condition leading to window reversal.

**NOTE:** After you have carried out the reset procedure, ensure measurements are rechecked as per the check & measurements attachment

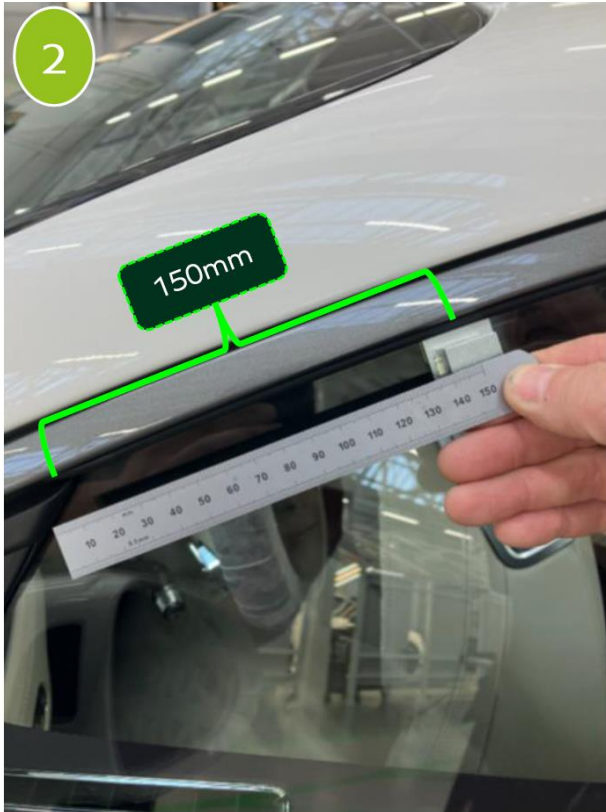
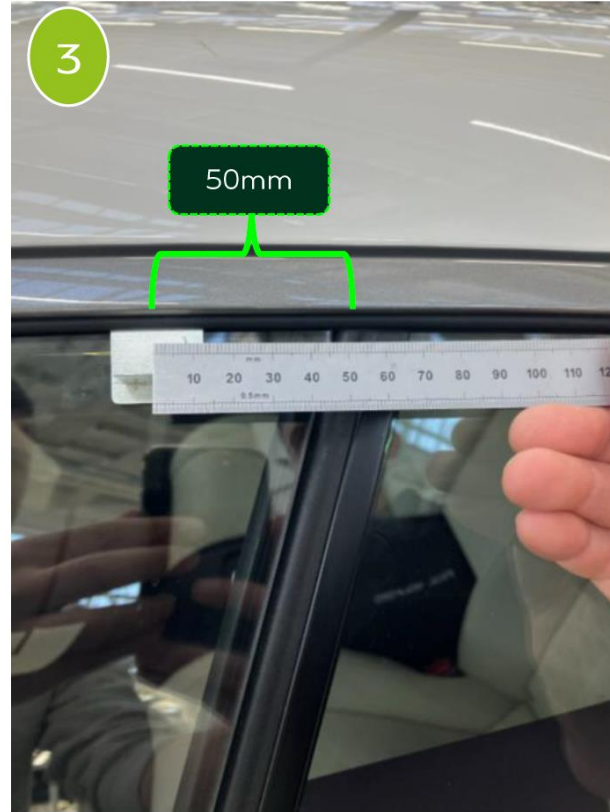
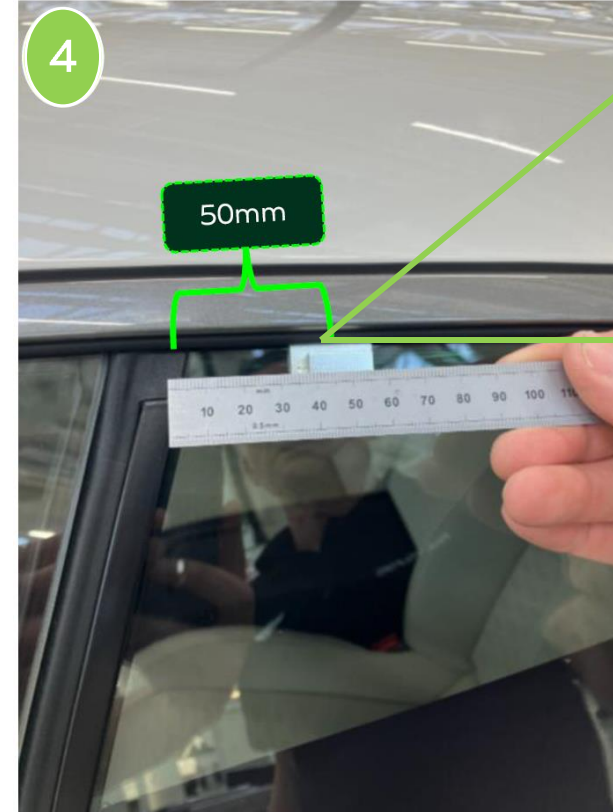
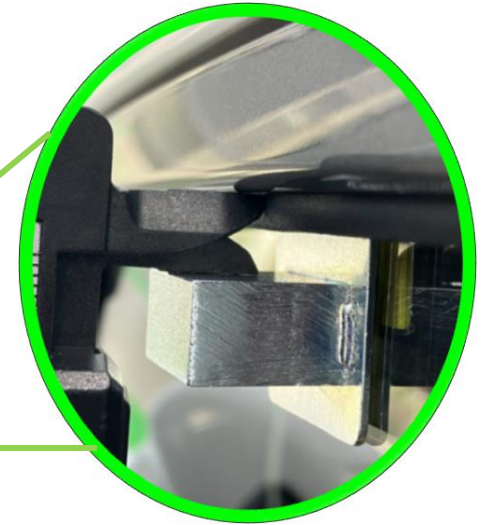
Place block 150mm  
behind corner of  
front div bar

Place block 50mm  
in front of rear div  
bar

Place block 50mm  
to rear of rear div  
bar

**Specification**  
8mm ± 1mm  
(Interlock Tool WT10549)

If the measurement is  
out of specification  
refer to ElsaPro

**Repair Group 64 'Slide  
glass checking and  
adjusting'**

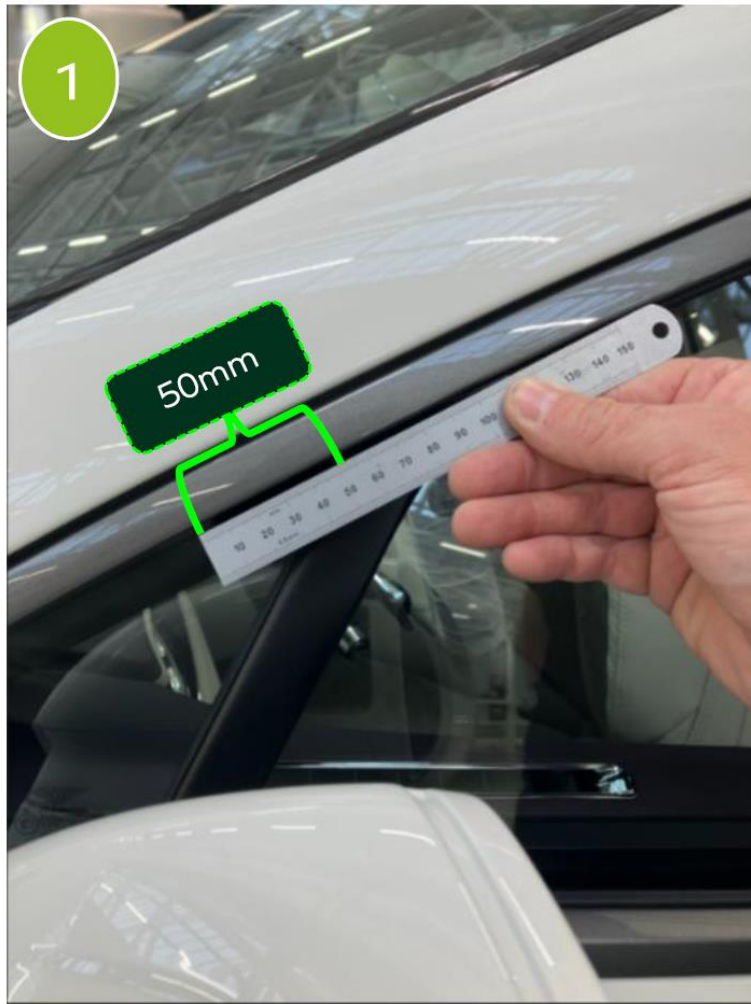
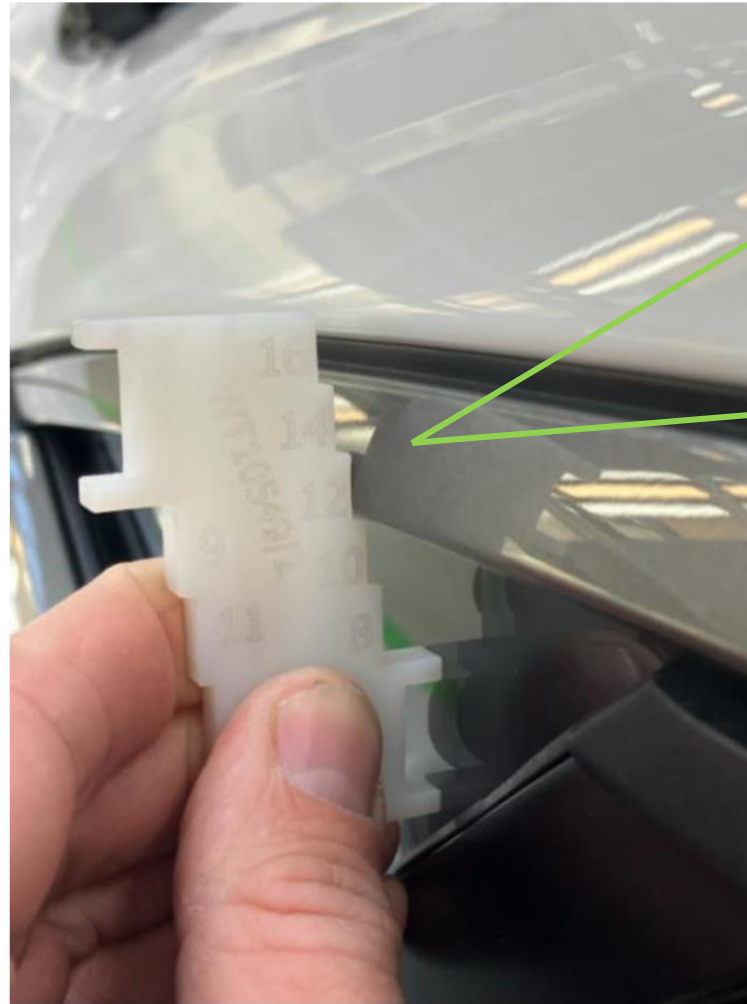
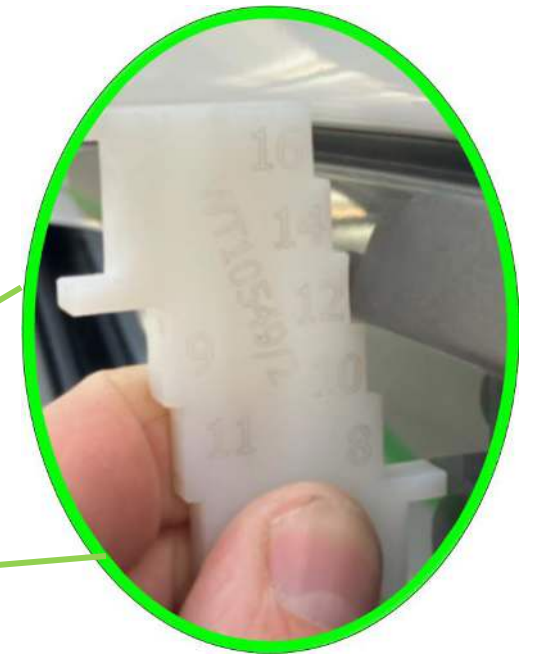
50mm in front of front div  
bar

Flat against glass to  
brightware

**Specification**  
10mm  $\pm$  1mm  
(Profile Tool WT10549/2)

For the front door, poor door profile point is a major contributing factor here and should be checked/adjusted if window found to be entering seal incorrectly.

If this is not correct, it will cause the window to bounce back causing a loss of basic settings.

If the measurement is  
out of specification refer  
to ElsaPro

**Repair Group 64 'Slide  
glass checking and  
adjusting'**

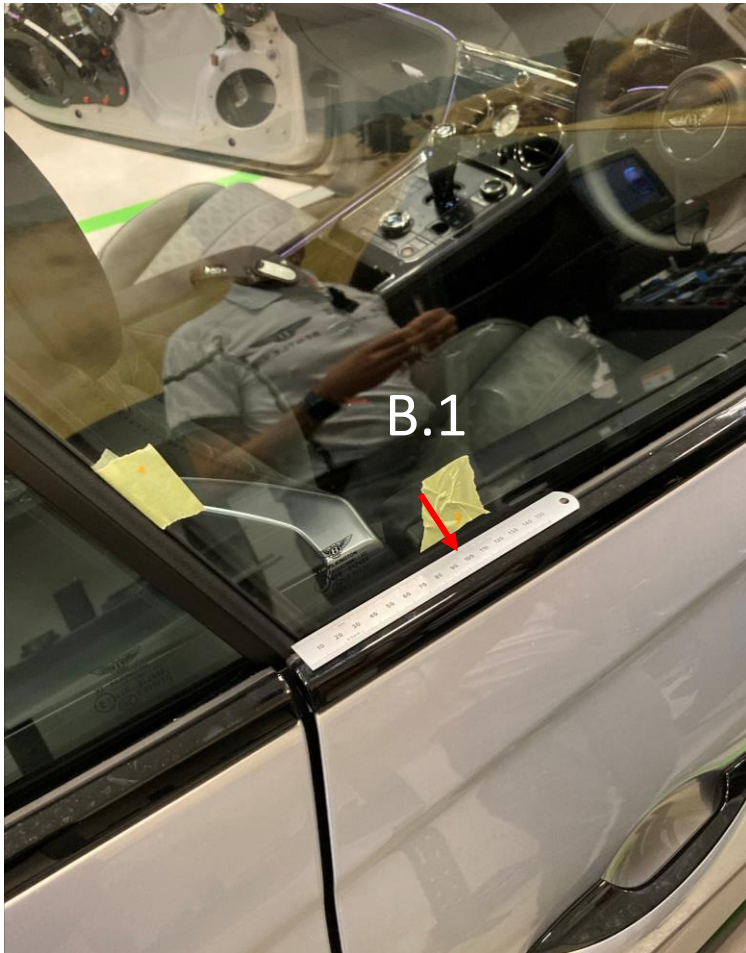
# WAIST SEAL MEASUREMENT POINT B

Mark on tape 100mm from  
div bar (B.1)

Measure from first lip rubber  
seal to window glass (B.2)

(B.1) 100mm from corner

(B.2) 5mm  $\pm$  1mm  
(Ruler)

If the measurement is out of  
specification refer to ElsaPro

**Repair Group 64 'Slide glass  
checking and adjusting'**

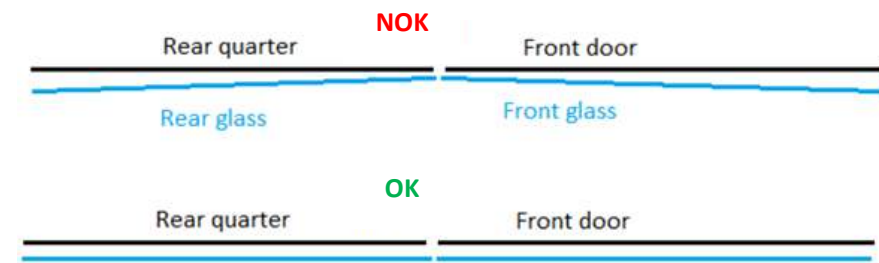
See image below, for OK and NOK after  
adjustment/checking

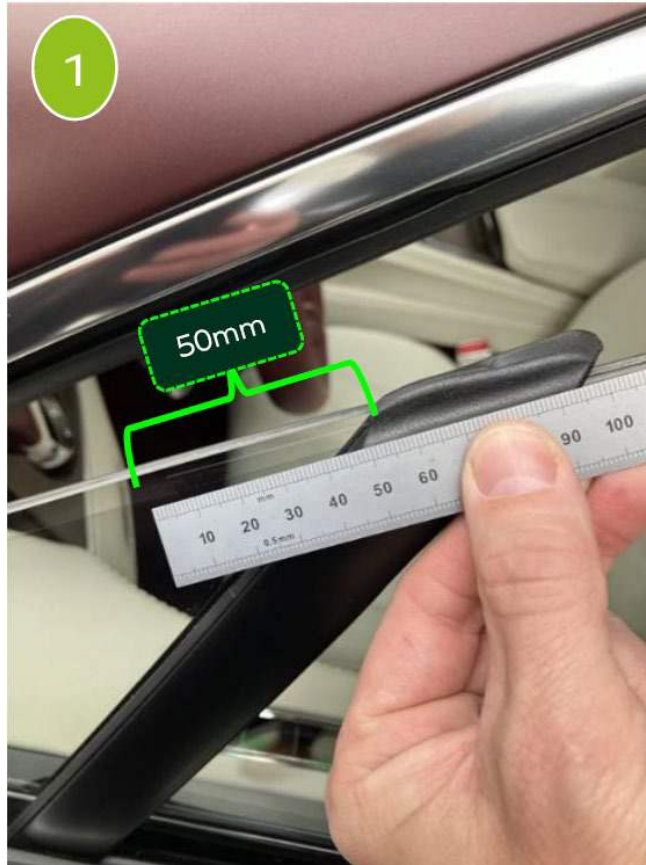
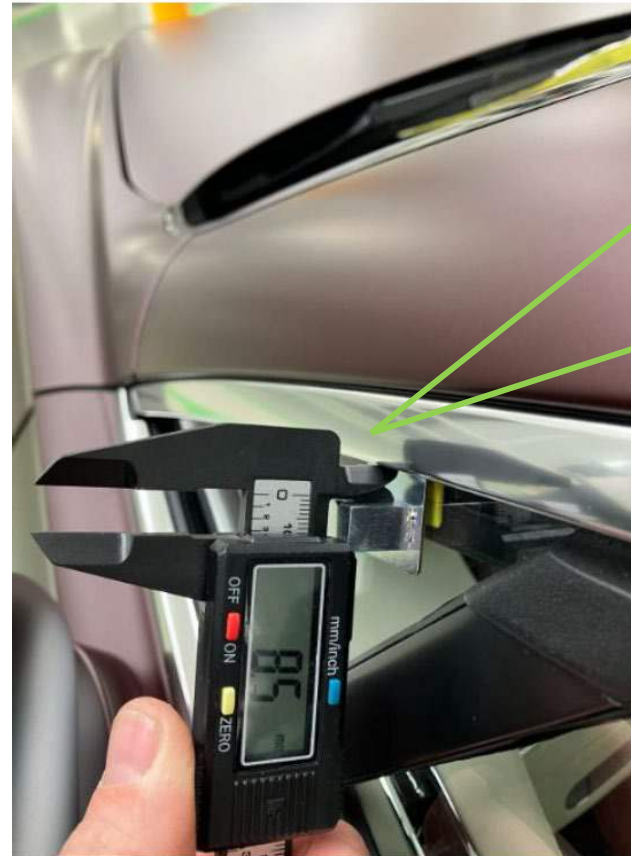
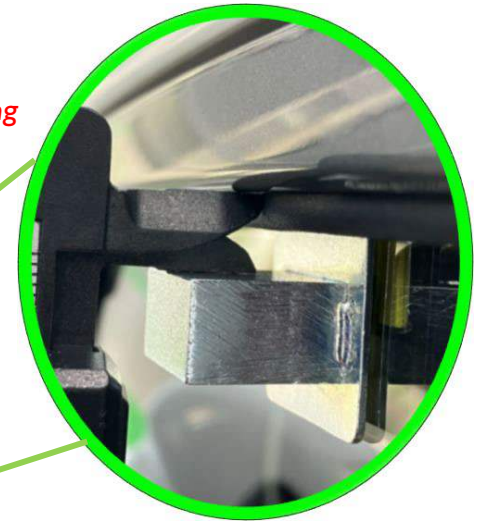
# INTERLOCK POINT 1

Place block 50mm in front of front div bar

Record measurement for all interlock points

From block to bright ware for all interlock points

**Repair Group 64 'Front door quarter glass – To adjust'**

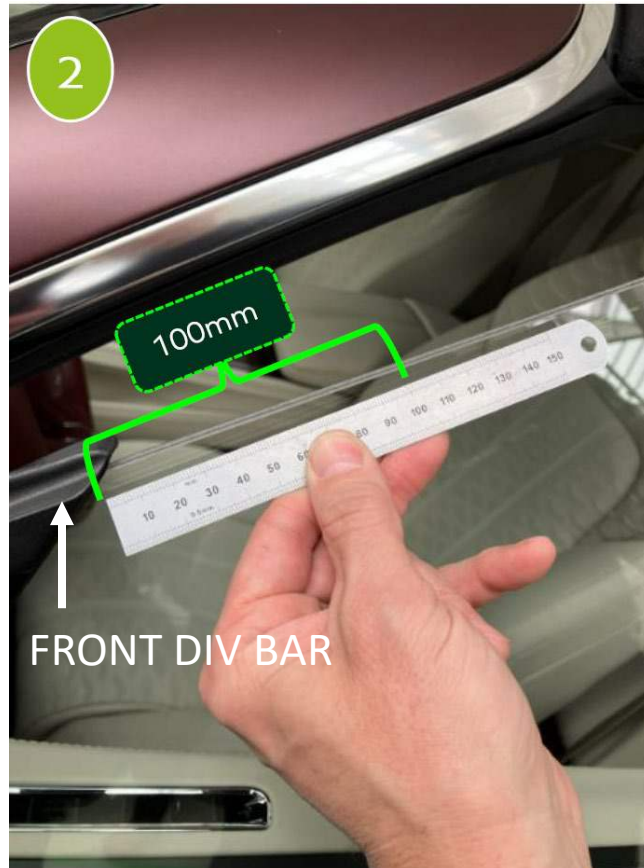
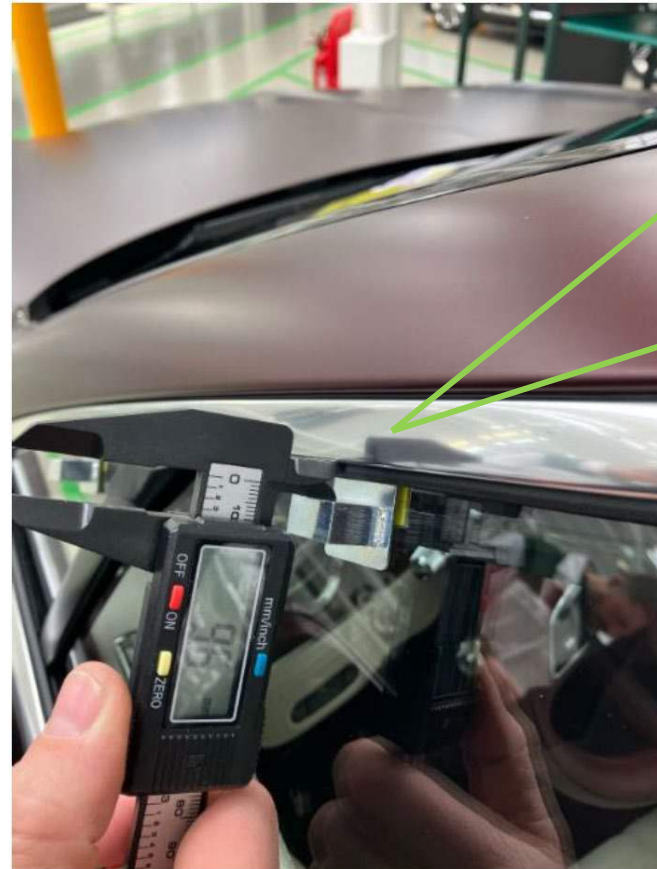
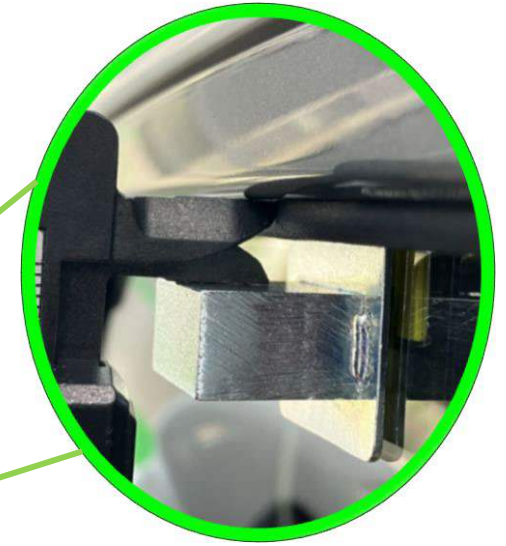
# INTERLOCK POINT 2

Place block 100mm in front of front div bar

Record measurement for all interlock points

From block to bright ware for all interlock points

**Repair Group 64 'Front door quarter glass – To adjust'**

*If the specification for interlock points 2, 3 or 4 cannot be achieved through normal adjustment, refer to page 6 of the glass reset procedure.*

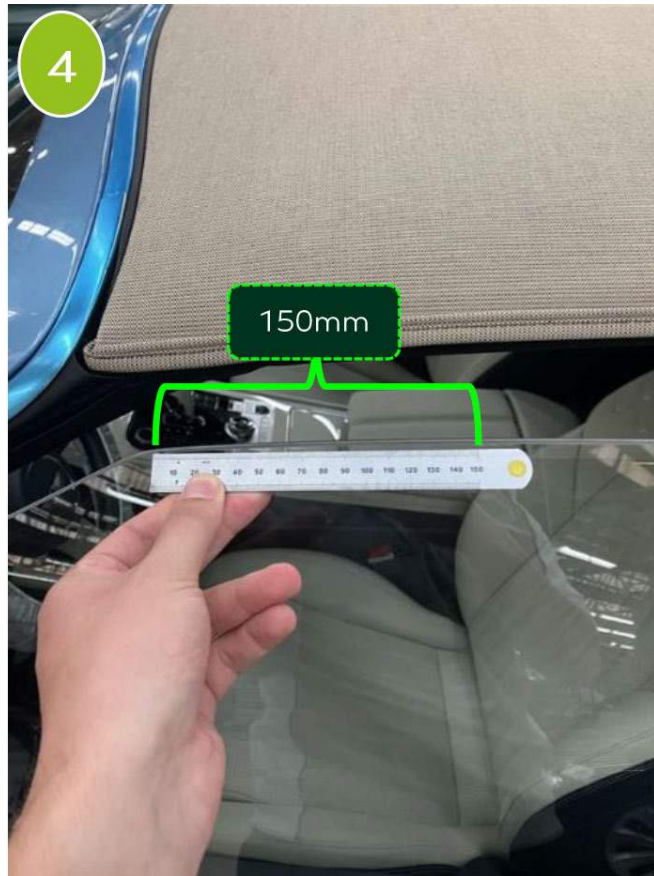
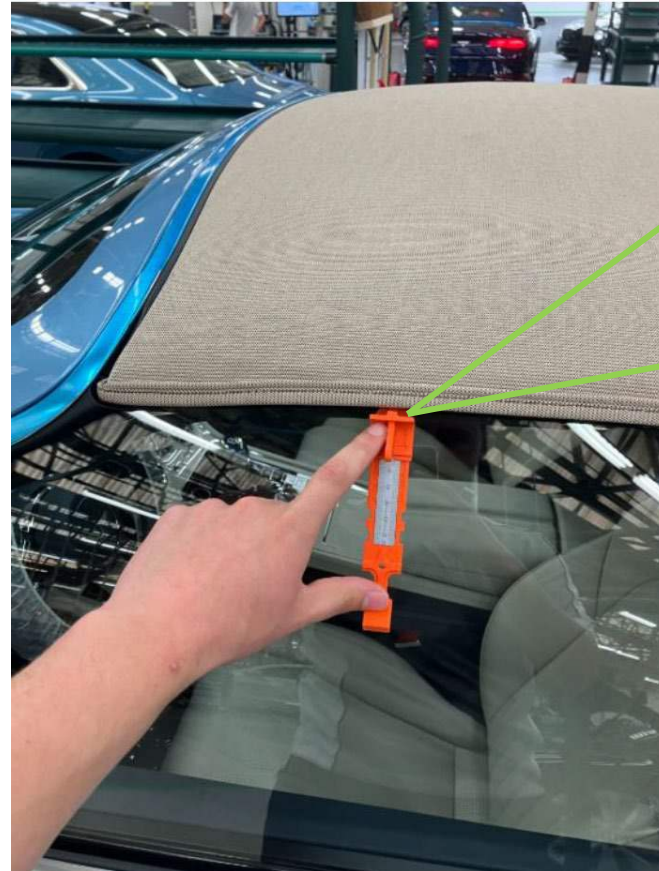
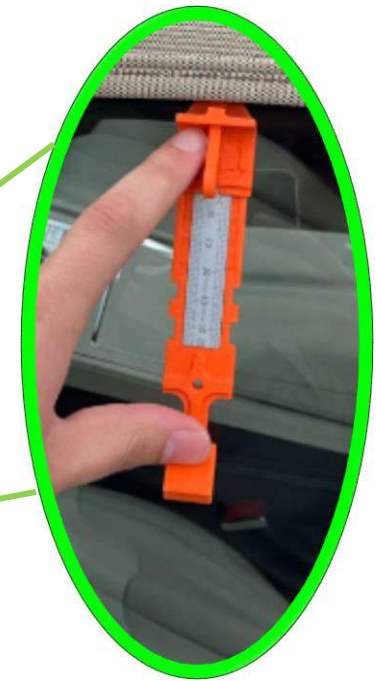
# INTERLOCK POINT 3

150mm from front corner of window glass as shown

1. Hook onto glass with door open at measured point
2. Close door and allow glass to close
3. Lightly push gauge to top and take measurement at indicated point. Do not deform the seal.

**Specification**  
8.5mm  $\pm$  1mm  
(Interlock Tool WT10554)

If the measurement is out of specification refer to ElsaPro Repair Group 64 'Front door quarter glass – To adjust'

*If the specification for interlock points 2, 3 or 4 cannot be achieved through normal adjustment, refer to page 6 of the glass reset procedure.*

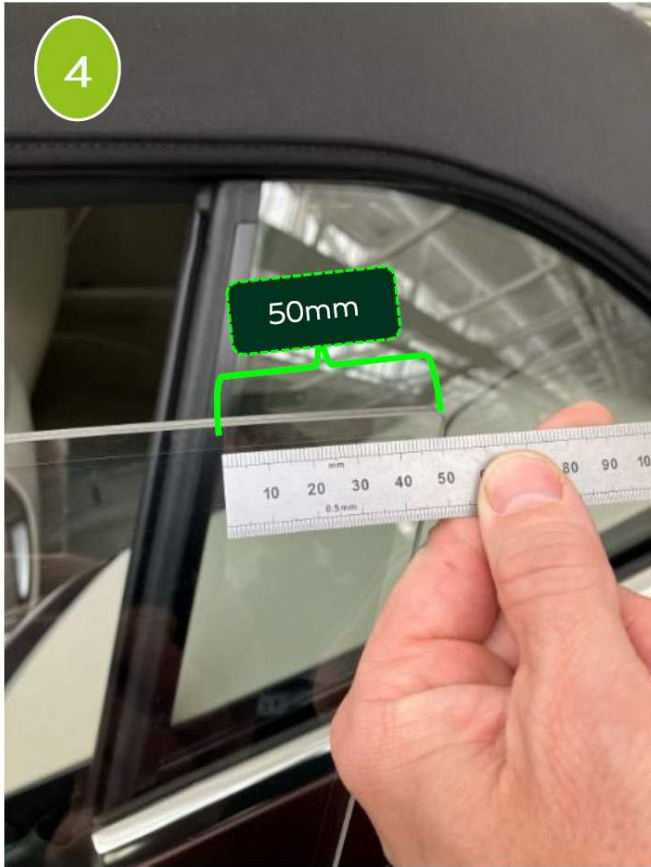
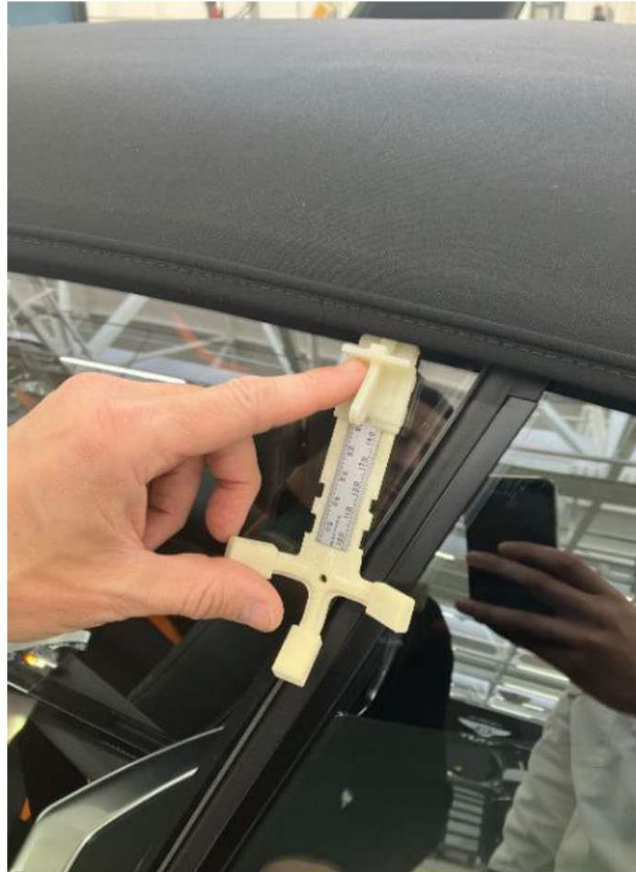
# INTERLOCK POINT 4

50mm from rear edge of the front door glass as shown

**Specification**  
8.5mm  $\pm$  1mm  
(Interlock Tool WT10554)

If the measurement is out of specification refer to ElsaPro Repair Group 64 'Front door quarter glass – To adjust'

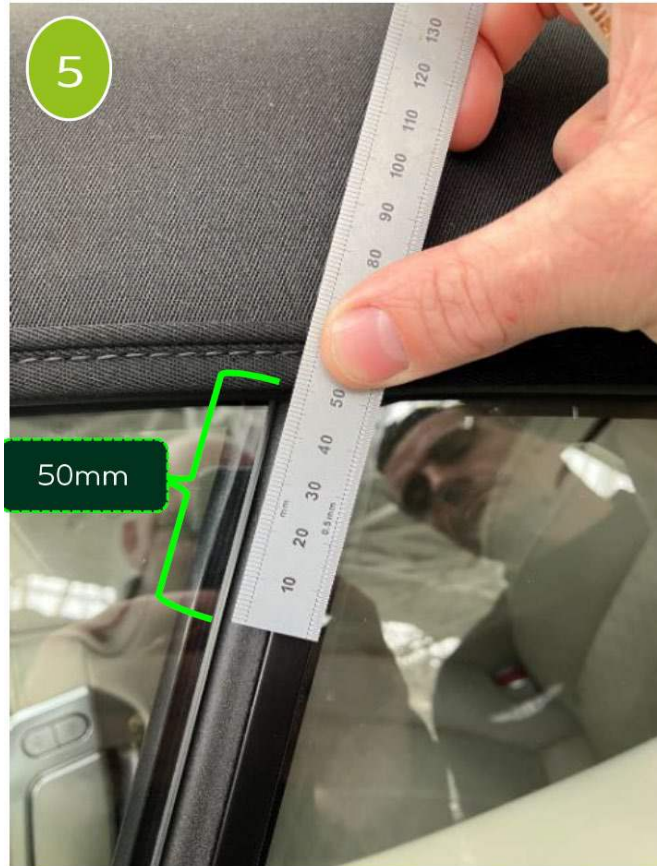
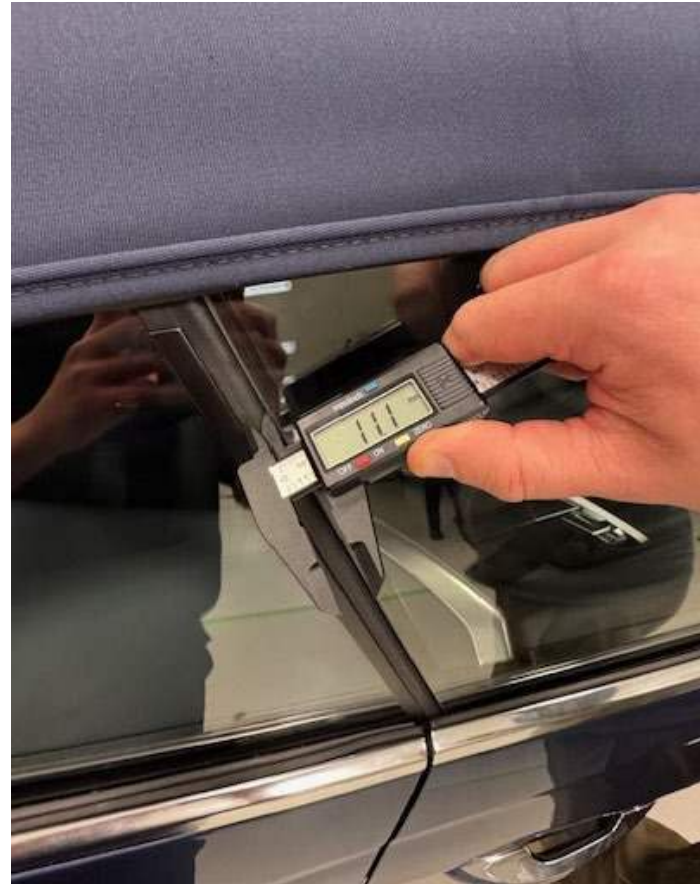
# INTERLOCK POINT 5 ROOF UP

50mm from corner

Record measurement

If the measurement is out of specification refer to ElsaPro Repair Group 64 'Front door quarter glass – To adjust'

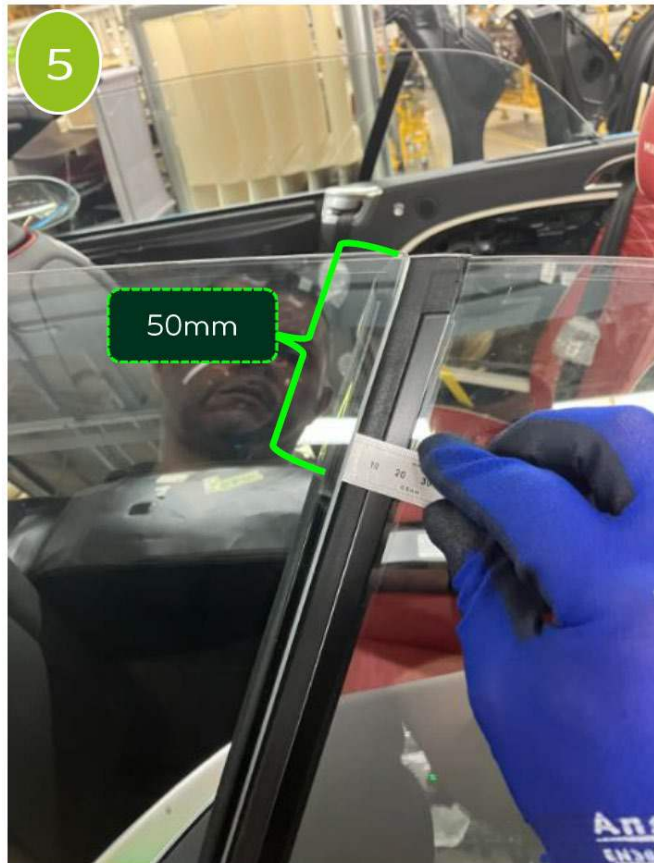
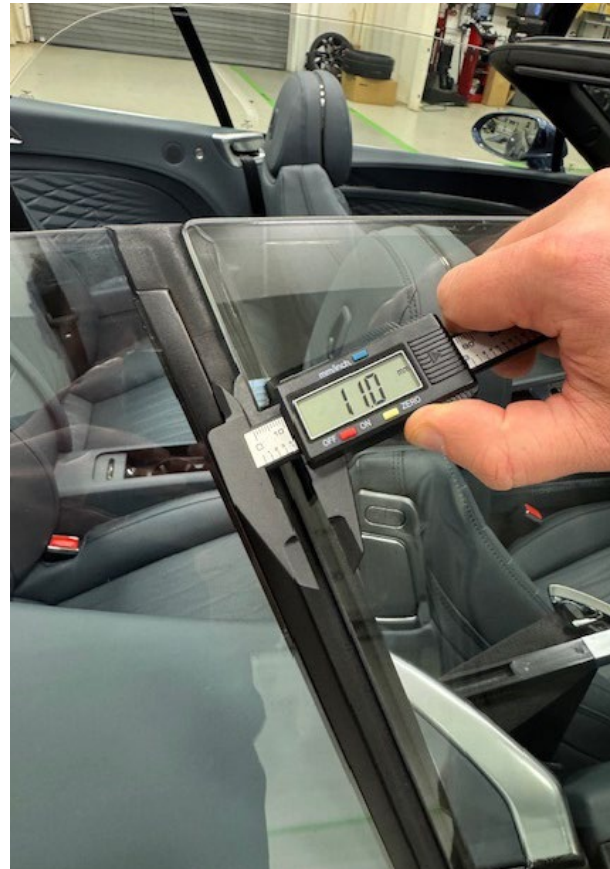
# INTERLOCK POINT 5 ROOF DOWN

Take measurement  
50mm from top of glass

Record measurement

**Specification**  
11mm  $\pm$  1mm  
(Ruler/vernier)

If the measurement is out of  
specification refer to ElsaPro  
**Repair Group 64 'Front door  
quarter glass – To adjust'**

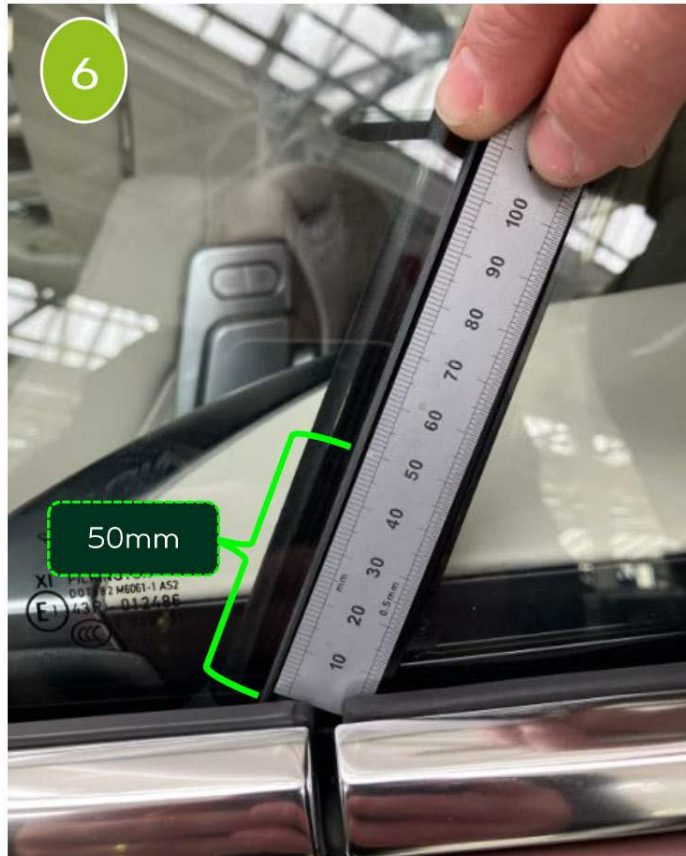
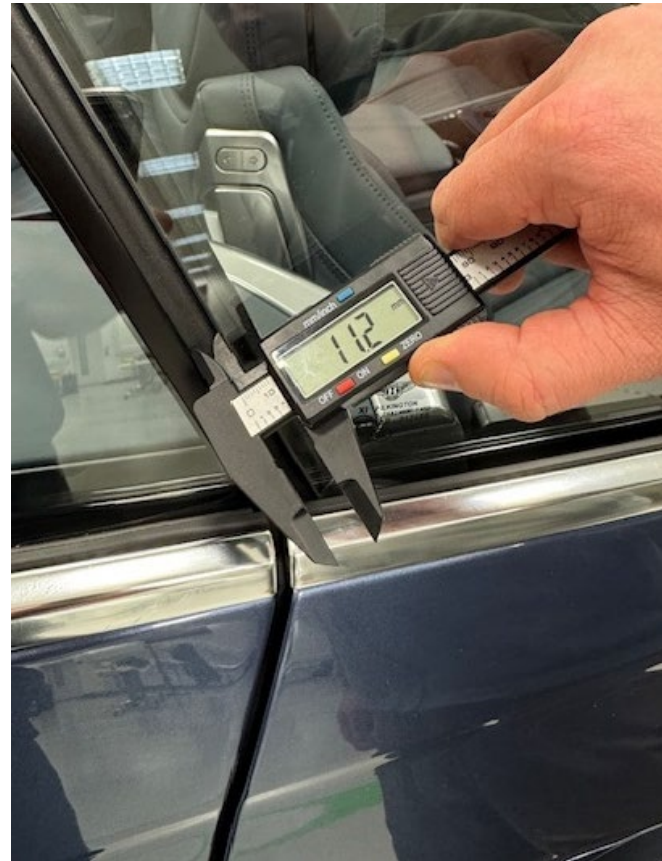
# INTERLOCK POINT 6 ROOF UP & DOWN

50mm from corner

Record measurement

**Specification**  
11mm  $\pm$  1mm  
(Ruler/vernier)

If the measurement is out of specification refer to ElsaPro Repair Group 64 'Front door quarter glass – To adjust'

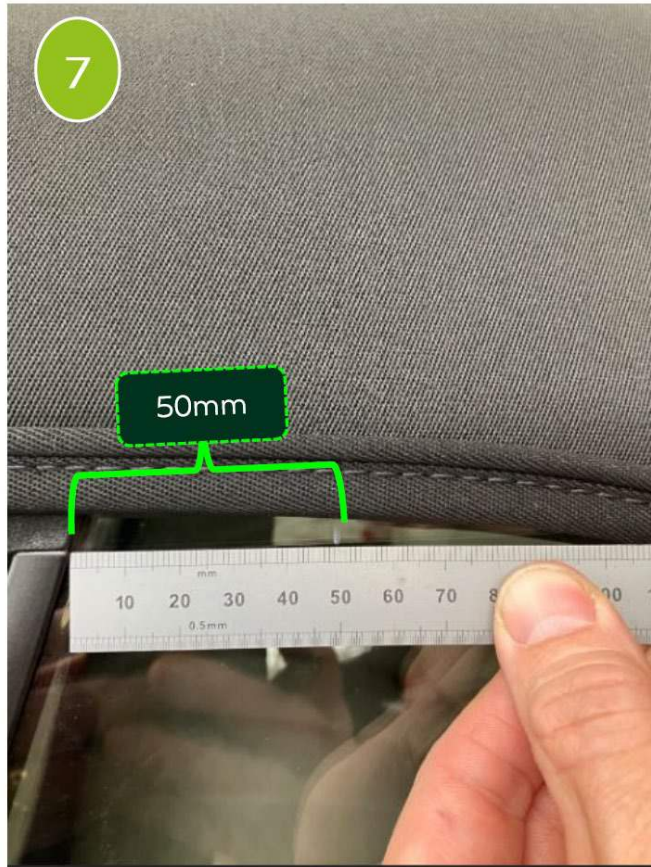
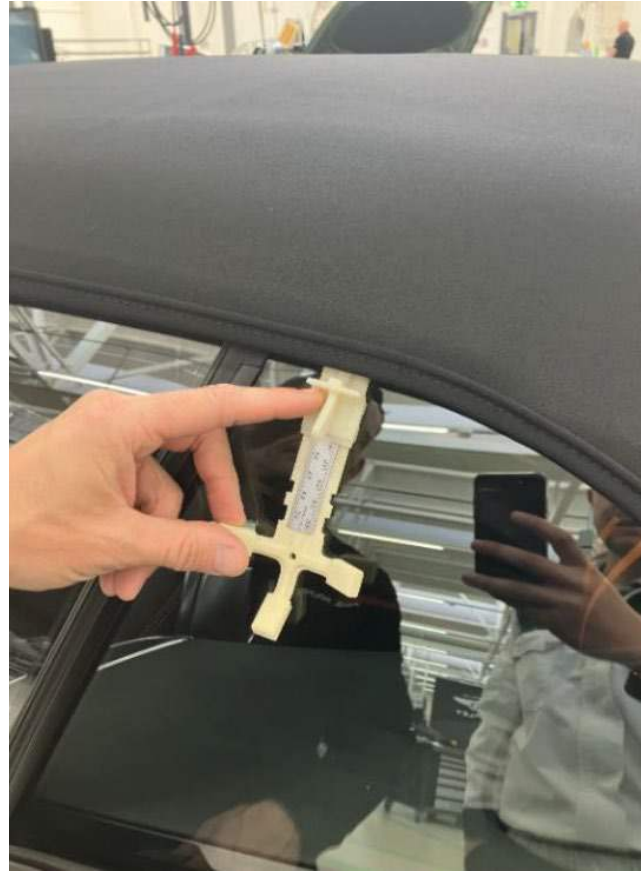
# INTERLOCK POINT 7

50mm behind rear div bar

**Specification**  
8.5mm  $\pm$  1mm  
(Interlock Tool WT10554)

If the measurement is out of specification refer to ElsaPro Repair Group 64 'Front door quarter glass – To adjust'

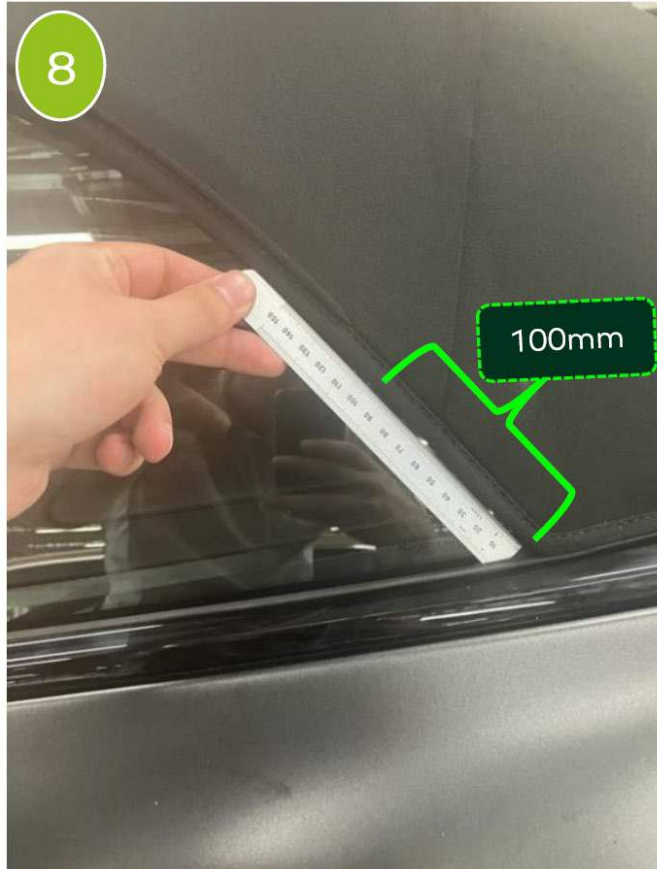
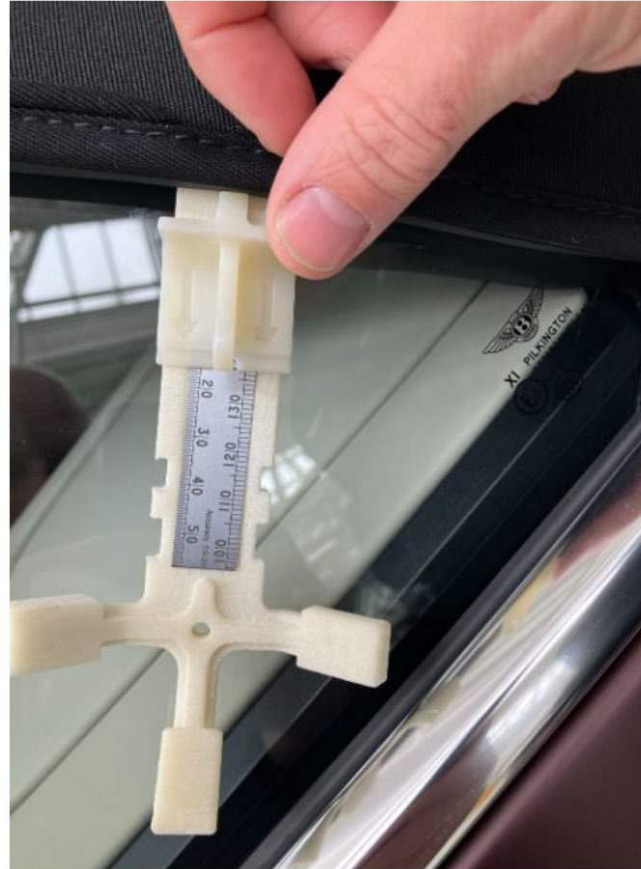
# INTERLOCK POINT 8

100mm from corner

**Specification**  
8.5mm – 16mm  
(Interlock Tool WT10554)

If the measurement is out of specification refer to ElsaPro Repair Group 64 'Front door quarter glass – To adjust'
