# Technical Service Bulletin

| <b>Topic</b> | Window Drop Glass Operation Continental GT/GTC 19-24MY |
| <b>Transaction No.</b> | 2080375/1 |
| <b>Release date</b> | Jan 20, 2026 |

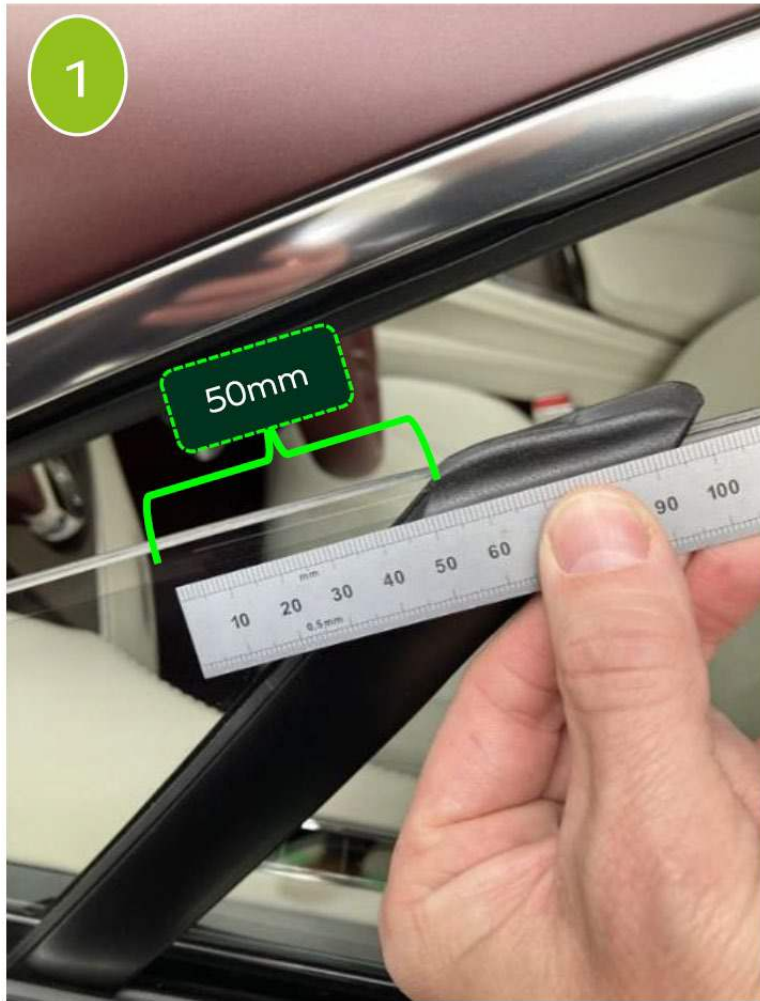
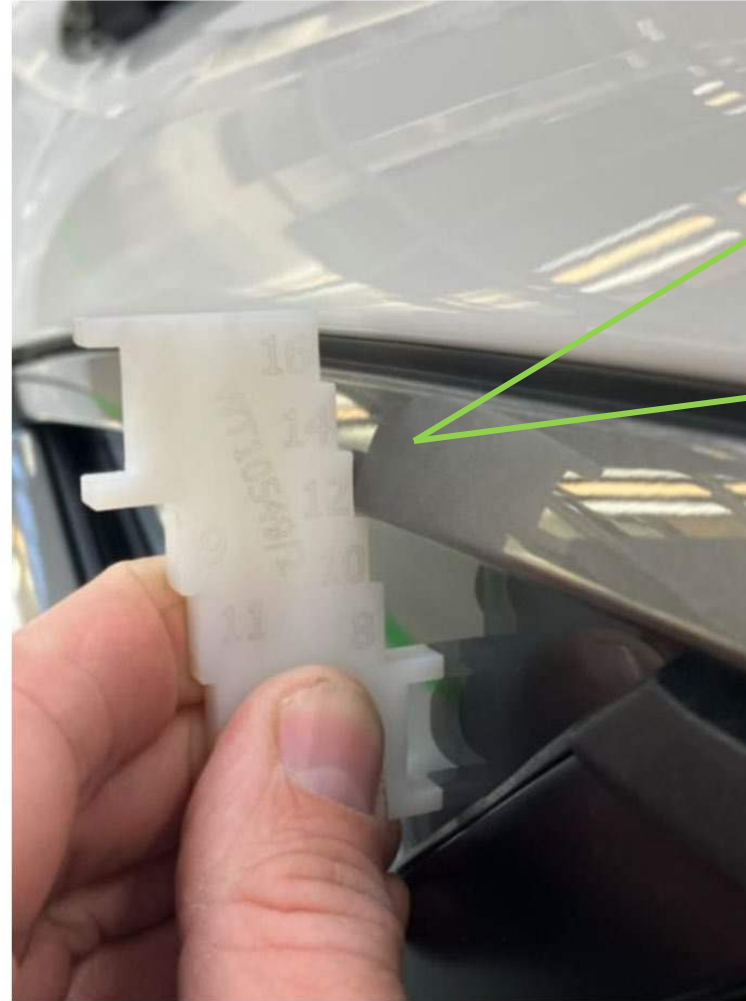
# PROFILE POINT 1

50mm in front of front div  
bar

**Specification**  
10mm  $\pm$  1mm  
(Profile Tool WT10549/2)

Flat against glass to  
brightware

If the measurement is out of  
specification refer to ElsaPro  
**Repair Group 64 'Slide glass  
checking and adjusting'**

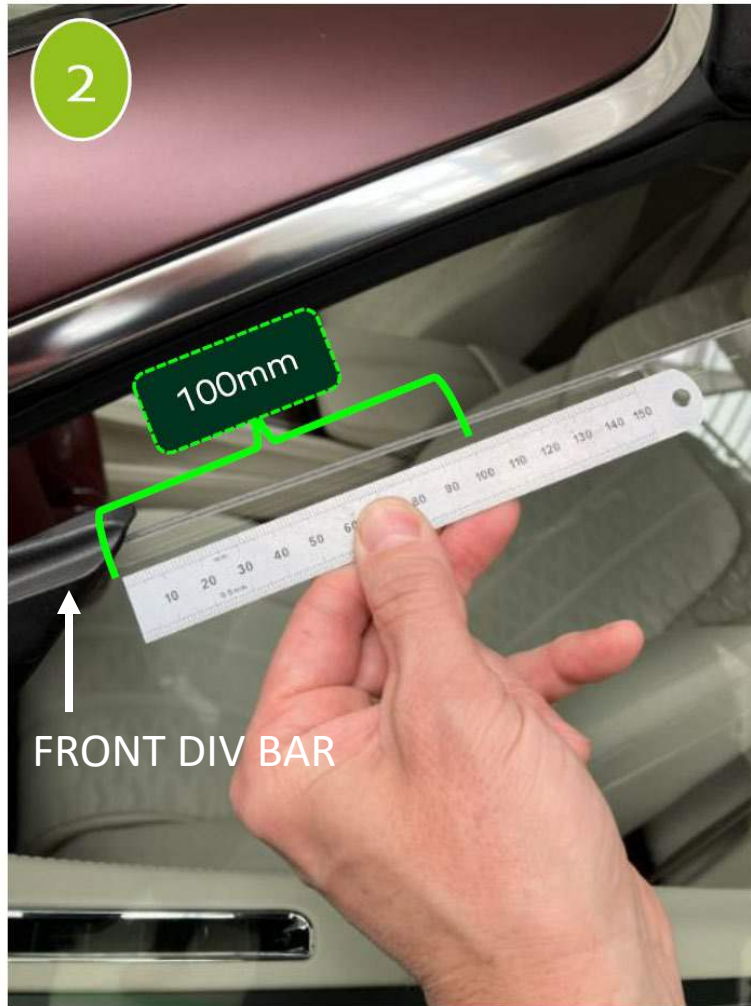
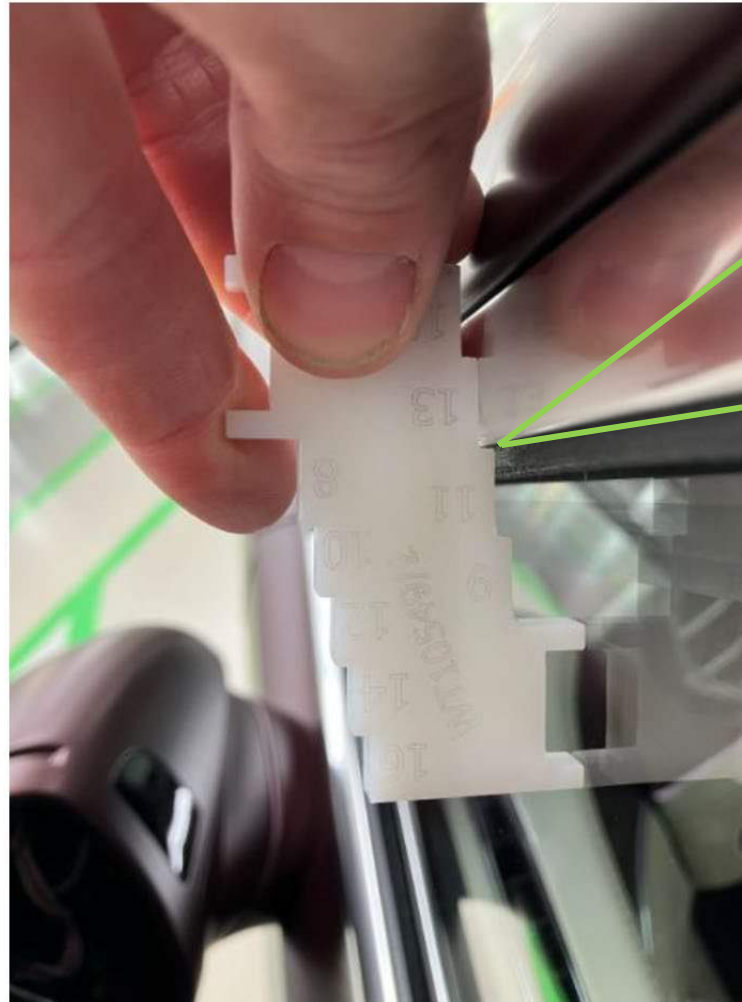
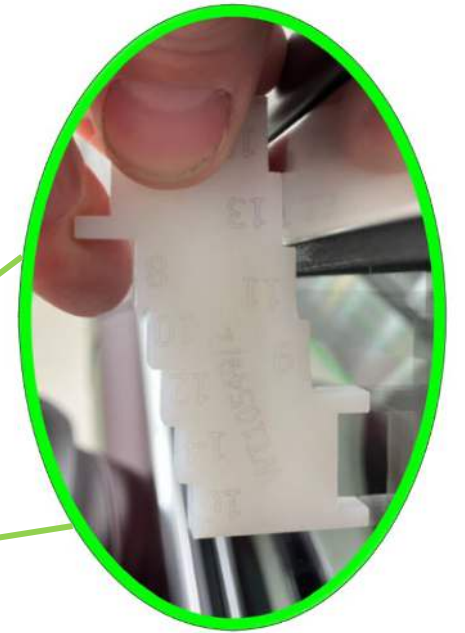
# PROFILE POINT 2

Place block 50mm in front  
of front div bar

Flat against glass to  
brightware

**Specification**  
14mm  $\pm$  2mm  
(Profile Tool WT10549/2)

If the measurement is out of  
specification refer to ElsaPro  
**Repair Group 64 'Slide glass  
checking and adjusting'**

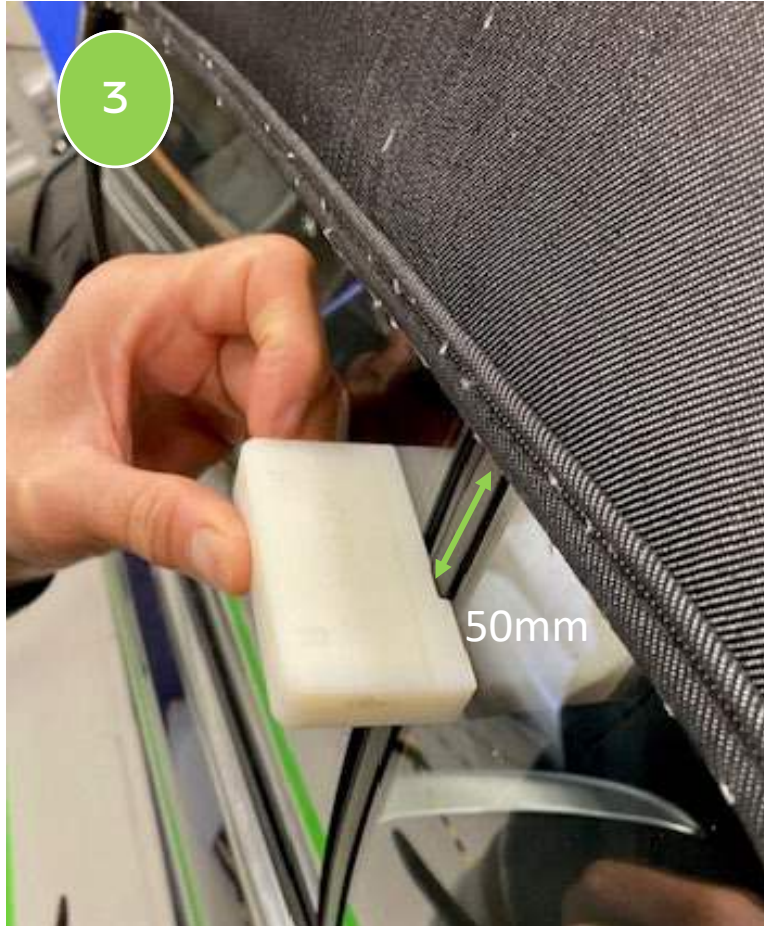
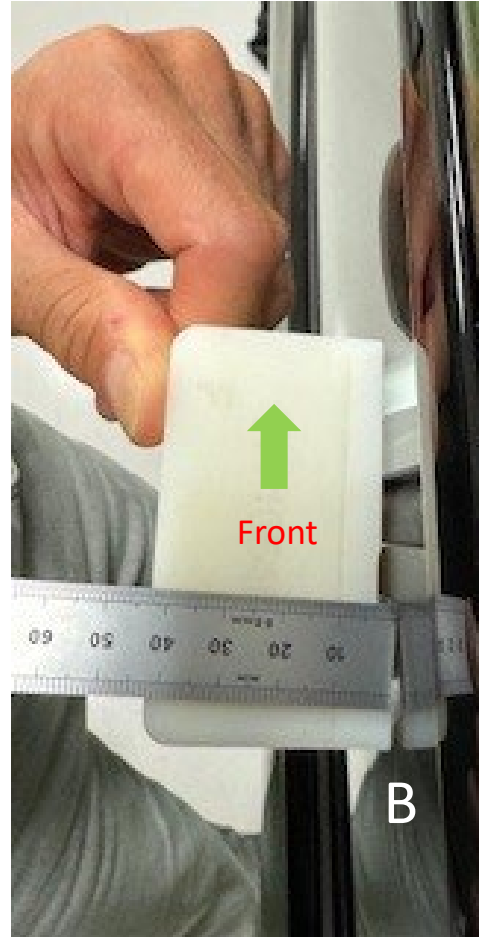
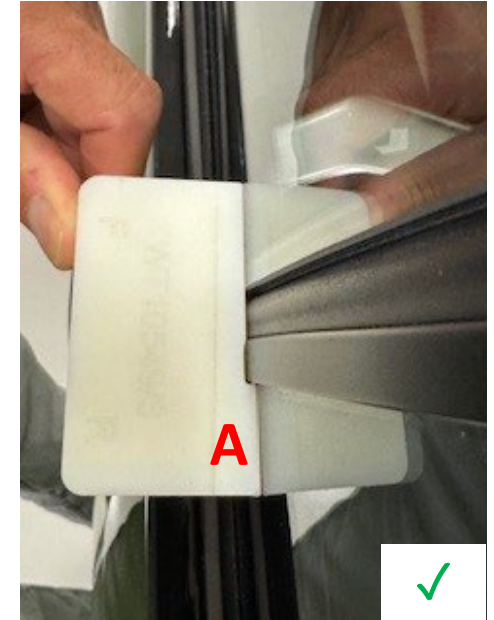
# PROFILE POINT 3 ROOF UP

50mm from upper corner

Flat against front  
window, measure gap

Point A tool against glass is +2mm  
Allowable up to 3mm refer to Point B  
(Profile Tool WT10549/3)

If the measurement is out of  
specification refer to ElsaPro  
**Repair Group 64 'Slide glass  
checking and adjusting'**

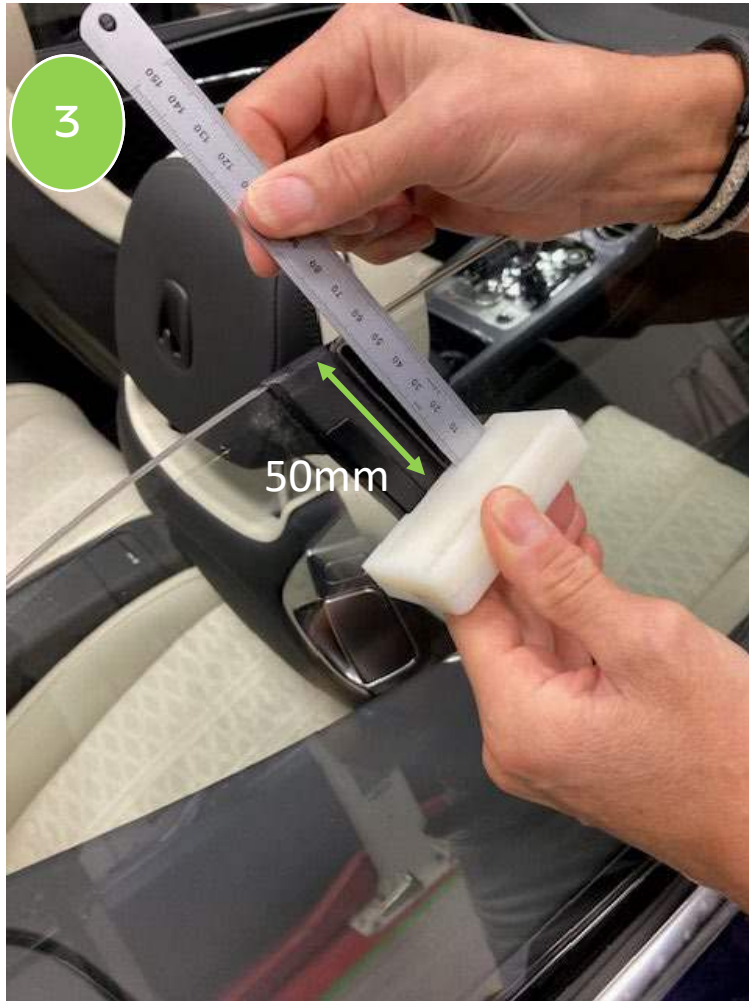
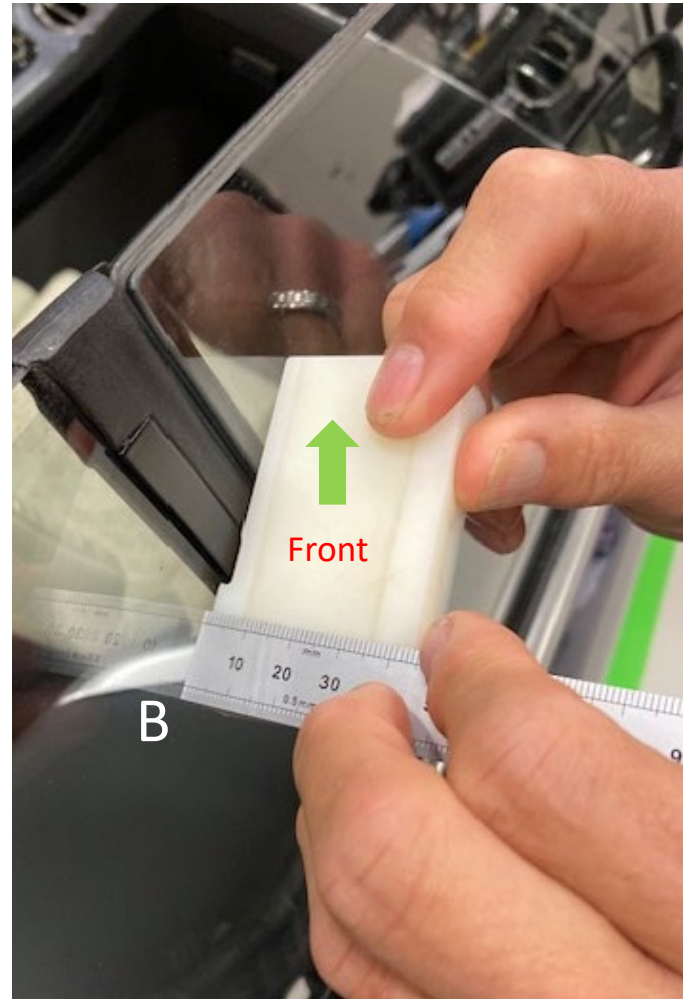
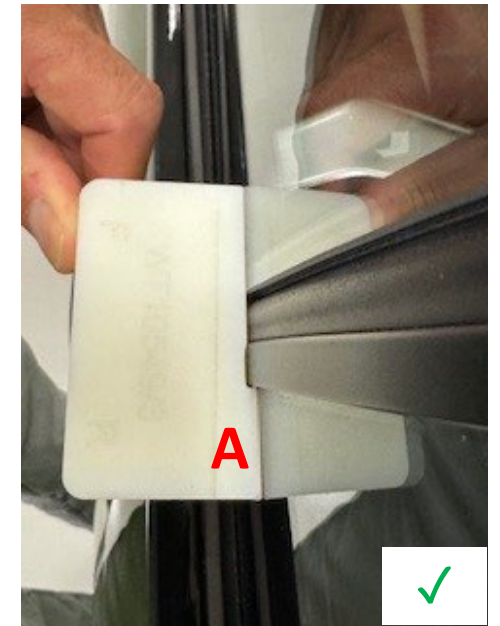
# PROFILE POINT 3 ROOF DOWN

50mm from upper corner

Flat against front window,  
measure gap

Point A tool against glass is  
+2mm

If the measurement is out of  
specification refer to ElsaPro  
**Repair Group 64 'Slide glass  
checking and adjusting'**

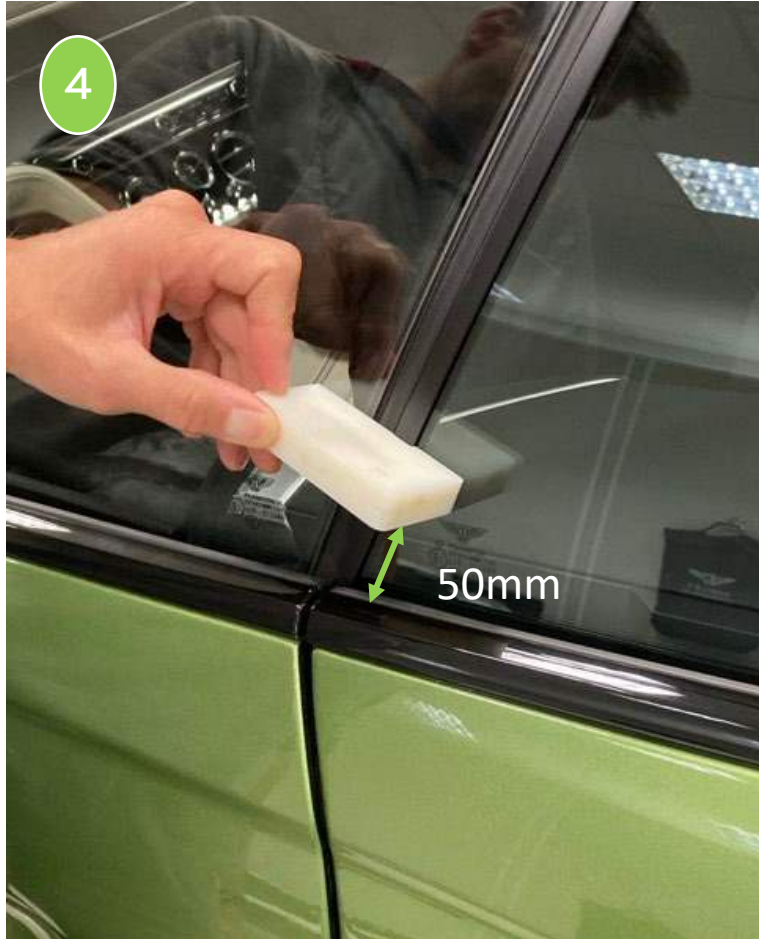
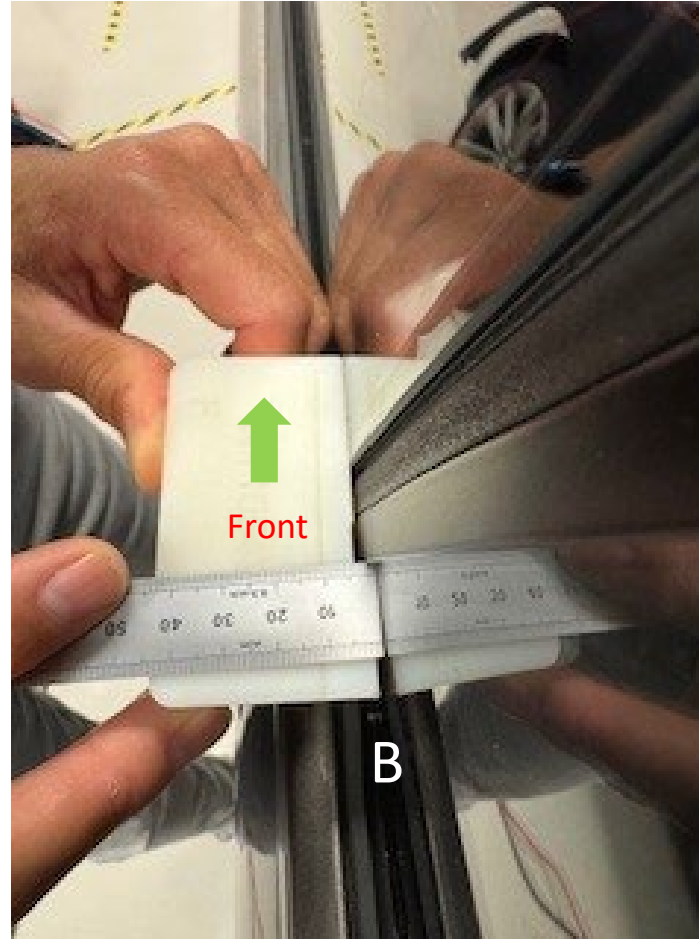
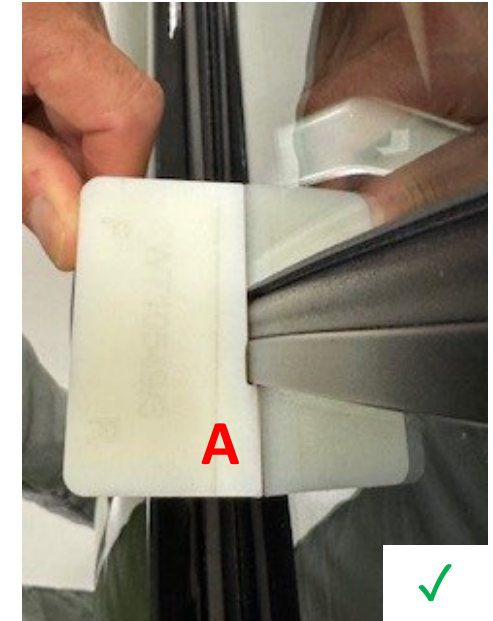
# PROFILE POINT 4

50mm from lower corner

Flat against front  
window, measure gap

Point A tool against glass = +2mm  
Allowable up to 3mm refer to Point B  
(Profile Tool 17301)

If the measurement is out of  
specification refer to ElsaPro  
**Repair Group 64 'Slide glass  
checking and adjusting'**

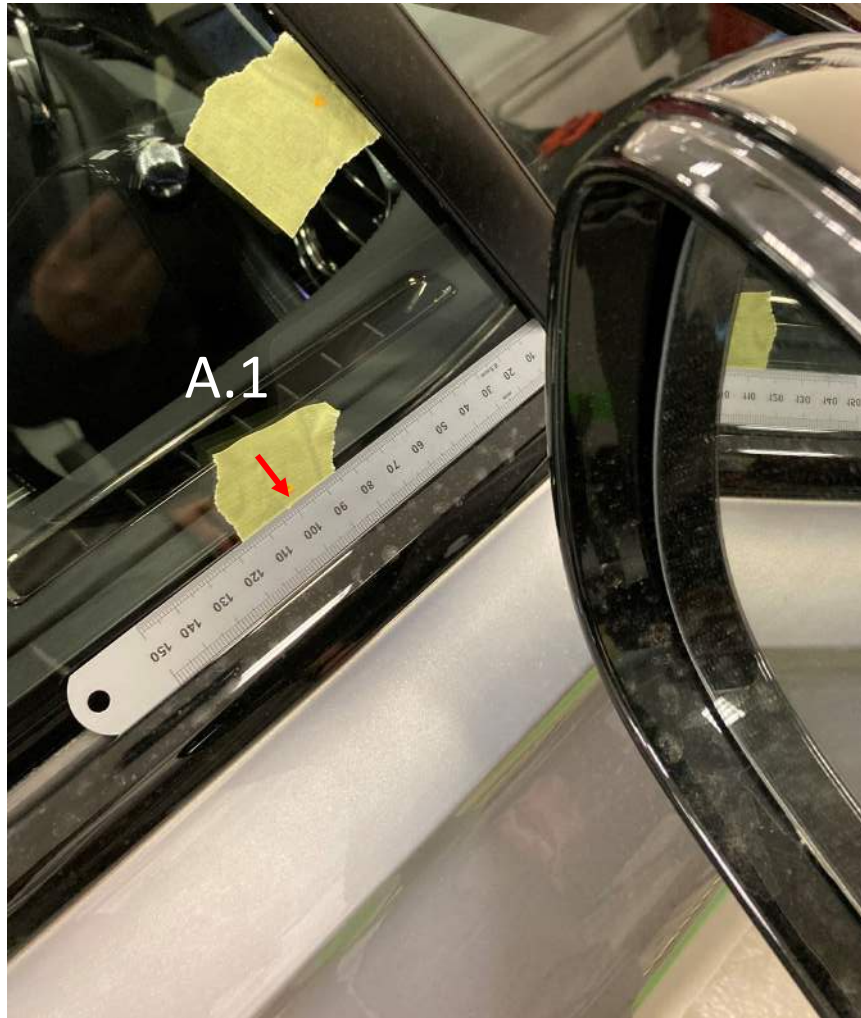
# WAIST SEAL MEASUREMENT POINT A

Mark on tape 100mm  
from div bar (A.1)

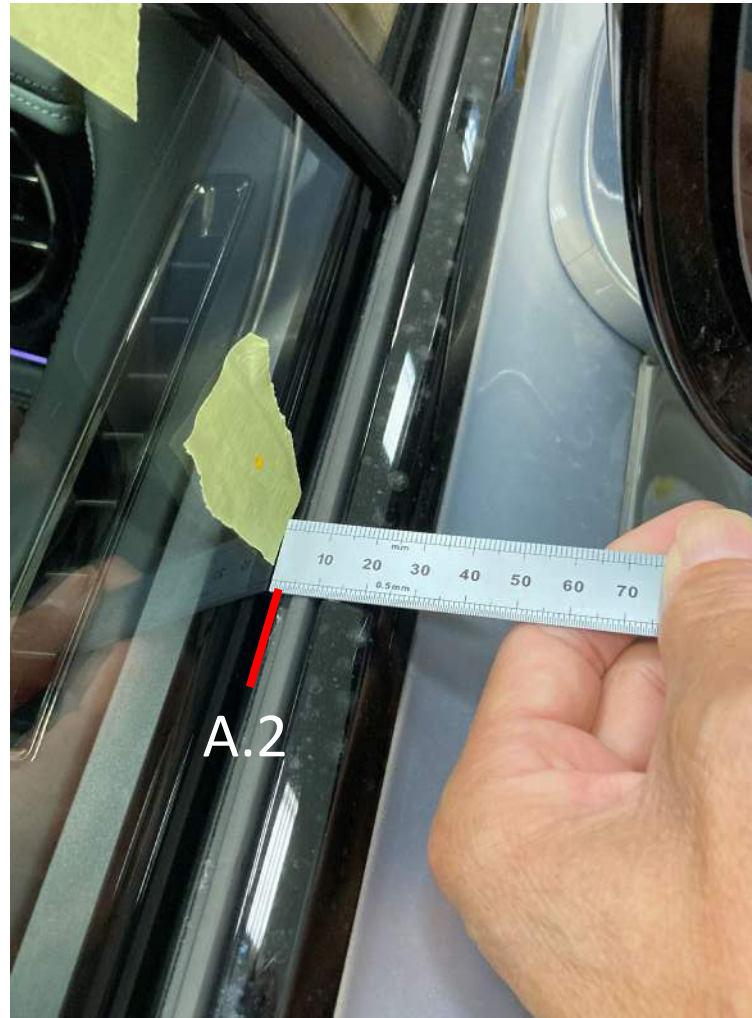
Measure from first lip rubber  
seal to window glass (A.2)

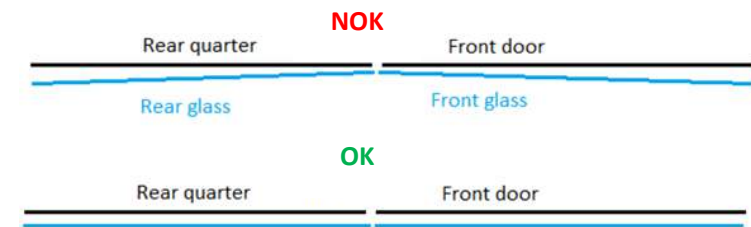
See image below, for OK and NOK after  
adjustment/checking

**Repair Group 64 'Slide glass  
checking and adjusting'**

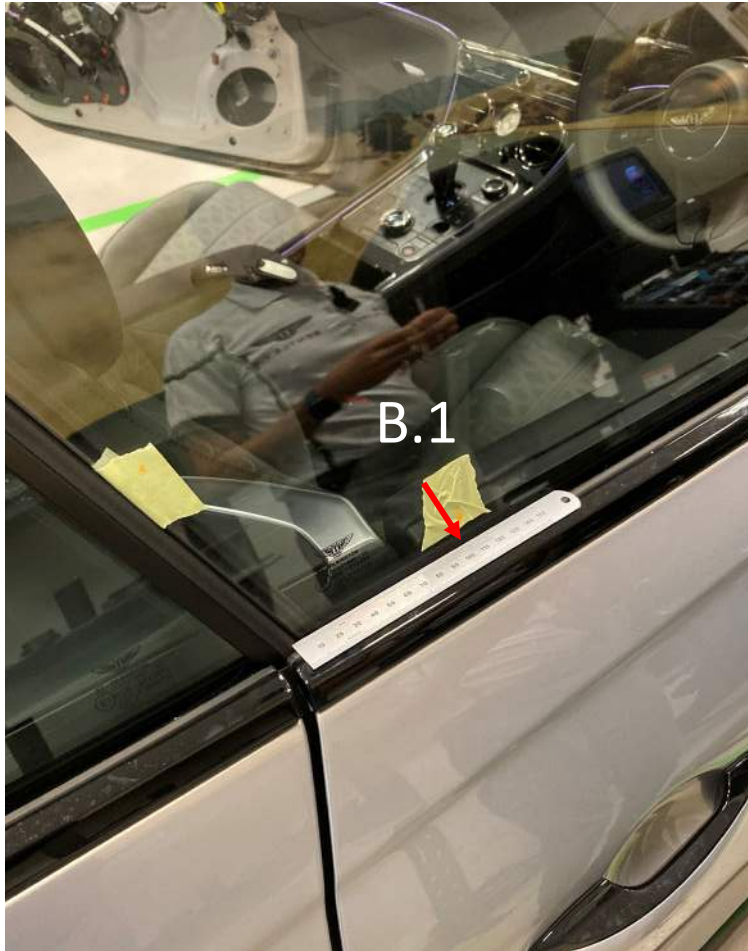
# WAIST SEAL MEASUREMENT POINT B

Mark on tape 100mm from  
div bar (B.1)

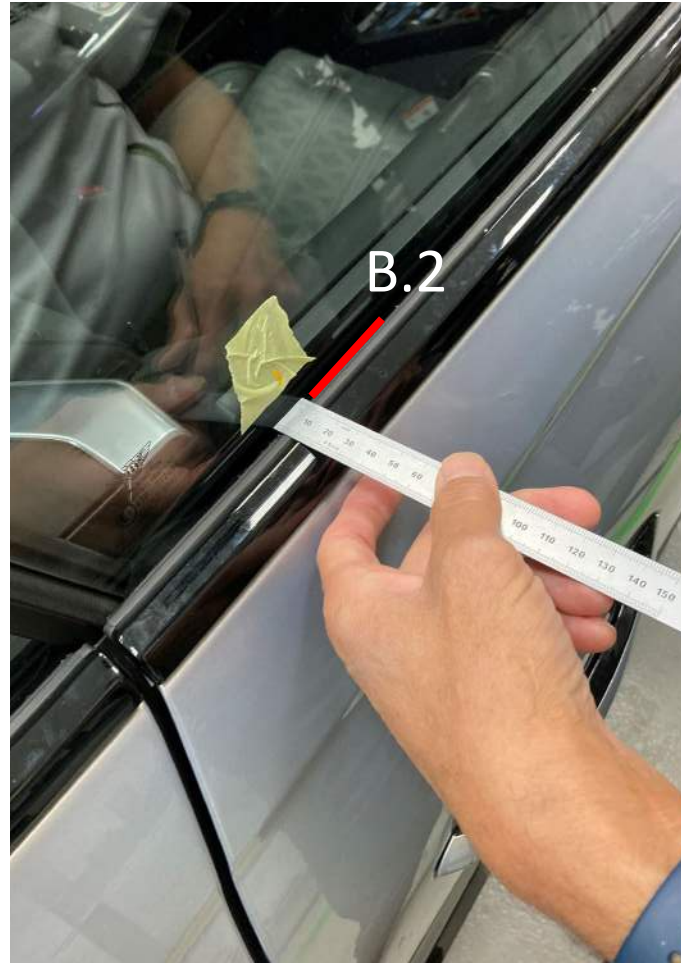
Measure from first lip  
rubber seal to window glass  
(B.2)

**Repair Group 64 'Slide glass  
checking and adjusting'**

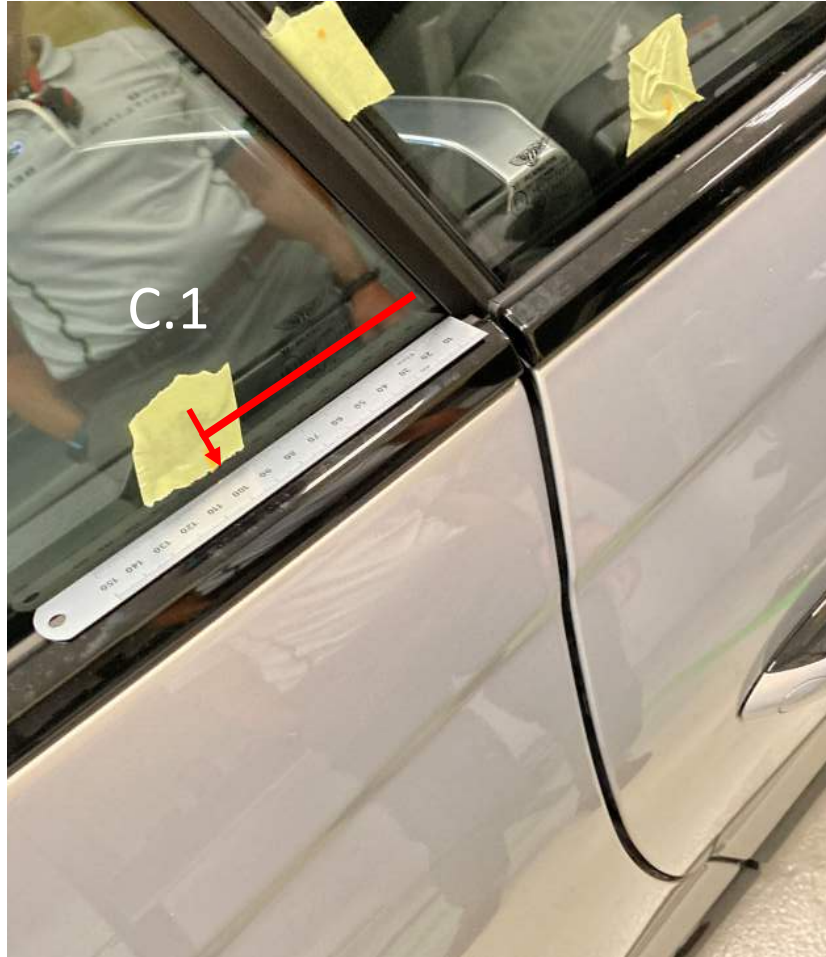
# WAIST SEAL MEASUREMENT POINT C

Mark on tape 100mm  
from div bar (C.1)

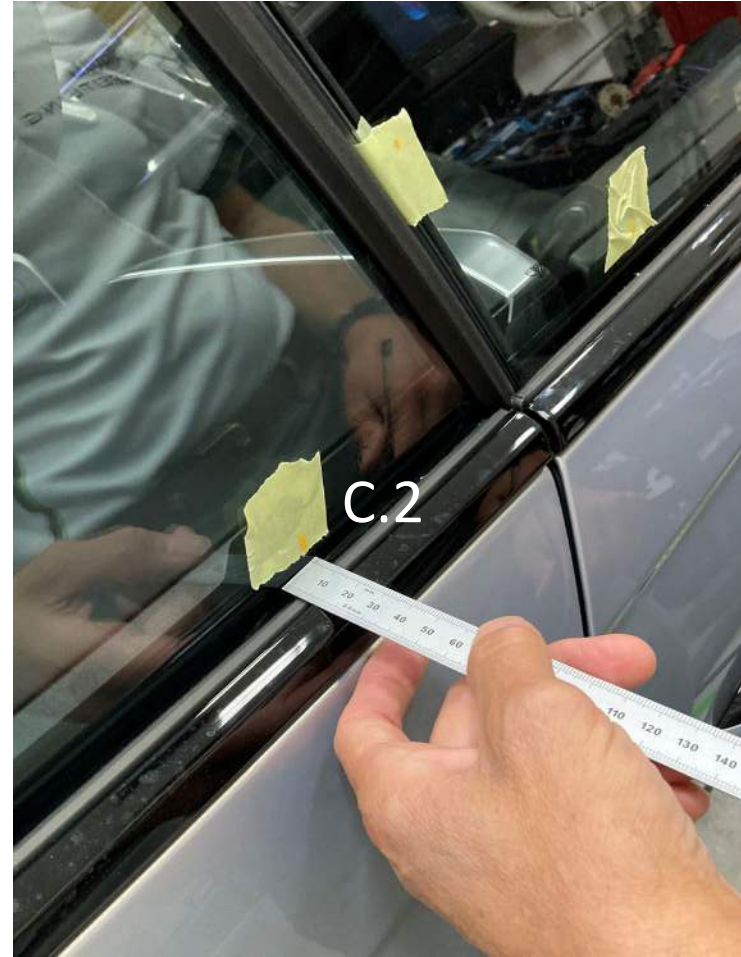
Measure seal to  
window gap (C.2)

If the measurement is out  
of specification refer to  
ElsaPro **Repair Group 64**  
**'Slide glass checking and  
adjusting'**
