## Technical Service Bulletin

| ENGINE<br>MECHANICAL | 26-EM-003H |
| FEBRUARY 2026 | SONATA<br>(DN8/DN8A) |

**SUBJECT:** INTEGRATED THERMAL MANAGEMENT (ITM) REPLACEMENT & ECM/TCU SOFTWARE UPDATE – DTCS P218100, P2181F0, P2181F1

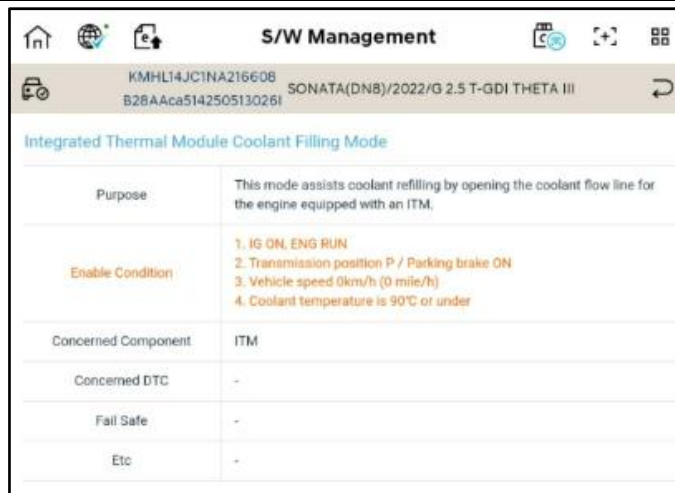
Failure to follow the ITM bleeding procedure under **S/W Management** in GDS may result in air pockets and overheating of the engine.

- **Engine Mechanical System > Cooling System > Coolant > Repair procedures**
