**HYUNDAI**  
**Technical Service Bulletin**

| GROUP<br><b>CAMPAIGN</b> | NUMBER<br><b>26-01-026H</b> |
| DATE<br><b>FEBRUARY 2026</b> | MODEL(S)<br><b>PALISADE (LX3)<br/>PALISADE HYBRID<br/>(LX3 HEV)</b> |

**SUBJECT:** ACTIVE AIR FLAP WIRING ASSEMBLY INSPECTION & REPLACEMENT (LIMITED COVERAGE CAMPAIGN LA13)

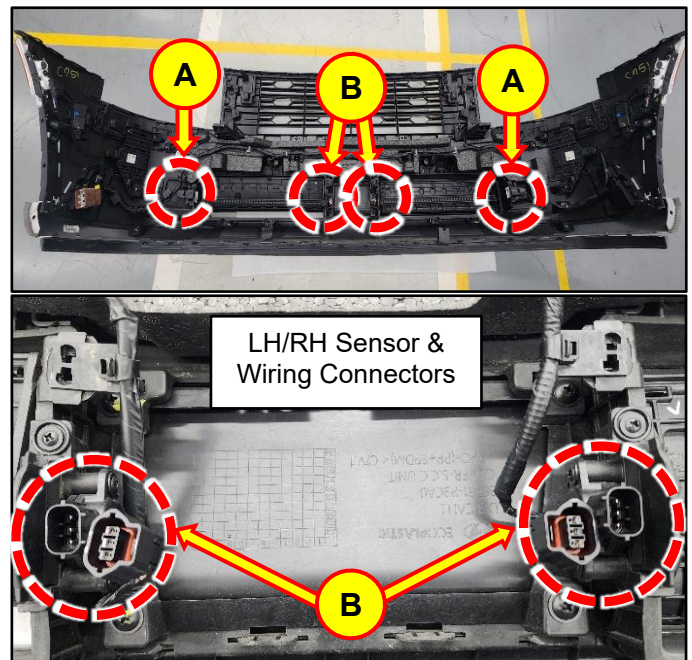
**AAF Sensor Inspection**

1. Disconnect the front bumper wiring and AAF actuator connectors (A) and the sensor connectors (B).

If **BOTH** LH/RH sides **FAILED** during initial inspection, proceed to the **Replacement of Front Bumper Harness, AAF Actuator(s), and AAF Sensor(s)** procedure.
