## Technical Service Bulletin

26-EM-008G

GV70 (JK1A)

CLOGGED DUAL PURGE EJECTOR ASSEMBLY & INTERCOOLER  
OUTLET DEBRIS – DTC P04F000

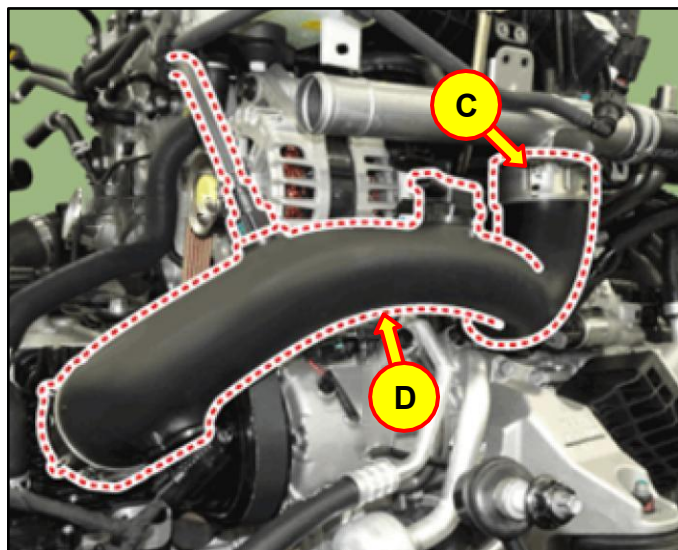
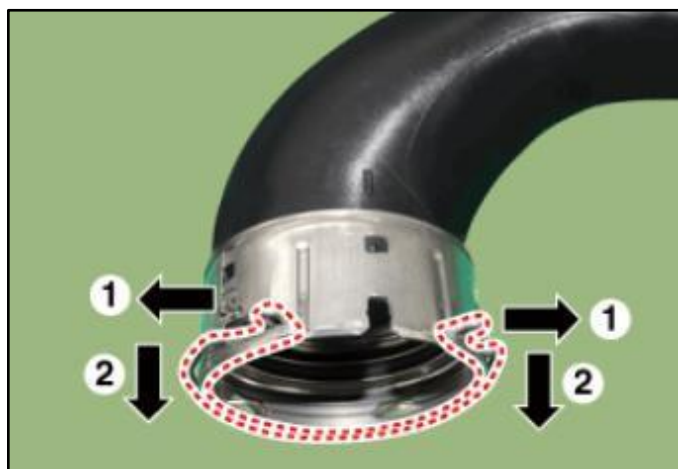
Pull the quick connector clamp in the direction and order of the arrows.

5. Disconnect the quick connector (C) then remove the intercooler outlet hose (D).
