| <br><b>Technical Service Bulletin</b> | <b>GROUP</b><br><b>ADAS</b> | <b>NUMBER</b><br><b>26-AD-001G</b> |
| <b>SUBJECT:</b> FRONT VIEW CAMERA WARNING AND CALIBRATION<br>(DTC C272246) | | |

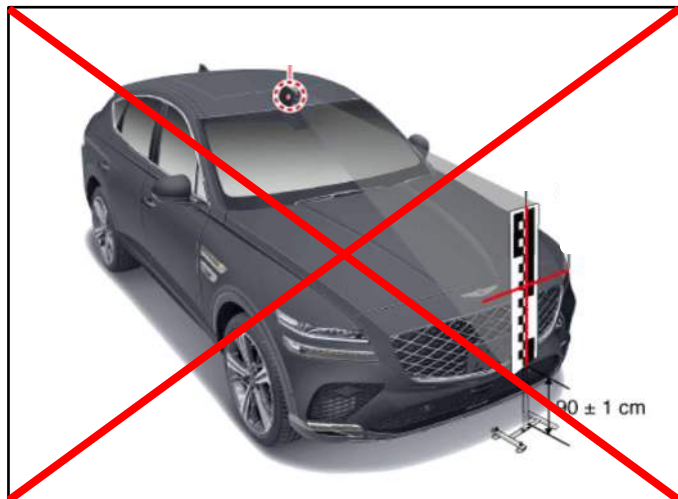
If **DTC C2721** is triggered, turn the ignition **OFF/ON** and then perform the driving calibration with the usage of the GDS.

Select “**FR/CMR – Front View Camera**”, “**Front Camera Driving Calibration (SPC)**”, then follow the instructions in the GDS to perform the driving calibration.
