| ELE | 2022-2025MY<br>Multiple Models |
| 394 | March 2026 |

## TECHNICAL SERVICE BULLETIN

### AVN5.0W DTC P17A000 DAIGNOSTIC PROCEDURE

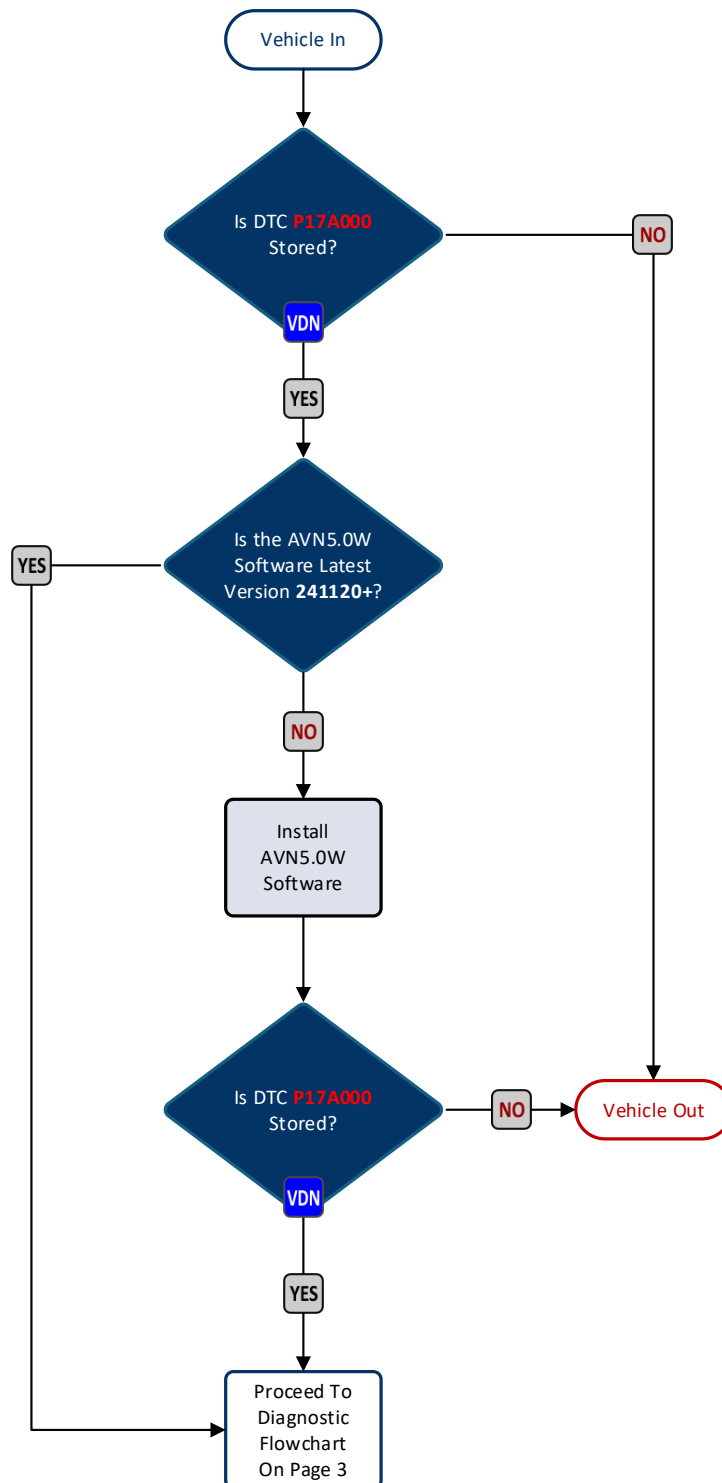
## AVN Software Flowchart:

This bulletin provides information regarding a potential illuminated Malfunction Indicator Lamp (MIL) accompanied by DTC P17A000 on some 2022-2025MY Hybrid Electric Vehicles (HEV) and Plug-In Hybrid Electric Vehicles (PHEV) equipped with AVN5.0Wide head units listed below. This condition occurs when the Global Positioning System (GPS) module within the Audio Video Navigation (AVN) head unit, sends an inaccurate signal to the Hybrid Power Control Unit (HPCU), causing the DTC to set. **There are no drivability symptoms associated with this condition.** Follow the procedures outlined in this TSB to inspect and if necessary, install the AVN5.0W software and inspect and if necessary, replace the antenna and/or the AVN5.0W head unit.

**Note:** A Vehicle Diagnosis Number (VDN) must be created for DTC P17A000 prior to ordering parts and performing necessary procedure(s), as outlined in this TSB. If a VDN is not created, Parts Ordering and Warranty claim submission issues WILL occur. Any claims for replacement parts are subject to Warranty review and chargeback.

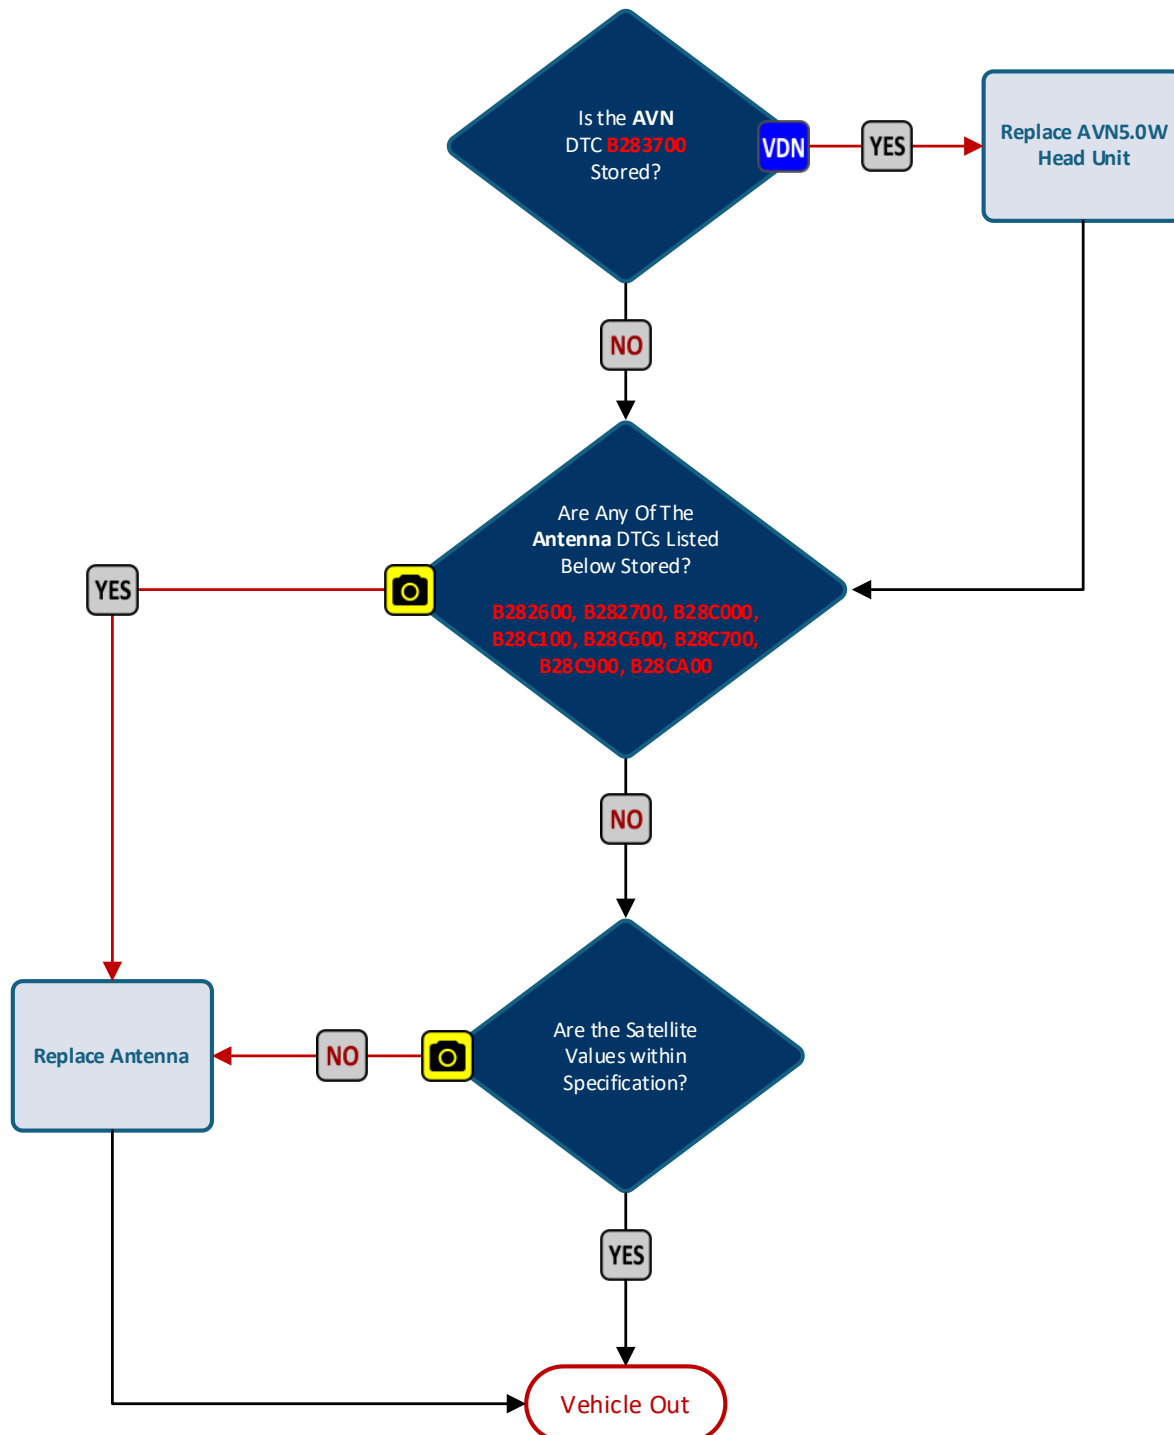
## Diagnostic Flowchart:

**Note:** One (1) or two (2) KVID photo(s) of DTC(s) B283700, B282600, B282700, B28C000, B28C100, B28C600, B28C700, B28C900 and/or B28CA00 MUST be attached to the claim using KDS Tablet Warranty Claim Attachment Tab 'XX - Other'.
