## STAR ONLINE PUBLICATION

**Case Number:** S2508000036 REV. E

**Symptom/Vehicle Issue:** The Occupant Restraint Controller (ORC) Sets B2204-00 Unknown Status (Pending), Sets B2204-00 ECU Configuration Mismatch Or/And DTC B222D-00 Active for ECU Unable to Configure/Configuration Not Learned

**Models:** 2025 RAM (DJ,DD,D2,DP)  
2026 - Grand Cherokee (WL)  
2024 - 2025 Wagoneer S (KM)  
2024 - 2025 Charger (LB)

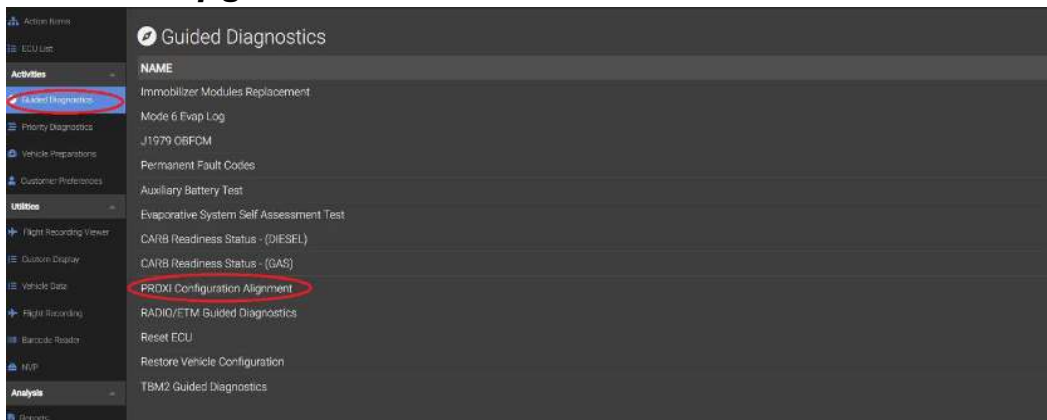
**Discussion:** After a PROXI Alignment or Vehicle Restore Configuration and while clearing Diagnostic Trouble Codes (DTCs), you may receive a "B2204-00 ECU Configuration Mismatch" DTC in the ORC with an "Unknown" status. After re-flashing the ORC module to the latest SW available you may receive a "B222D-00 ECU Unable To Configure/Configuration Not Learned" DTC in the ORC with an "Active" status.

1. Perform ORC PROXI alignment for the ORC module
2. Wait 5 seconds
3. Perform ORC ECU Diagnostic Reset (not to be confused with Vehicle Reset)
4. Wait 5 seconds
5. Perform 4 Key Ignition Cycles. (OFF 2sec to ON) x4
6. Airbag light will go off 30 seconds after 4th Key ignition Cycle

***Note: These steps must be completed in the order mentioned above for a successful result see pg-1 and 2.***
