# Service Bulletin

## PRELIMINARY INFORMATION

**Subject:** EBCM Wheel Speed Sensor Diagnostic Aid for ABS Message - Click Or Ratchet Noise - Service Traction Message - Service Stabilitrak Message

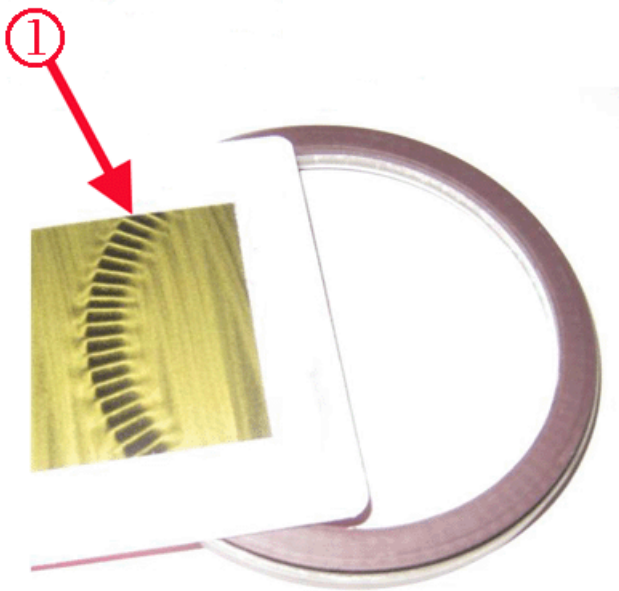
1. Wheel Speed Sensor Magnetic Encoder Ring

North and South Poles are shown

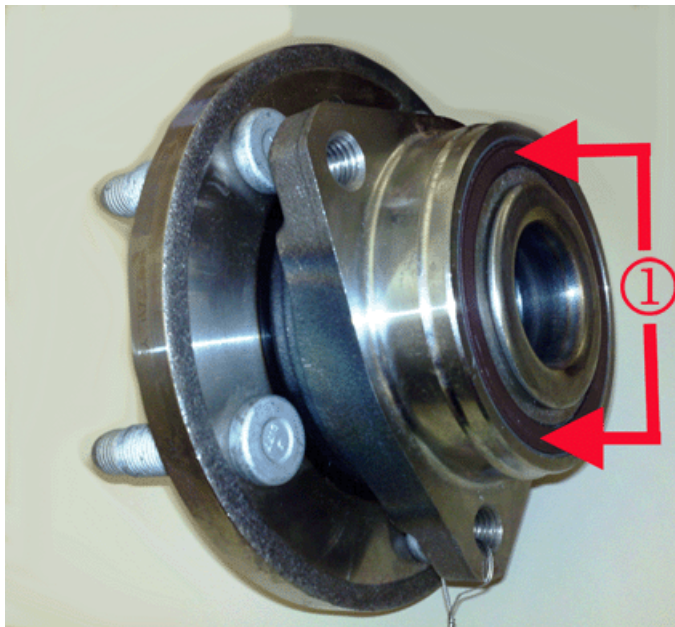
NEW BEARING DESIGN

These conditions may be caused by single or multiple pieces of ferrous metallic debris stuck to the wheel speed sensor magnetic encoder ring. This magnetic encoder ring is now part of the inboard bearing hub assembly.

1. Magnetic Encoder Ring

Inspect and clean debris from the Encoder Ring.
