# Service Bulletin

## PRELIMINARY INFORMATION

**Subject:** EBCM Wheel Speed Sensor Diagnostic Aid for ABS Message - Click Or Ratchet Noise - Service Traction Message - Service Stabilitrak Message - Service Steering Message

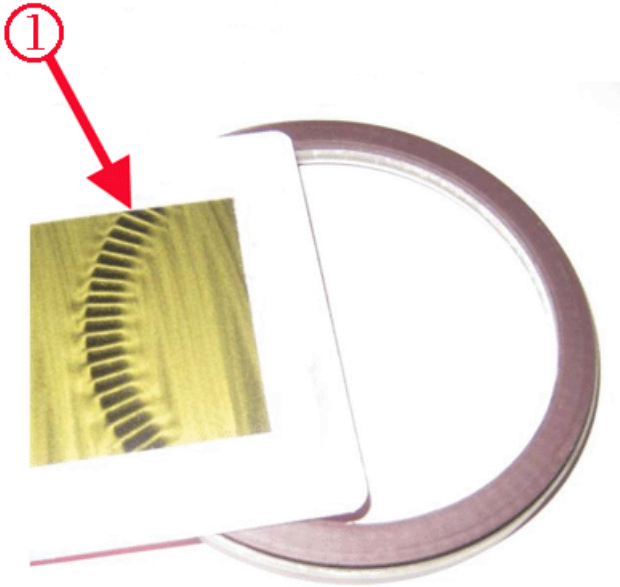
(1.) Wheel Speed Sensor

Magnetic Encoder Ring - North and South Poles are shown

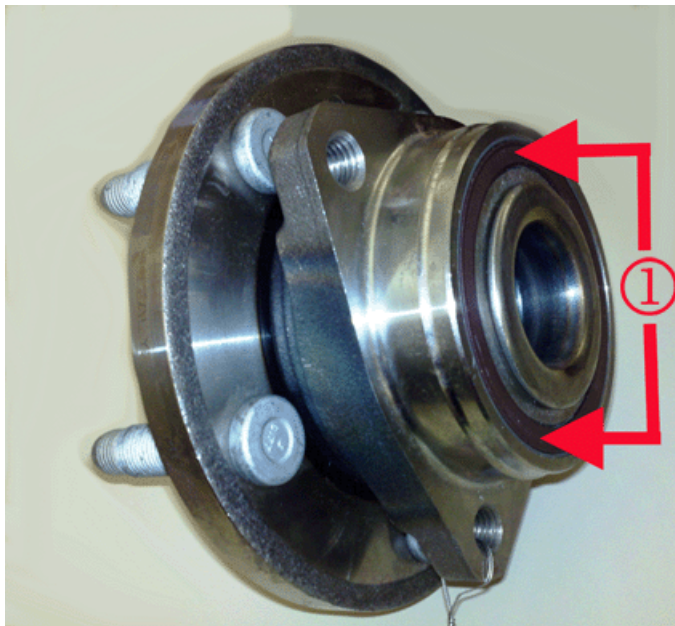
These conditions may be caused by single or multiple pieces of ferrous metallic debris stuck to the wheel speed sensor magnetic encoder ring. This magnetic encoder ring is now part of the inboard bearing hub assembly.

(1.) Magnetic Encoder Ring

Some new model vehicles today have begun to use a different type of wheel speed sensor encoder ring or tone wheel. Instead of a traditional mechanical type tooth tone wheel, the wheel speed sensor tone wheel is now made of a magnetized nitrile rubber ring, typically brown in color. This magnetic encoder consists of multiple North and South Pole pairs surrounding the outer circumference. When this magnetic encoder ring rotates and passes by the wheel speed sensor head; it generates a sign wave in the wheel speed sensor. The wheel speed sensor converts an analog signal to a digital square wave, and typical digital signal

Inspect and clean debris from the Encoder Ring.
