GLOBAL SAFETY FIELD INVESTIGATIONS  
DCS5422  
URGENT - DISTRIBUTE IMMEDIATELY

Subject: A202302140-01 - Service Update  
Engine Oil Pressure Sensor Performance Error  
Revised Part, Warranty and Service Procedure sections

Models: 2020 Buick Encore GX  
2021 Chevrolet Trailblazer  
Equipped with 1.2L Turbo Engine (RPO LIH)

## A202302140 Engine Oil Pressure Sensor Performance Error

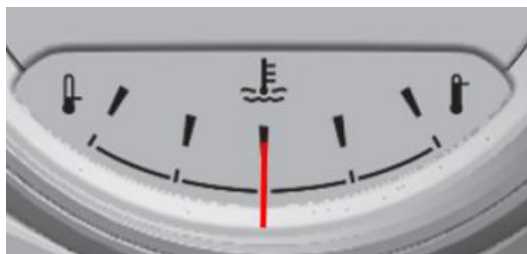
5584378

Module Diagnostics => [K20] Engine Control Module => Data Display => Engine Mechanical Data

3. Start and run engine for minimum 15 minutes until the coolant temperature gauge needle is centered in the gauge.

4. Raise the engine speed to 2,000 rpm for 30 seconds.
5. Rev up the engine rpm to 4,000 rpm limit and hold for 15 seconds.
6. Release the acceleration pedal to go down rpm to idle and wait for 15 seconds.
