Preliminary Information

PIC5650H Diagnostic Tip - Security Light on Intermittently / No Crank/No Start or Start Stall / Keyless Access Vehicles May Display No Remote/Fob Detected / Poor or No RKE Range / Service TPM

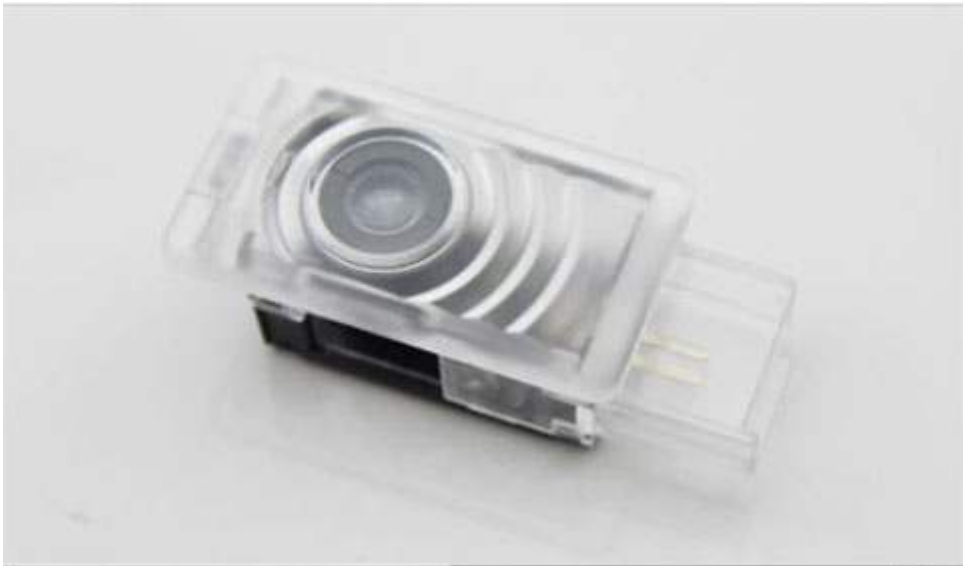
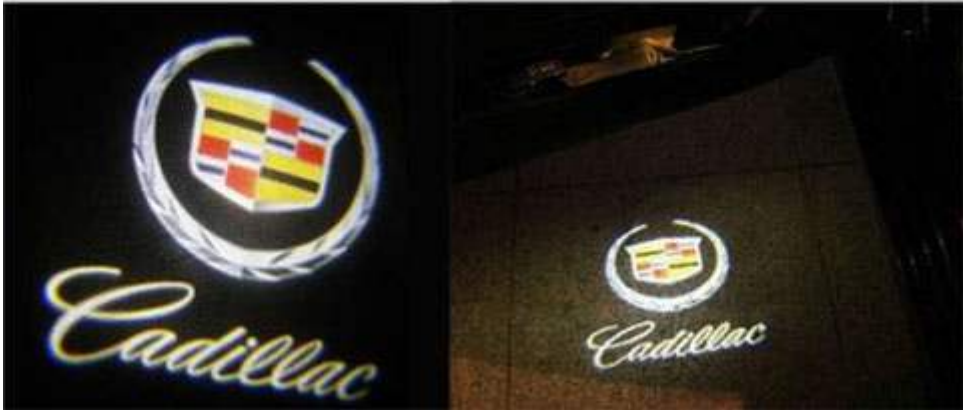
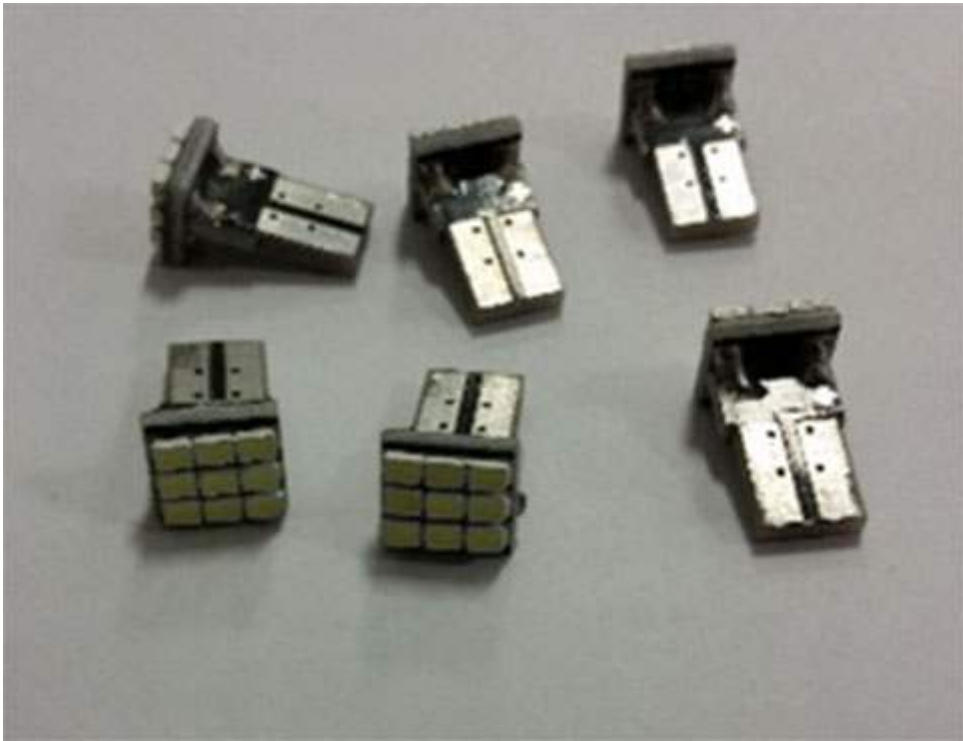
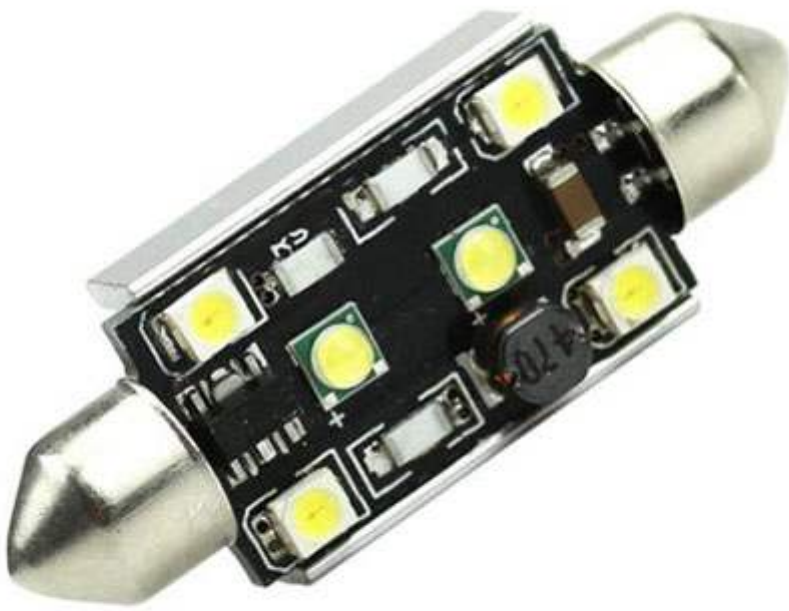
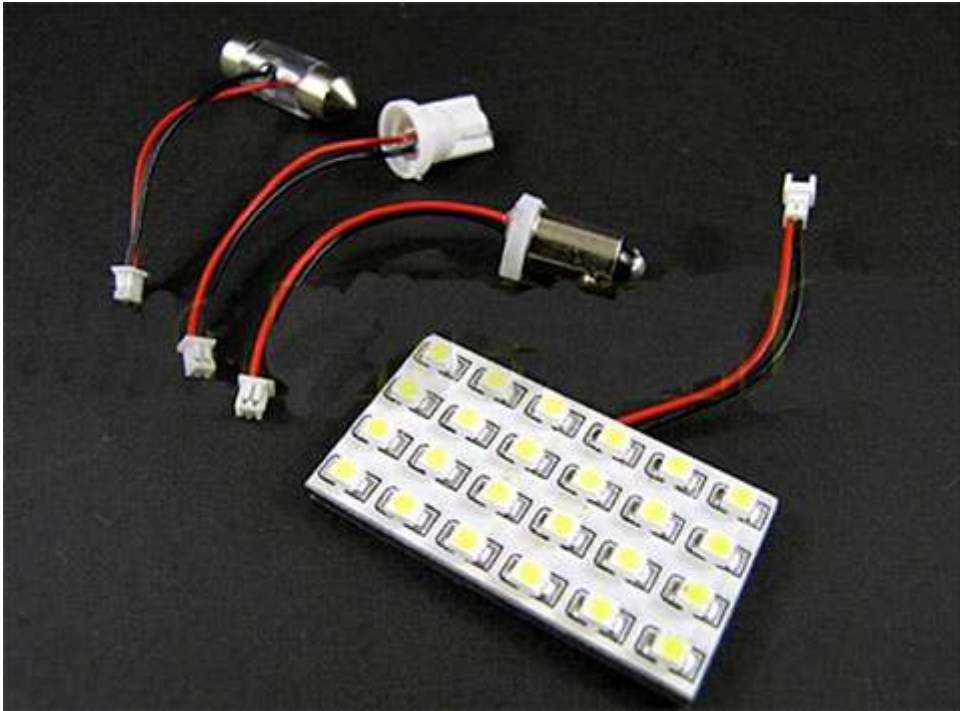
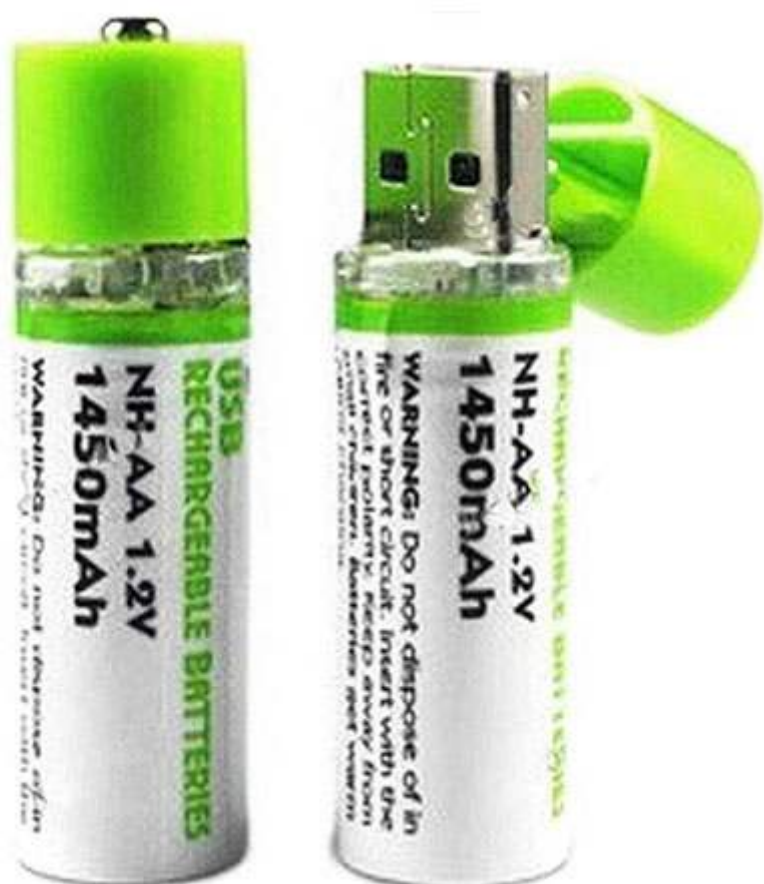
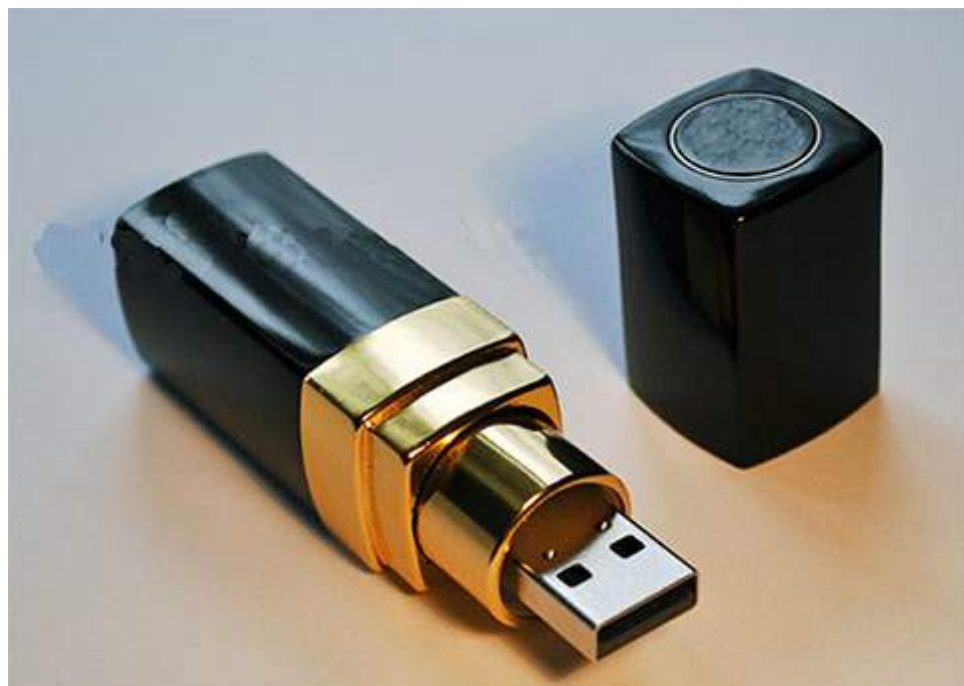
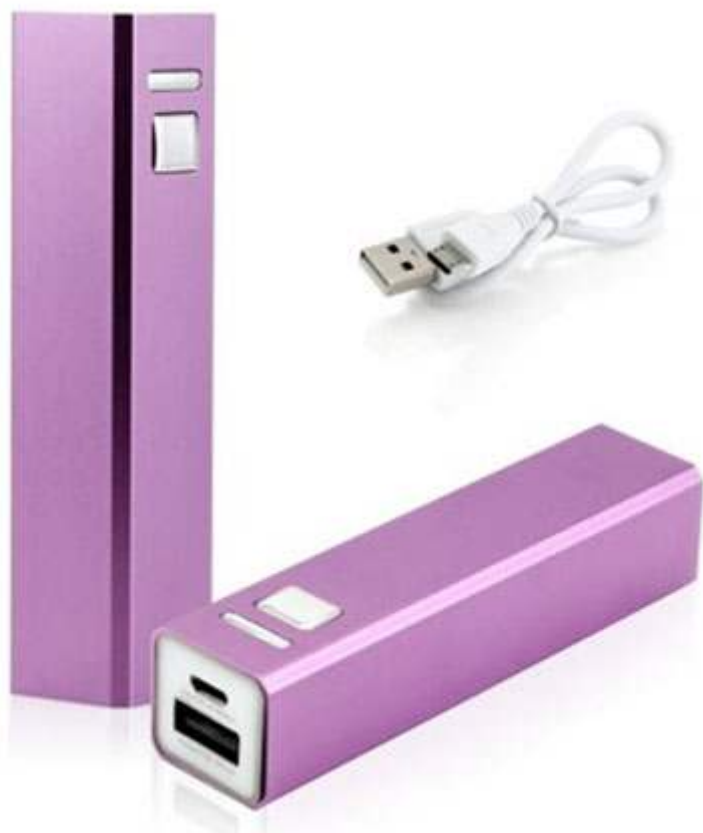
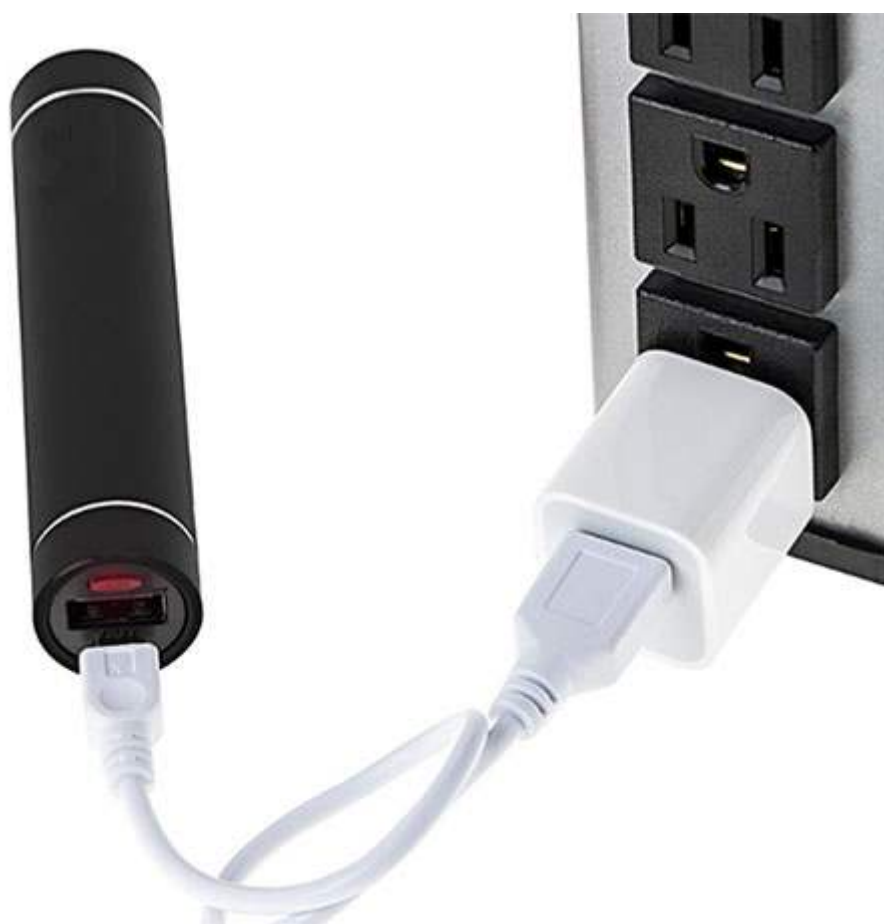
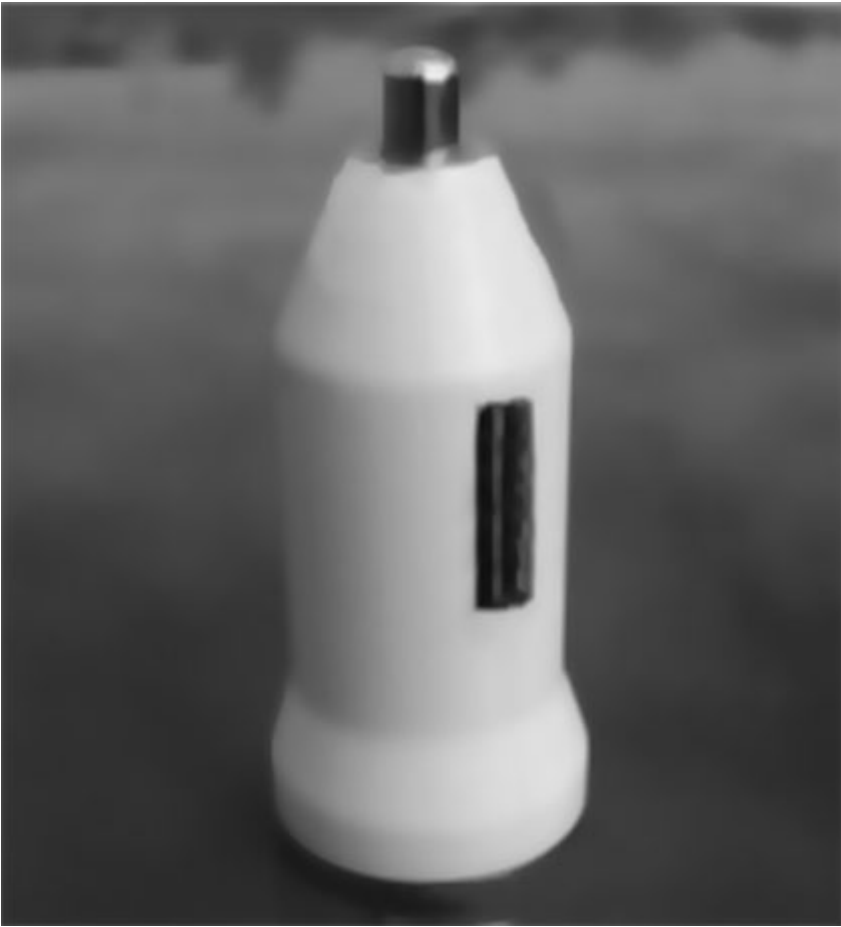
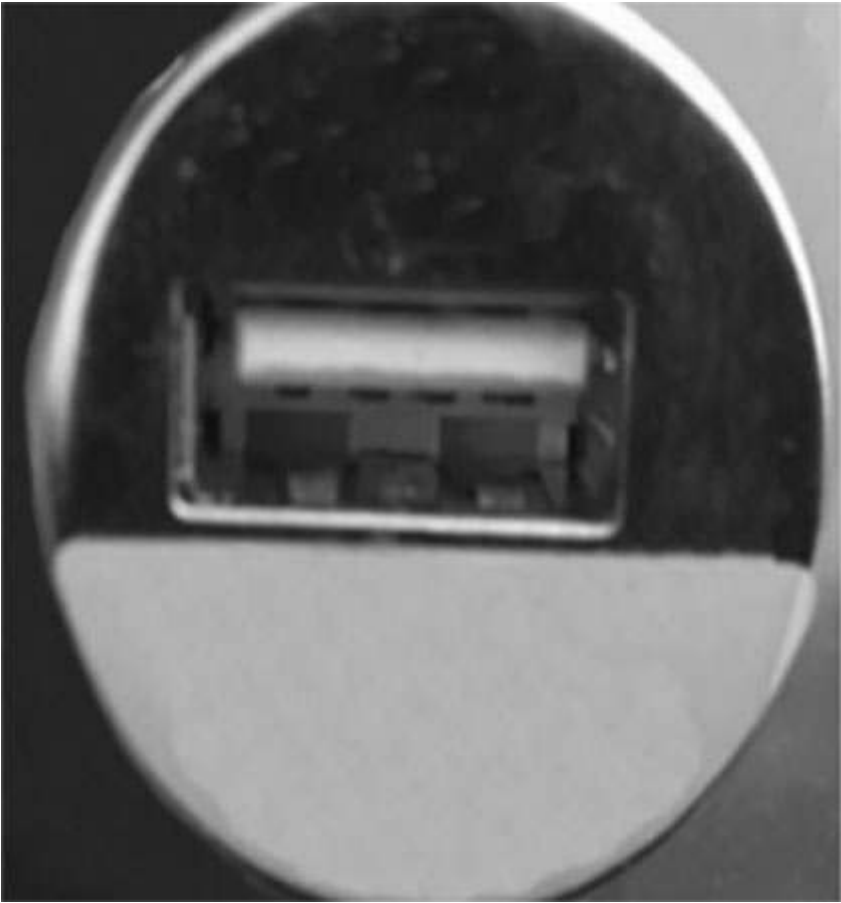
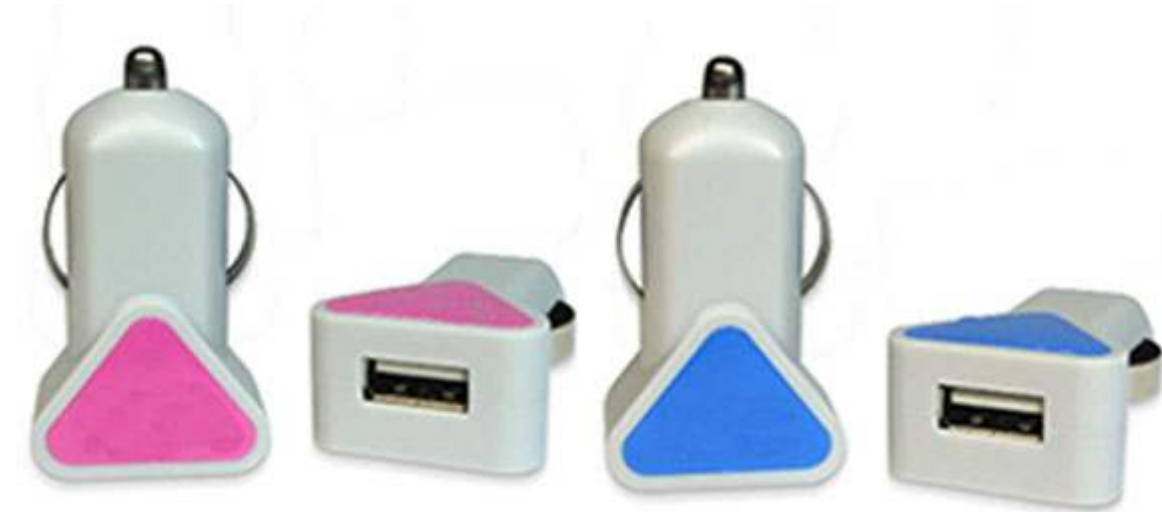
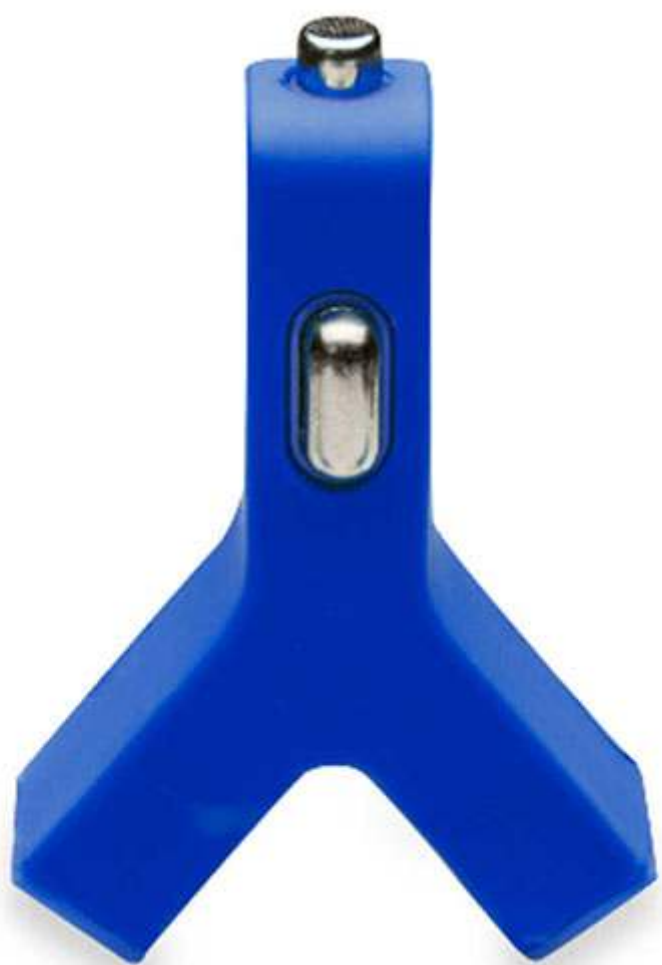
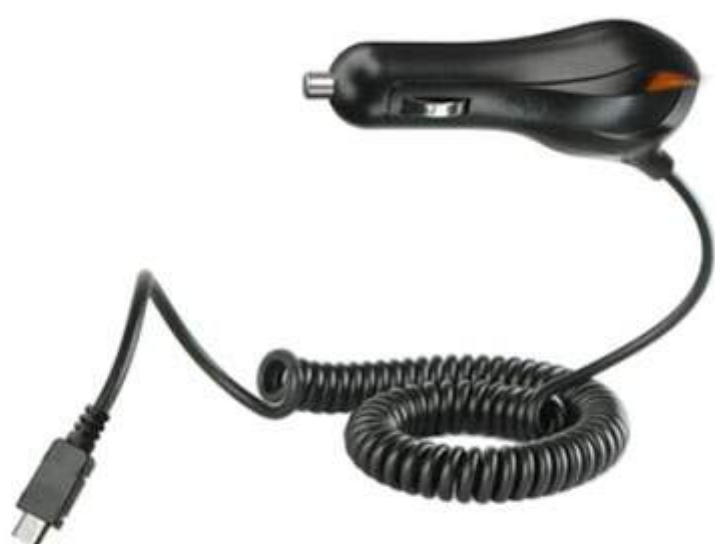
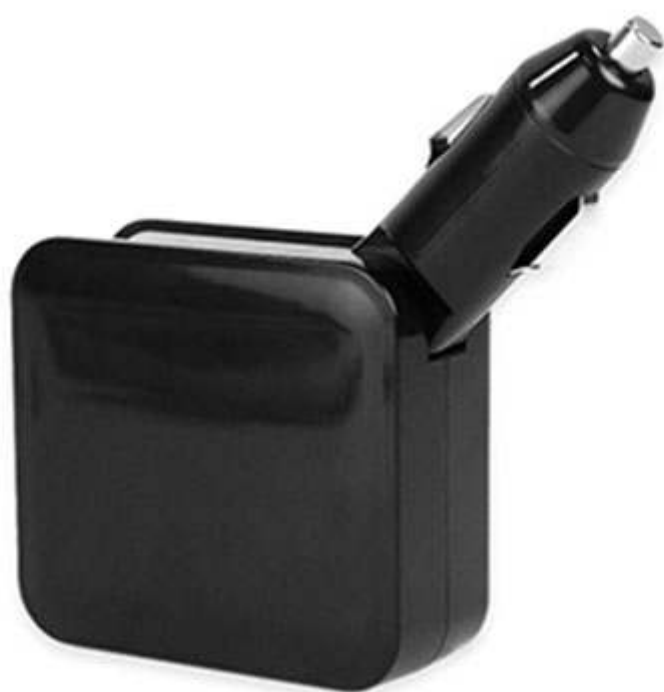
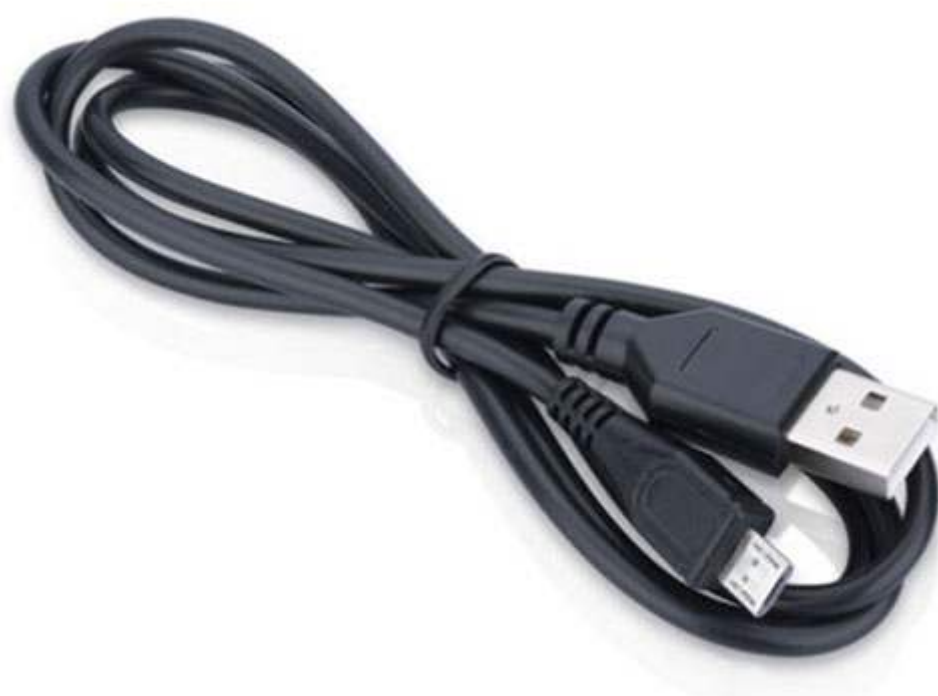
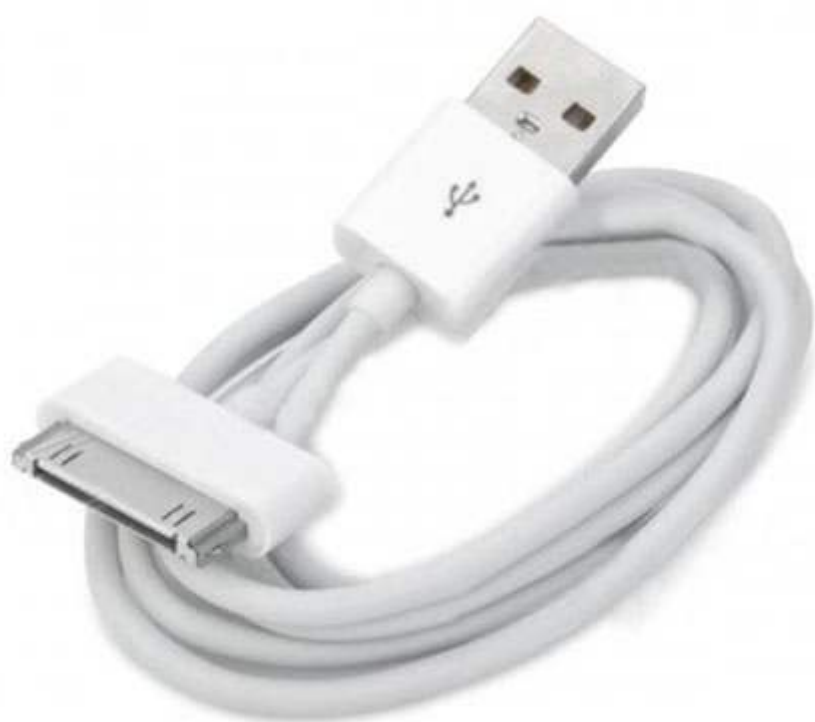
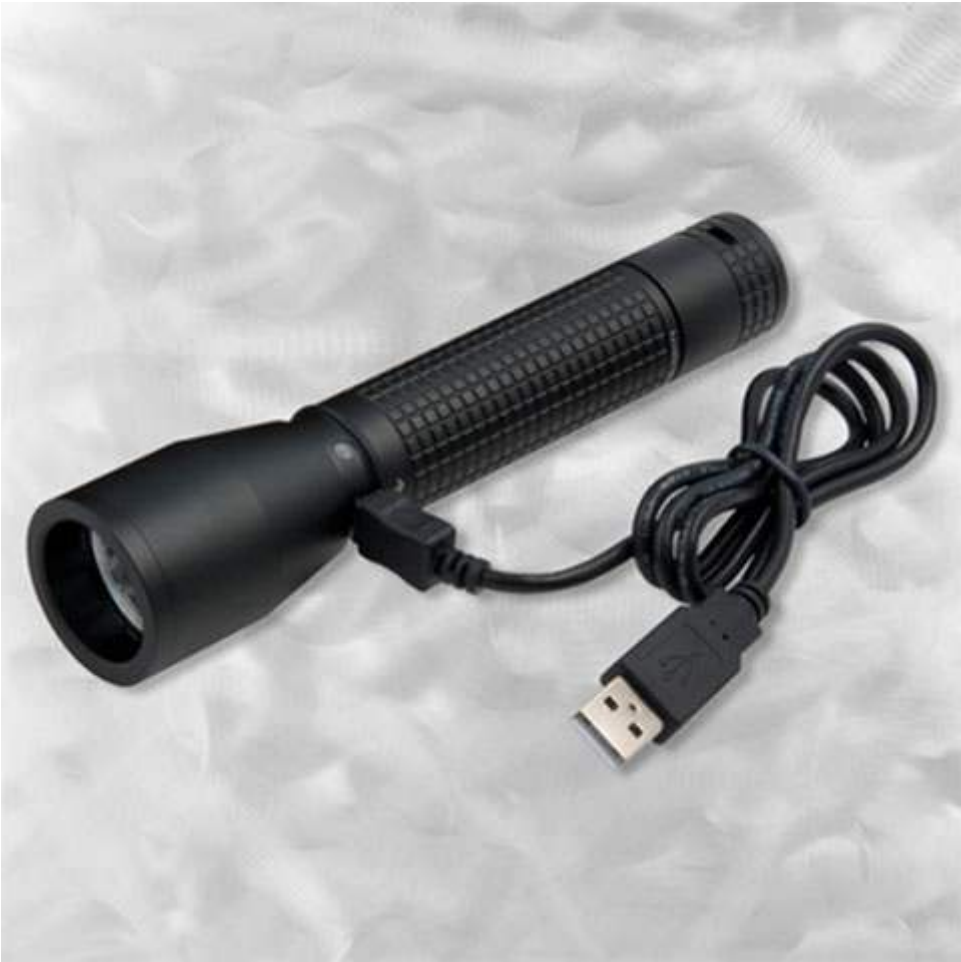
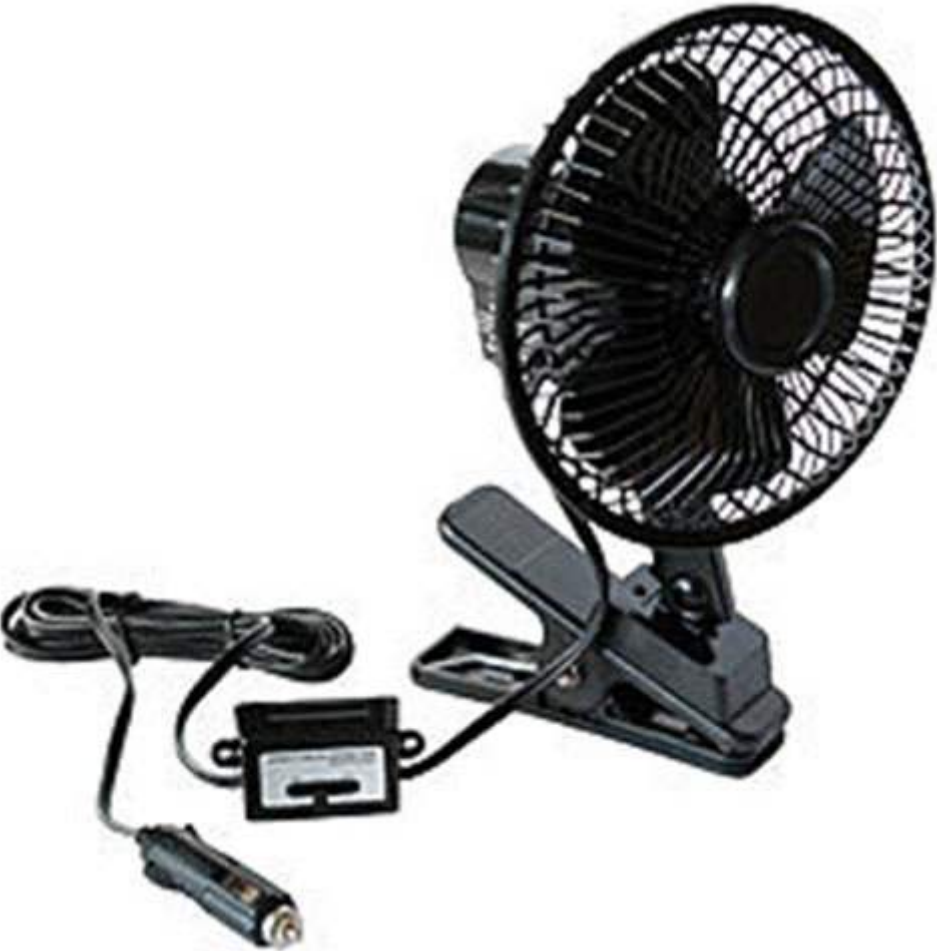
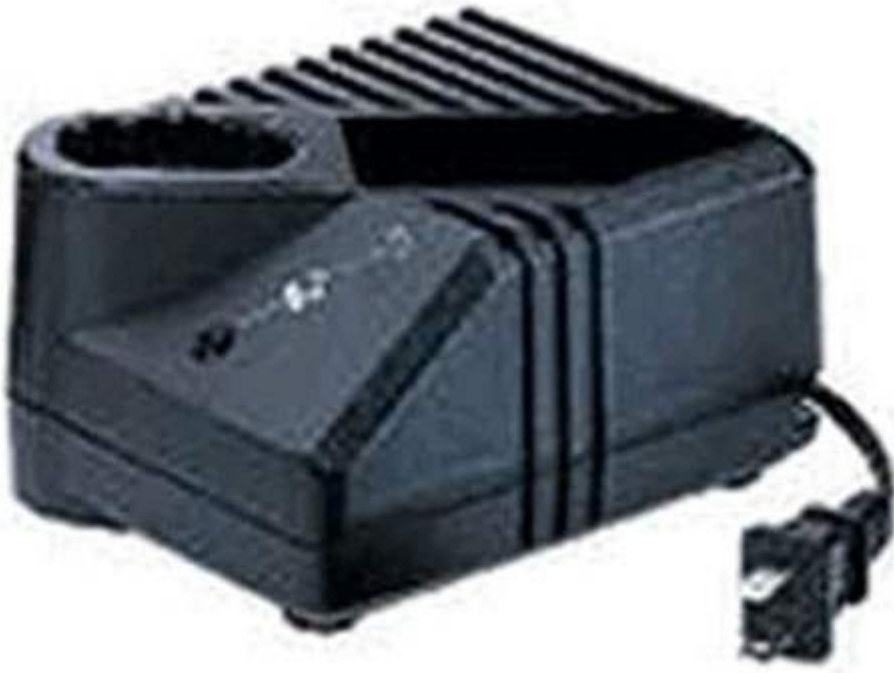
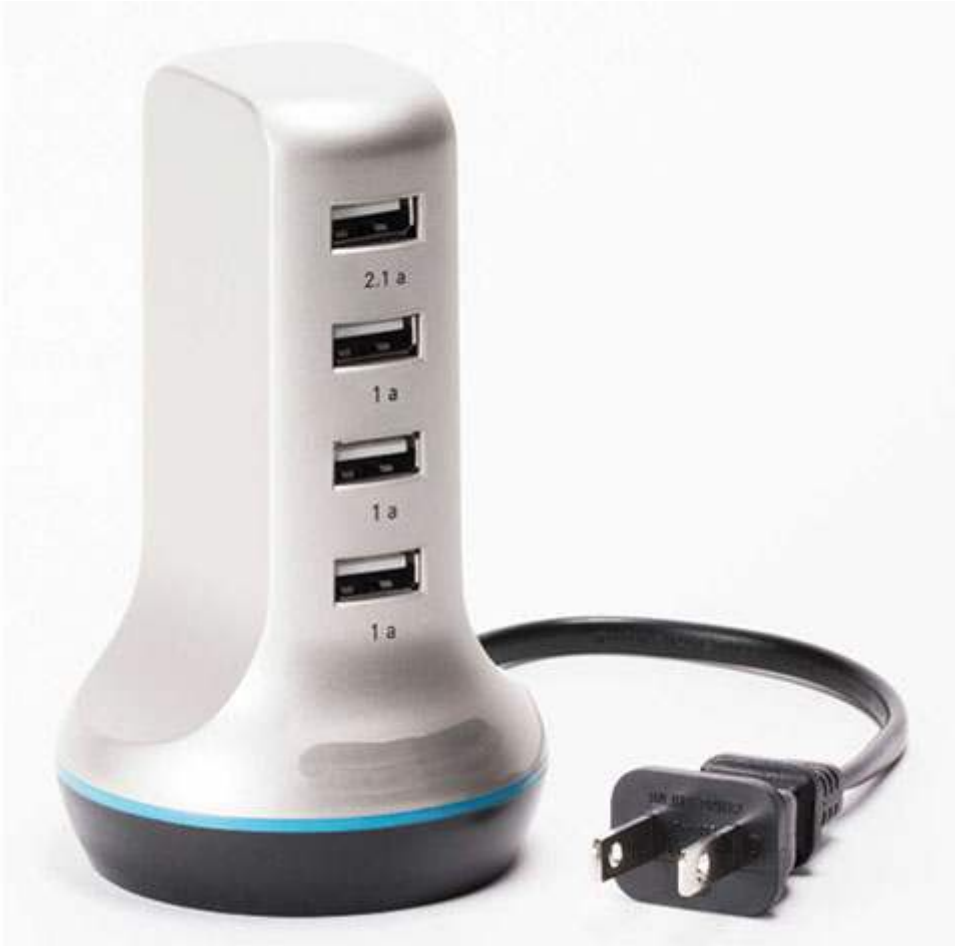
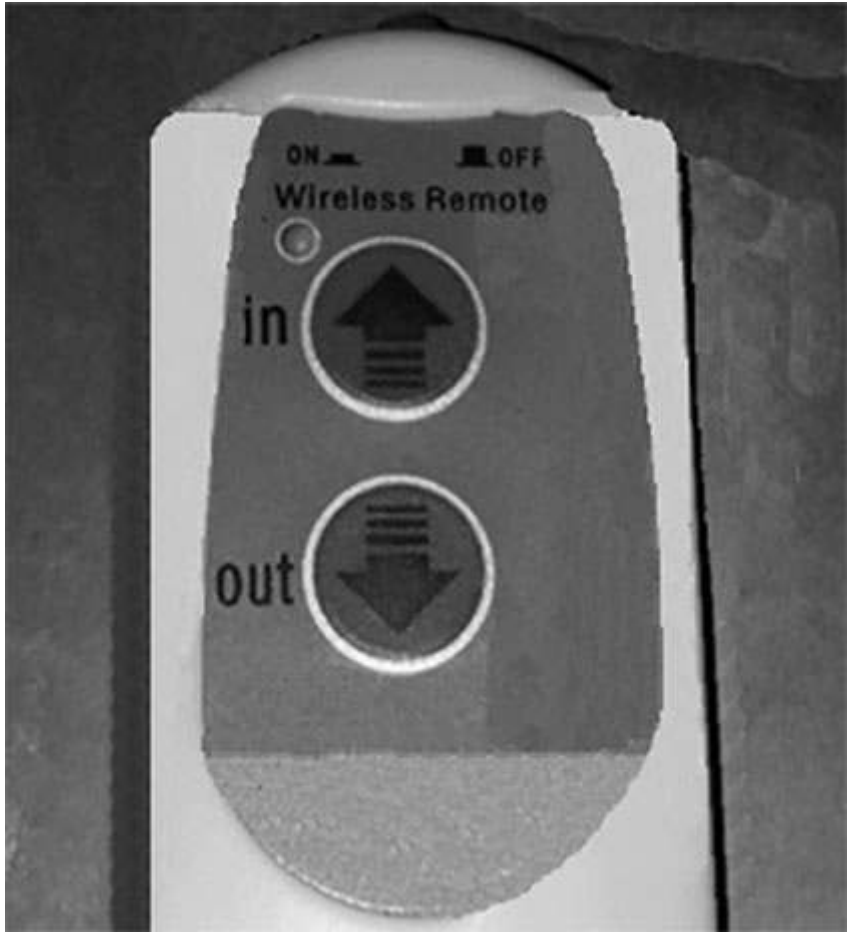
Listed below are a number of aftermarket devices that can cause RFI. In many cases, these types of devices will be attached to the customer's key ring and could be removed from the key ring or from inside the vehicle when the customer drops the vehicle off for service.

- Aftermarket LED dome, tail, turn, stop, strip, floor, door, Logo, head lights

- Certain cell phone chargers
- USB power banks
- USB flash lights
- Fans (12 volt or 110 volt)
- Any type of USB, 12 volt or 110 volt chargers
- "Bedazzle Trim Ring" surrounding ignition lock cylinder, shown below (1)

**Before any in depth diagnosis is performed, question the customer or inspect the vehicle for any types of aftermarket equipment, like shown above, which could cause RFI. These items need to removed and/or disconnected from the vehicle.**

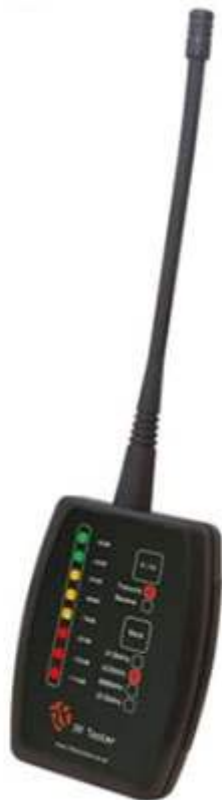
**It is possible to get RFI from transponders or other frequency emitting devices in the area. An RFI meter is available from the aftermarket that can be utilized as an aid to locate stray RFI signals. One example of an RFI meter is from RF Solutions model 006-ND, shown below. As a general rule of thumb, any interference which does not illuminate the red LED's on the tester would be considered acceptable.**
