MODEL  
2021MY  
K5 (DL3a)

NUMBER  
048

SUBJECT: **SERVICE ACTION: LOW PRESSURE FUEL LINE ROUTING  
INSPECTION AND/OR ADJUSTMENT (SA432)**

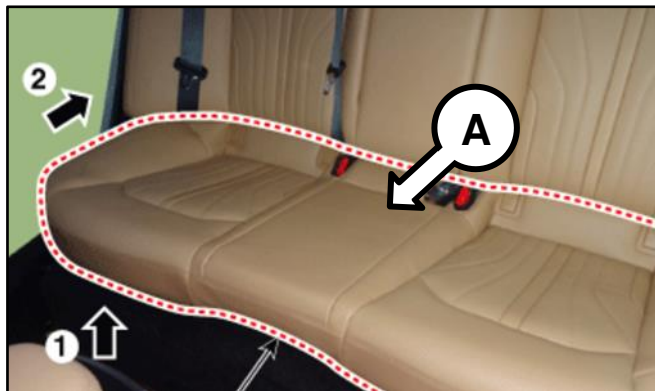
1. Remove the rear seat cushion assembly (A) by referring to the “Body (Interior and Exterior) → Rear Seat → Rear Seat Assembly → Repair procedures” chapter in the applicable Shop Manual on KGIS.

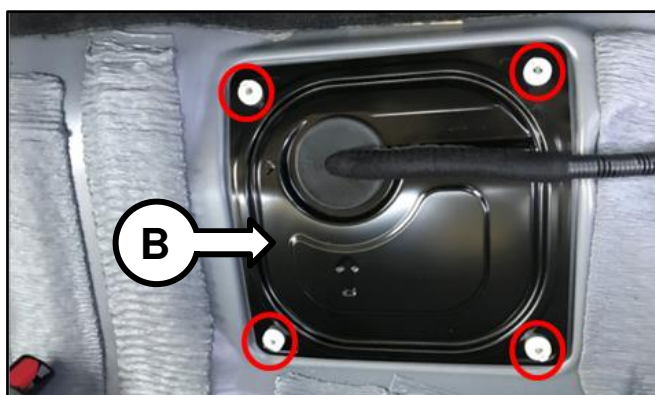
2. Remove the fuel pump service cover (B).

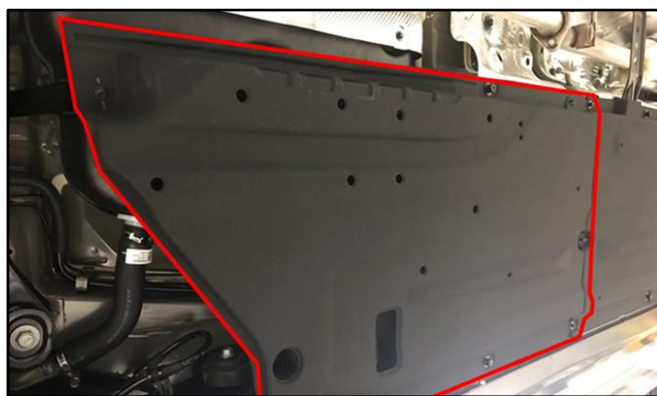
1. Lift vehicle on hoist and remove the left rear lower cover.

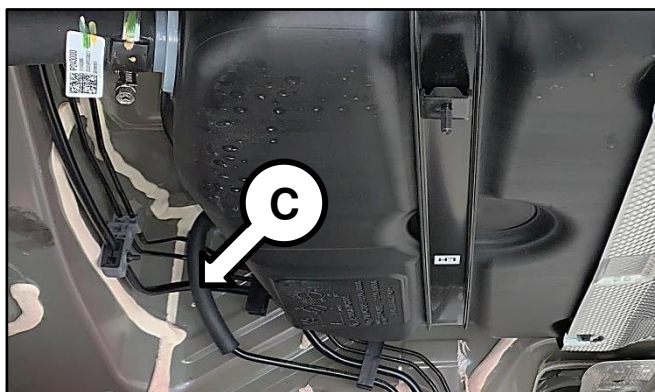
2. Locate the low pressure fuel line (C).

When adjusting, be careful not to cause damage to the low pressure fuel line.
