ITB17-042c

September 14, 2020

## INFINITI; DTC P0456 CAUSED BY EVAP LEAK AT VENT CONTROL VALVE O-RING

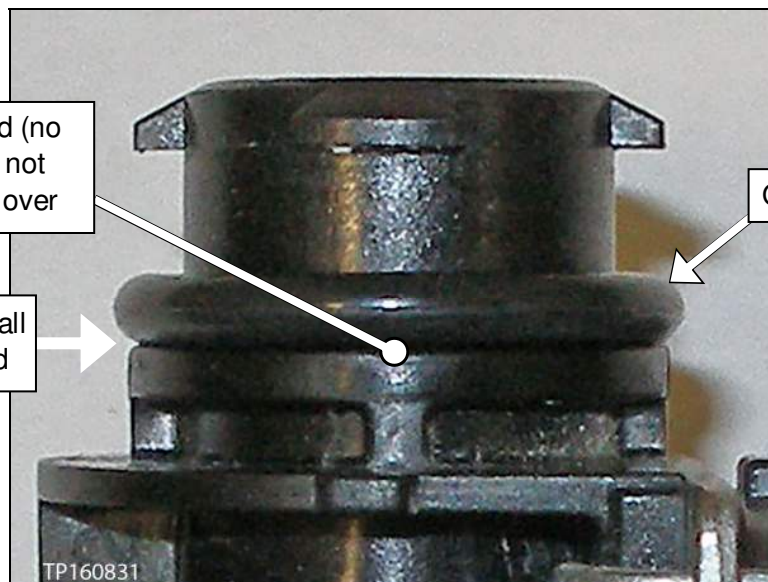
Figure 7

No gap all  
around

O-ring

- Make sure the surfaces that the O-ring comes in contact with are clean.
- When installed, make sure the O-ring is not twisted or rolled over.
- Verify the repair is complete by checking for leaks with a “smoke” leak detection machine or CONSULT-III plus (C-III plus).
  - If a “smoke” leak detection machine is used, follow the manufacturer’s operating instructions.
  - If C-III plus is used:
    1. Confirm the fuel filler cap is secure.
      - Vehicles with a service port see page 5.
      - Vehicles without a service port see page 6.
    2. Using Active Test, close the vent control valve.
    3. Apply pressure using special tool J-42909 until the bar graph reaches about halfway.
    4. Monitor the bar graph for 10 minutes.
