# Service Bulletin

Bulletin No.: 20-NA-071

**Subject:** Service Engine Soon Lamp Illuminated and/or Service Power Brake Assist Message Displayed, with DTCs P0557 or P0558 Stored

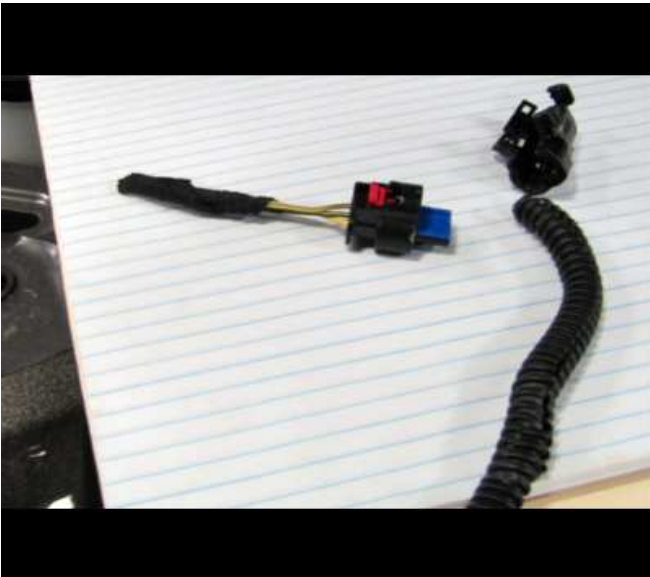
5549619

Note: The top graphic shows the LGX connector intact; the bottom one shows the LFY wiring already cut.

2. Locate the power brake booster vacuum sensor electrical connector. Fold conduit back and cut off connector, leaving approximately 5.0 cm (2.0 in) of wiring on the engine harness side.
3. Tape the cut wiring end to the engine harness. These wires will no longer be used.

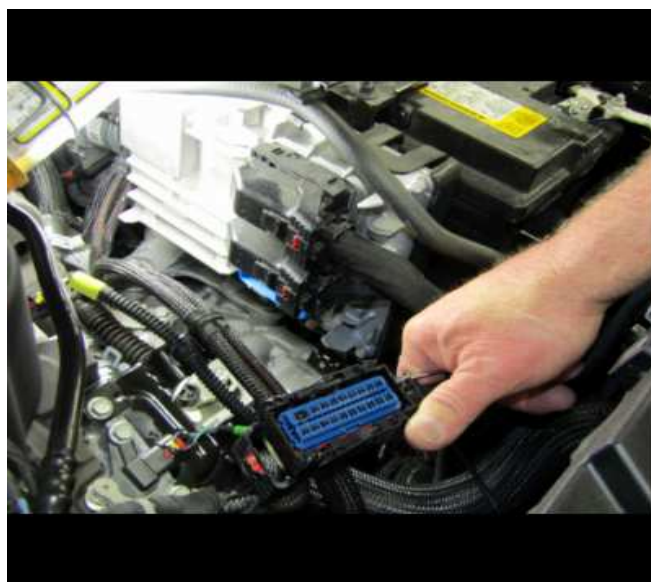
5549626

Note: The LFY harness routing is shown in the top graphic, the LGX routing is shown in the bottom math file. The routing for LCV is similar to the routing of the LGX.

10. Start routing the new harness alongside the engine harness.

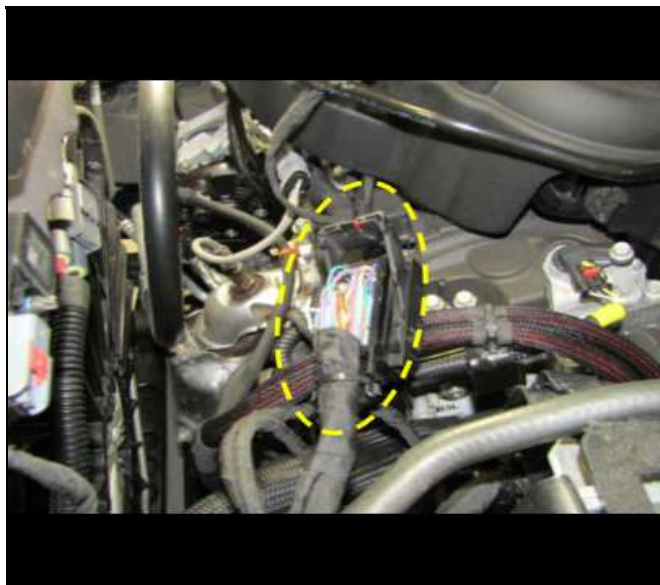
5549632

Important: There are multiple ground circuits tied to ECM ground circuit #2151 and the existing vehicle harness wire MUST be spliced into the new harness.

21. Strip the end of all three of these wires, leaving enough length to make a splice in the butt connector.
22. Twist the engine harness side of circuit #2151 with the new harness #6272 and insert in the butt connector and crimp.
23. Insert circuit #2151 wire from the ECM connector into the butt connector and crimp.
24. Apply heat to shrink and seal the butt connector to complete the splice. Refer to Wire to Wire Repair, in SI.
