# Loss of Air Conditioning Cooling With DTC B1423

| YEAR(S) | MODEL(S) | ADDITIONAL INFORMATION |
|---|---|---|
| 2020 | Highlander, Highlander HV | |

Some 2020 model year Highlander and Highlander Hybrid vehicles may experience a sudden loss of air conditioning cooling with Diagnostic Trouble Code (DTC) B1423 (Open in Pressure Sensor Circuit/Abnormal Refrigerant Pressure) present. Follow the Repair Procedure in this bulletin to address these conditions.

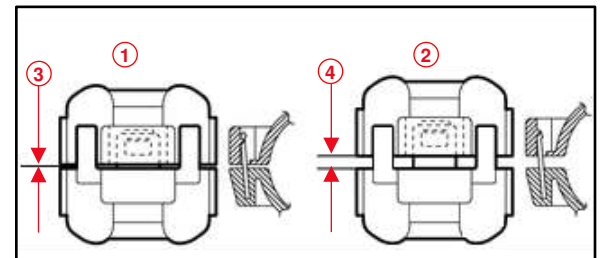
**Figure 10.**

Make sure that the piping clamp is engaged securely with no gap.

- D. Connect the air conditioning tube assembly to the No. 2 air conditioner tube and accessory assembly.
- E. Install the piping clamp to the air conditioning tube assembly.

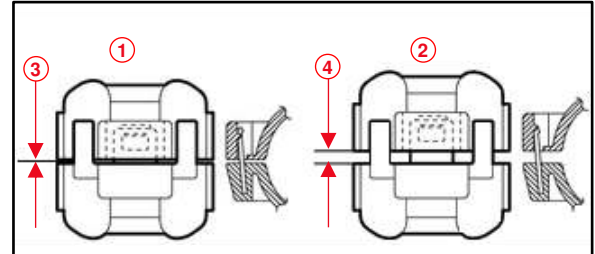
**Figure 22.**

Make sure that the piping clamp is engaged securely with NO gap.

- N. Install the piping clamp to the No. 1 air conditioning accessory assembly.

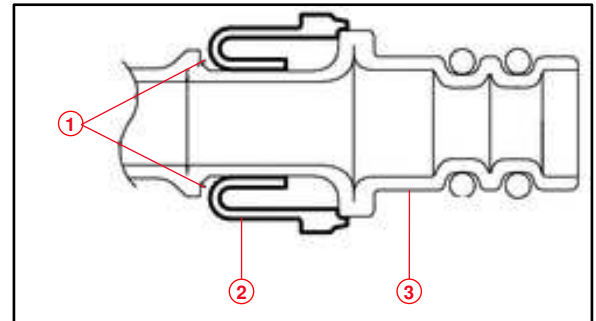
**Figure 26.**

- Securely engage the piping clamp to the groove of the air conditioning tube assembly/cooler refrigerant pipe A.
- Do NOT open the piping clamp more than the diameter of the air conditioning tube assembly/cooler refrigerant pipe A when installing it.
- Do NOT install the piping clamp with the large diameter section facing the wrong direction.
