Preliminary Information

PIP5495M Check Engine Light On With P0299 Or P0234

| Cause: | Misdiagnosis Leading to Returned Turbochargers with NTF |

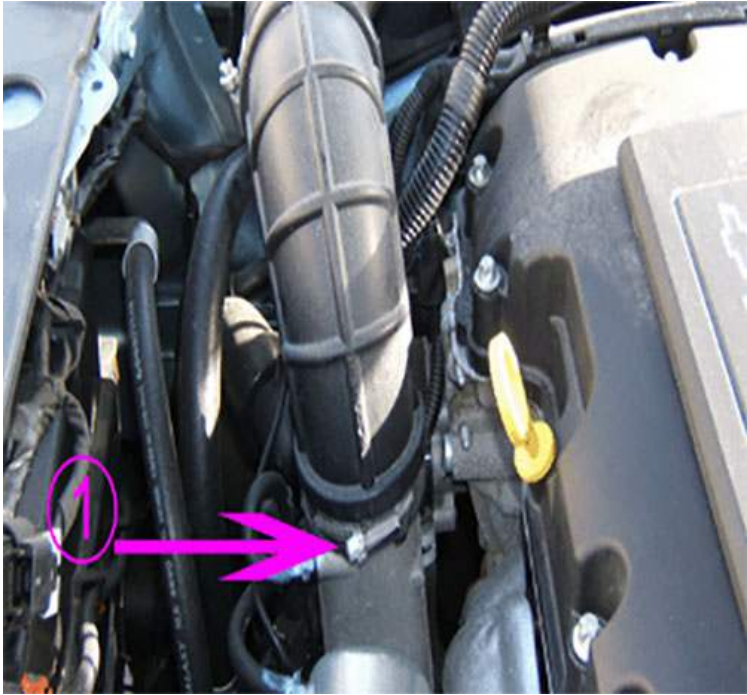
Remove the turbocharger rubber outside air inlet duct.
