## SERVICE BULLETIN

EC16-007

March 23, 2016

### 2013-2015 PATHFINDER; MIL ON WITH DTC P0116

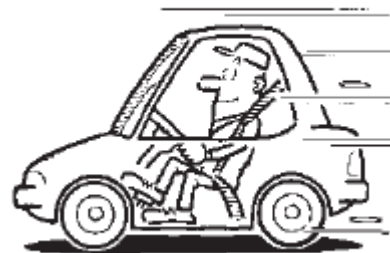
Figure A

- Most instructions for reprogramming with CONSULT-III plus (C-III plus) are displayed on the CONSULT PC screen.
- If you are not familiar with the reprogramming procedure, [click here](#). This will link you to the "CONSULT- III plus (C-III plus) ECM Reprogramming" general procedure.
- Take the vehicle for a 10 minute drive in order to meet the following Idle Air Volume Learn (IAVL) conditions:
  - Engine coolant temperature: 70 -100°C (158 -212°F)
  - Battery voltage: More than 12.9V (At idle)
  - Transmission: Warmed up

- After reprogramming is complete, you will be required to perform Throttle Valve Closed Position, Idle Air Volume Learn, Accelerator Closed Position, and DTC erase. The above conditions are required for the IAVL to complete
