## SERVICE BULLETIN

EC16-011

### 2016 ALTIMA; MIL ON WITH DTC P0101

**APPLIED VEHICLES:** 2016 Altima (L33)

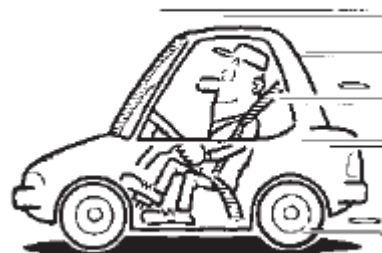
Figure A

- Most instructions for reprogramming with CONSULT-III plus (C-III plus) are displayed on the CONSULT PC screen.
- If you are not familiar with the reprogramming procedure, [click here](#). This will link you to the "CONSULT- III plus (C-III plus) Reprogramming" general procedure.
- Take the vehicle for a 10 minute drive in order to meet the following Idle Air Volume Learn (IAVL) conditions:
  - Engine coolant temperature: 70 - 105°C (158 - 221°F)
  - Battery voltage: More than 12.9V (at idle)
  - Transmission: Warmed up

**NOTE:** After reprogramming is complete, you will be required to perform Throttle Valve Closed Position, Idle Air Volume Learn, Accelerator Closed Position, and DTC erase. The above conditions are required for IAVL to complete.
