Preliminary Information

PIP5495N Check Engine Light On With P0299 Or P0234

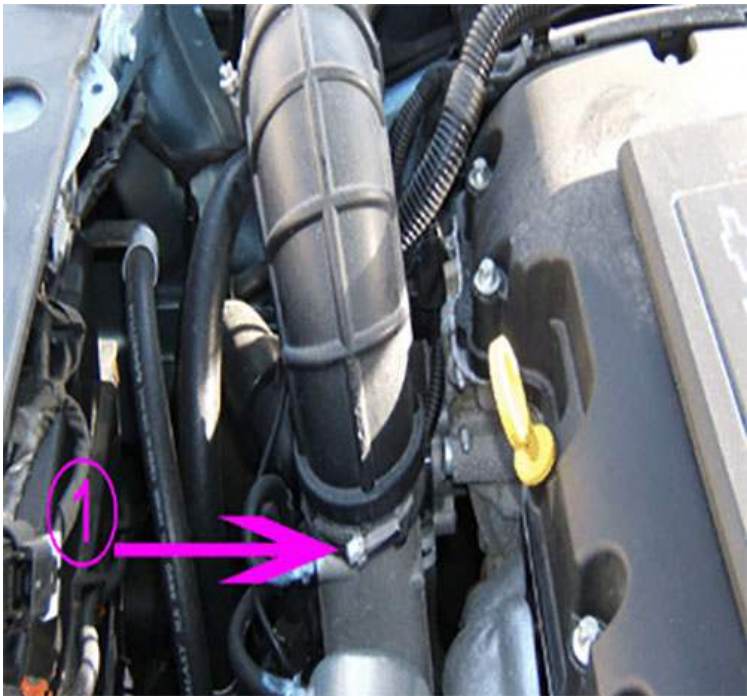
Note: The view shown below indicates NORMAL oil staining in the turbocharger outside air inlet. This dry stain does not represent an oil leak.

Remove the turbocharger rubber outside air inlet duct.

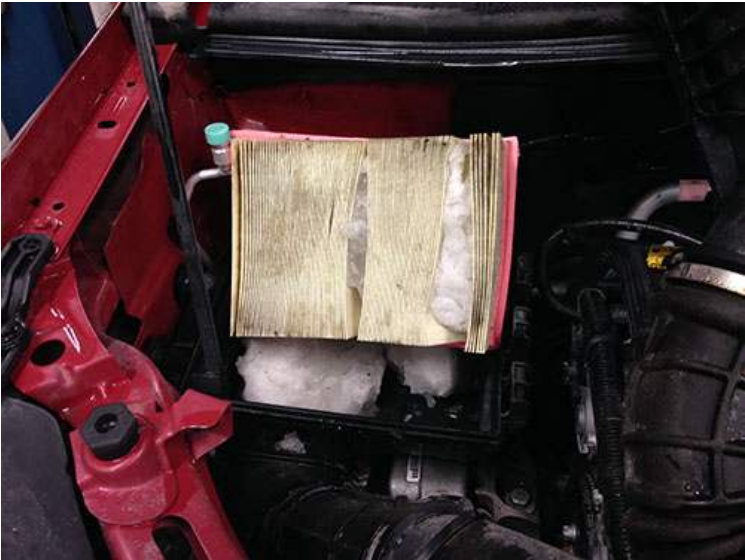
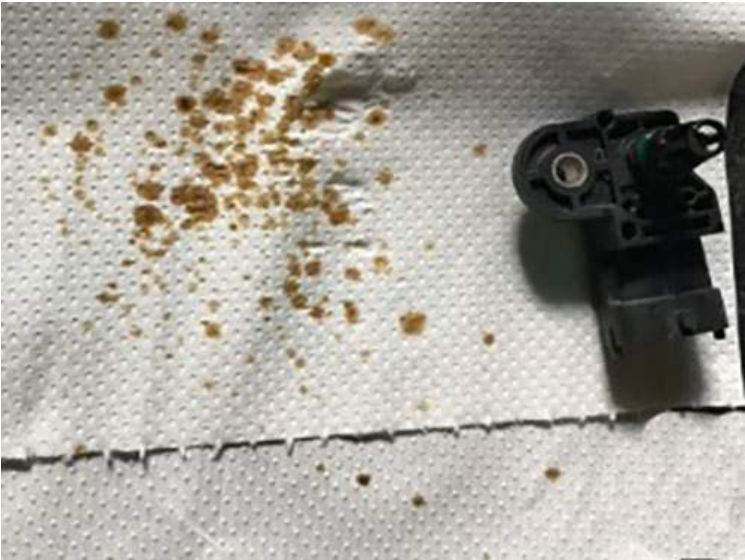
P0299 could set as a result of ice buildup in the Induction system, Charge Air Cooler (CAC) and/or the Boost Pressure sensor.

For Encore and Trax refer to the latest version of [16-NA-405](#) ; (Poor Engine Performance in Extremely Cold Weather Conditions, PCV Bypass Hose and Charge Air Cooler Icing - Malfunction Indicator Lamp (MIL) Illuminated, DTC P0299, P0236, P2227, and P00C7 Set)

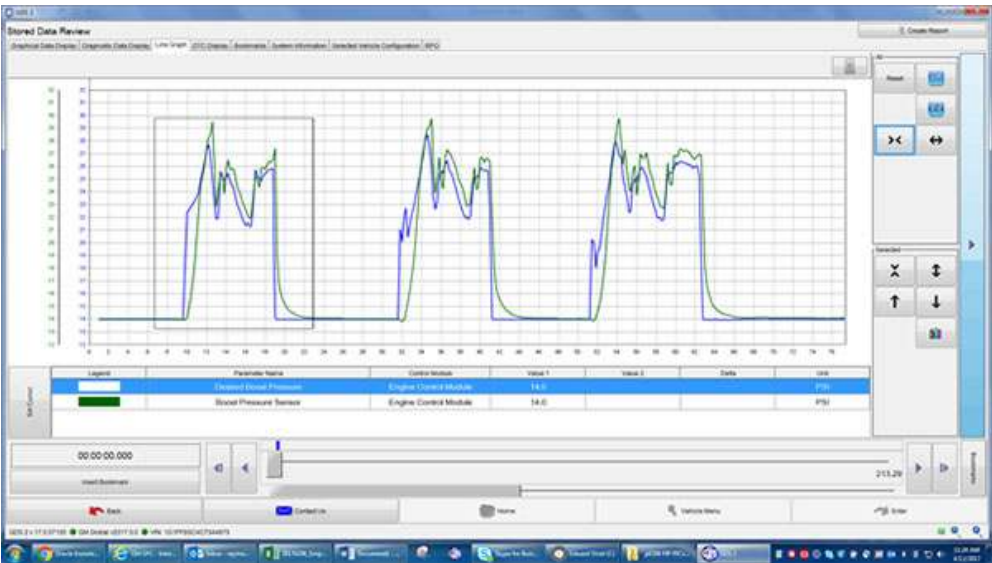
Example of normal turbocharger wastegate operation:

In this example, notice that the measure window begins once the Boost Pressure Sensor reading (Green) meets the Desired Boost Pressure reading (Blue) and ends when the APP is released per the testing instructions.
