| <b>HYUNDAI</b><br><b>Technical Service Bulletin</b> | | GROUP<br><b>Engine Mechanical</b> | NUMBER<br><b>21-EM-007H</b> |
| | | DATE<br><b>June, 2021</b> | MODEL(S)<br><b>Sonata Hybrid (LF HEV),<br/>Sonata Plug-In Hybrid (LF PHEV)</b> |
| <b>SUBJECT:</b> | <b>DTC P2600 ENGINE ELECTRIC WATER PUMP<br/>DIAGNOSIS AND REPAIR GUIDELINE</b> | | |

**Description:** This bulletin describes the procedure to diagnose and repair the Engine Electric Water Pump (EEWP) on certain Sonata Hybrid (LF HEV) and Sonata Plug-In Hybrid (LF PHEV) vehicles with DTC P2600, causing an HEV and/or MIL warning lamp illumination.

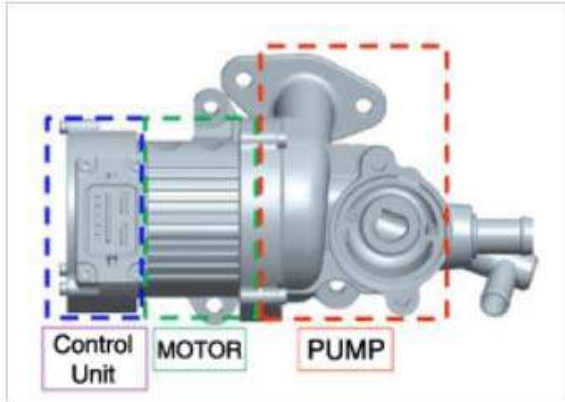
- P2600 - COOLANT PUMP "A" CONTROL CIRCUIT / OPEN
  - Internal circuit of EEWP (opened/ shorted) or Engine coolant level may be too low.

| PART NAME | Figure | Part Number | QTY |
|---|---|---|---|
| PUMP ASSY-COOLANT<br>(Engine Electric Water Pump) | | 25100-2E272 | 1 |

7. If EEWP fails inspection portion of the service procedure or if P2600 resets, then the EEWP must be replaced following the steps below.
8. Shut off the High Voltage circuit.
