# Technical Service Bulletin

## 66 Rear spoiler is inoperative

66 21 79 2065220/1 December 7, 2021.

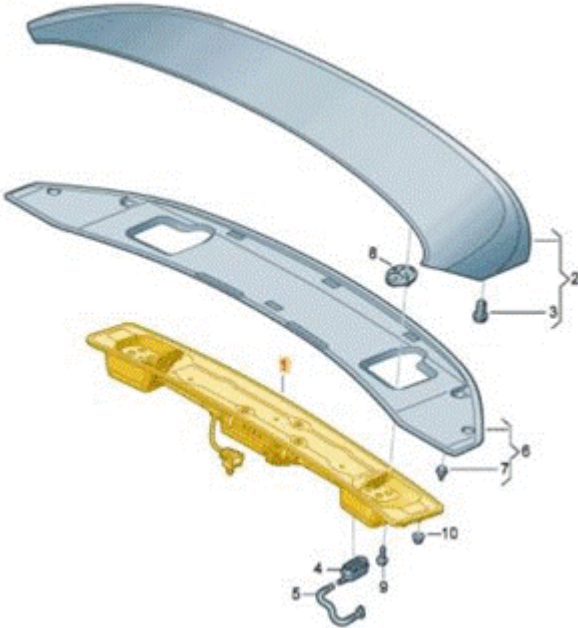
| Always check with your Parts Department and/or ETKA for the latest information and parts bulletins. | | |
|---|---|---|
| 4K8827948F | <br>Bracket for spoiler drive unit | 01 |

1. Should the vehicle exhibit the symptom profile described in this TSB, replace the rear spoiler drive unit. Figure 3 shows the rear spoiler drive assembly.
