Subject: 49 CFR Part 579.5 Monthly Communications – January 2016

**INDEX OF SERVICE BULLETINS,  
NOTICES, AND COMMUNICATIONS TO DEALERS**

| <u>NO.</u> | <u>DESCRIPTION</u> | <u>DATE</u> |
|---|---|---|
| 2 | Customer Satisfaction Program 15B23:<br>Certain 2012-2014 Focus Electric Vehicles -<br>High Voltage Wire Harness Update and Reprogram<br>Powertrain Control Module | January 7, 2016 |
| 4 | Customer Satisfaction Program 15B39: Certain<br>2015 Model Year Transit Vehicles - Under Hood<br>Water Management Repair | January 21, 2016 |

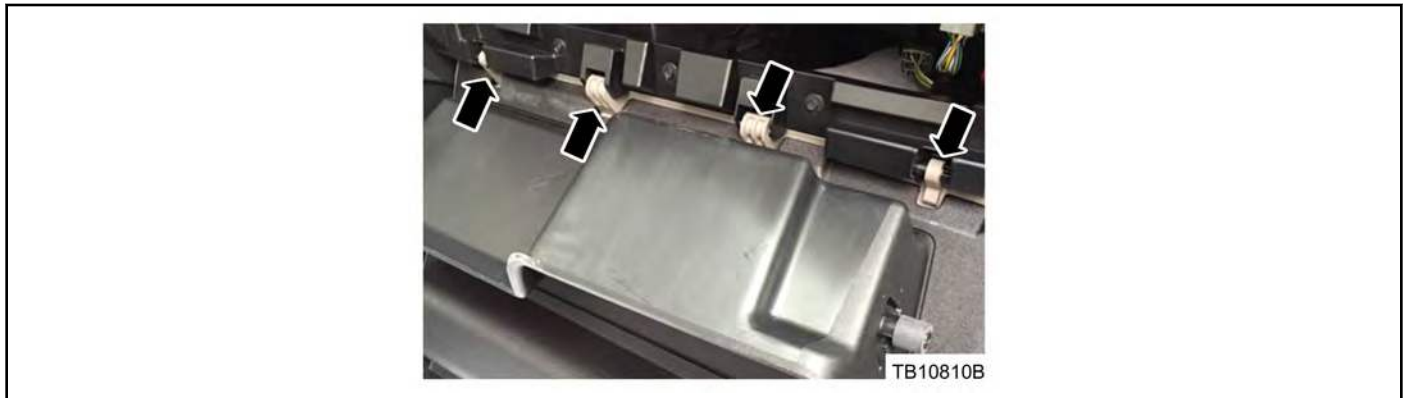
Figure 1 - Article 16-0005

1. Open the glove compartment and release the glove compartment down stops. Remove the dampener by pushing down and forward at the damper end then fully lower the glove compartment. Refer to Workshop Manual (WSM), Section 501-12.
2. Inspect both glove compartment hinge pins to make sure they are properly installed through the glove compartment hinge and supported at both ends by the instrument panel. (Figure 1)
