**Wayne E. Bahr, Global Director**  
Automotive Safety Office  
Sustainability, Environment & Safety Engineering

Subject: 49 CFR Part 579.5 Monthly Communications – February 2016

**INDEX OF SERVICE BULLETINS,  
NOTICES, AND COMMUNICATIONS TO DEALERS**

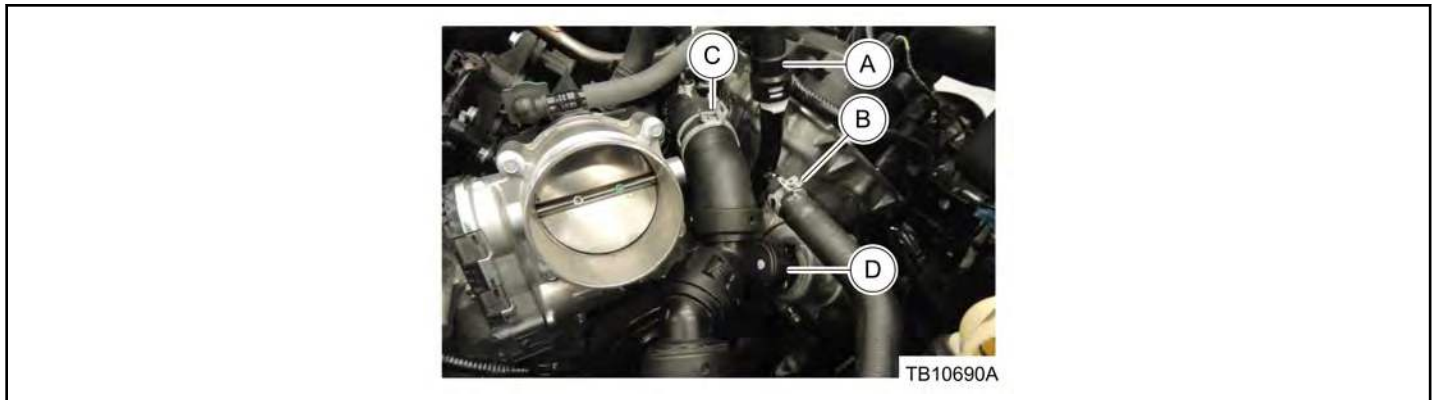
Figure 2 - Article 16-0019

Some 2015 F-150 and Mustang vehicles equipped with a 5.0L Dual Overhead Camshaft (DOHC) engine may exhibit a coolant leak caused by a heater outlet hose becoming disconnected at the heater outlet tube on the coolant pump.

- a. No - this procedure does not apply. Refer to WSM, Section 303-03 for normal diagnosis.
  - b. Yes - proceed to Step 3.
3. Drain the cooling system. Refer to WSM, Section 303-03.
4. Remove the air cleaner outlet pipe. Refer to WSM Section 303-12.
5. Remove the bolts and position the degas bottle aside.
6. Completely cover the accessory drive belts with waterproof plastic.
7. Disconnect the heater outlet hose from the heater outlet tube. (Figure 2A)

8. Release the clamp and disconnect the lower degas bottle hose from the heater outlet tube. (Figure 2B)
9. Release the upper radiator hose clamp from the heater outlet water connection. (Figure 2C )
10. Pull the upper radiator hose T-connector spring clip up until the end of the clip is in the detent on the quick connect coupling and remove the upper radiator hose T-connector from the thermostat housing. (Figure 2D)
11. Remove the bolt and the heater outlet tube.
12. Install the new heater outlet tube and the bolt. Tighten to 10 Nm (89 lb-in.).
  - a. Lubricate the O-ring seal on the heater outlet tube with clean engine coolant.
13. To install the remaining components, reverse the removal procedure.

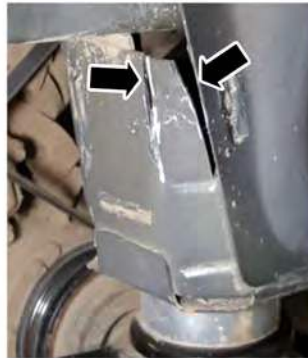
Figure 2 - Article 16-0021

Some 2016 Explorer vehicles built on or before 1/31/2016 may exhibit a pop or creak noise from the right front mounting bolt of the front subframe. This condition may be due to a mispositioned weld between the barrel nut and the subframe mounting bracket.

6. Using an abrasive cut off wheel, cut the bracket sheet metal along the marked lines. (Figure 2)

a. Make sure to only cut through the outer layer.
