NUMBER  
PI1802Y/Z (Rev 6, 12/23/2021)

## PRODUCT IMPROVEMENT CAMPAIGN

### ENGINE REPLACEMENT INSTRUCTIONS FOR DTC P1326 (PI1802Y/Z)

This bulletin provides information related to the Technical Service Bulletin previously published [PI1802](#) titled "Knock Sensor Detection System - ECU Logic Improvement" equipped w/THETA II engine. Specifically, this bulletin provides instructions on which procedures to follow if, after installation of the KSDS, any one of the subject vehicles below returns to the dealer with Diagnostic Trouble Code (DTC) P1326 (Knock Signal Range/Performance).

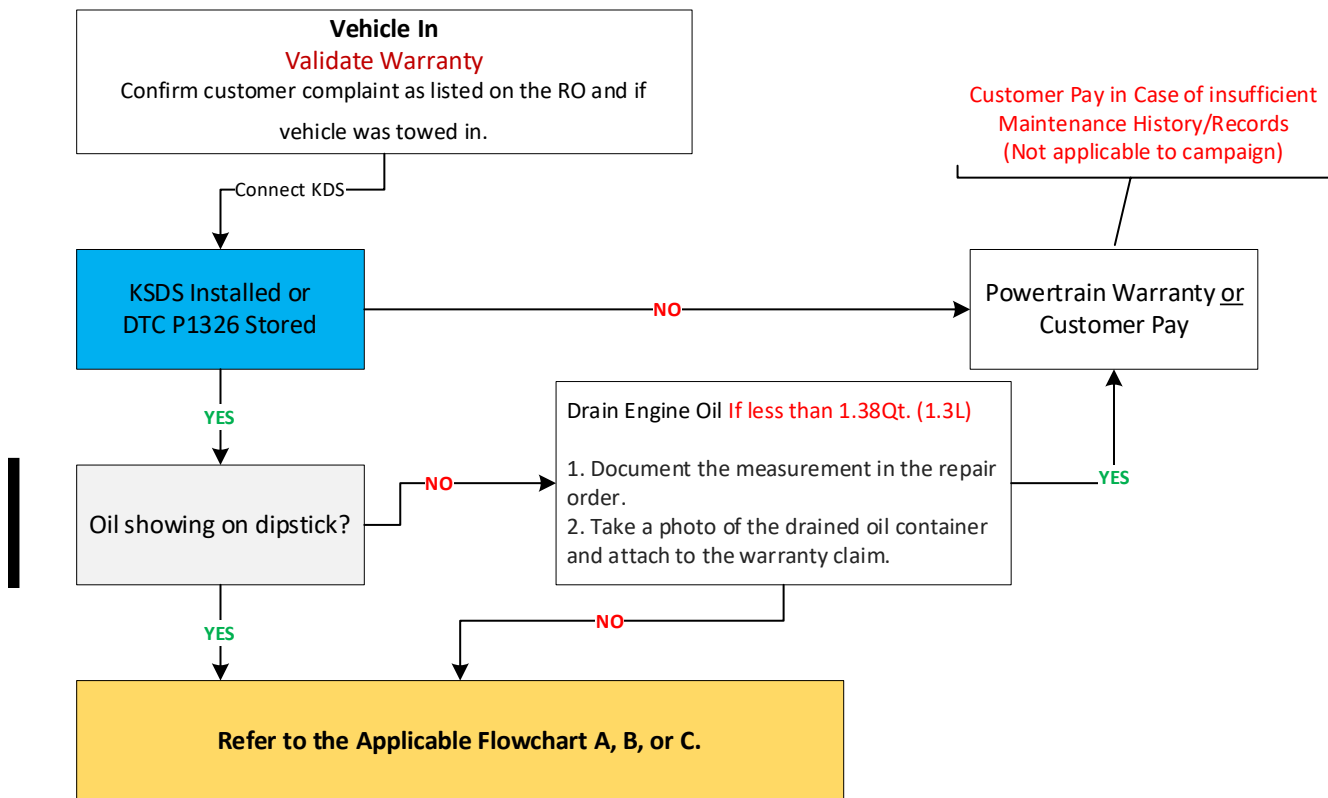
**Main Flowchart:**

Follow the applicable Main Flowchart below upon documenting customer complaint. Then follow the corresponding flowchart for one (1) of the three (3) following concerns:

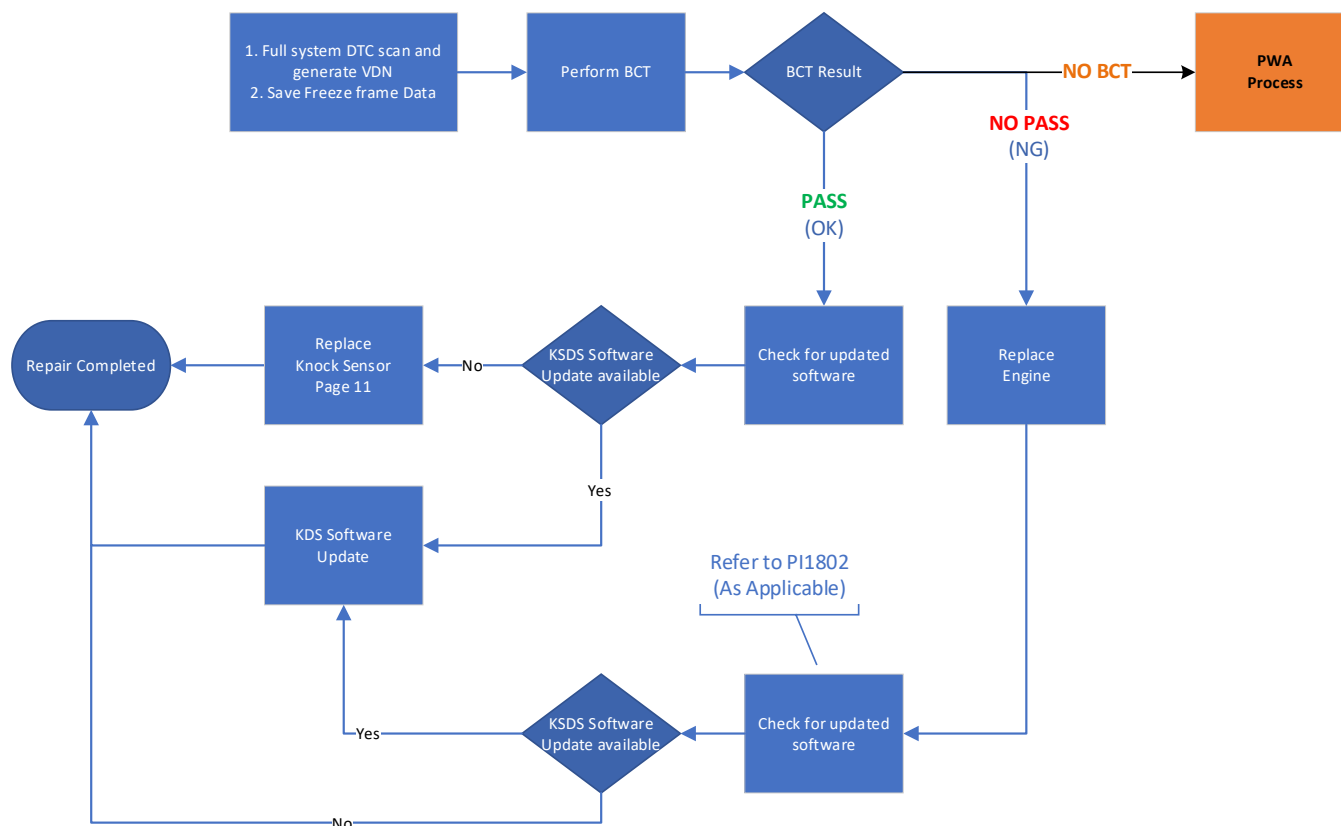
**SUBJECT: ENGINE REPLACEMENT INSTRUCTIONS FOR DTC P1326 (PI1802Y/Z)****A. DTC P1326 Stored**

Create PI1802Y Claim - No PWA Required (Pass/No Pass result)

Create PI1802Z Claim - PWA Required (No BCT result)

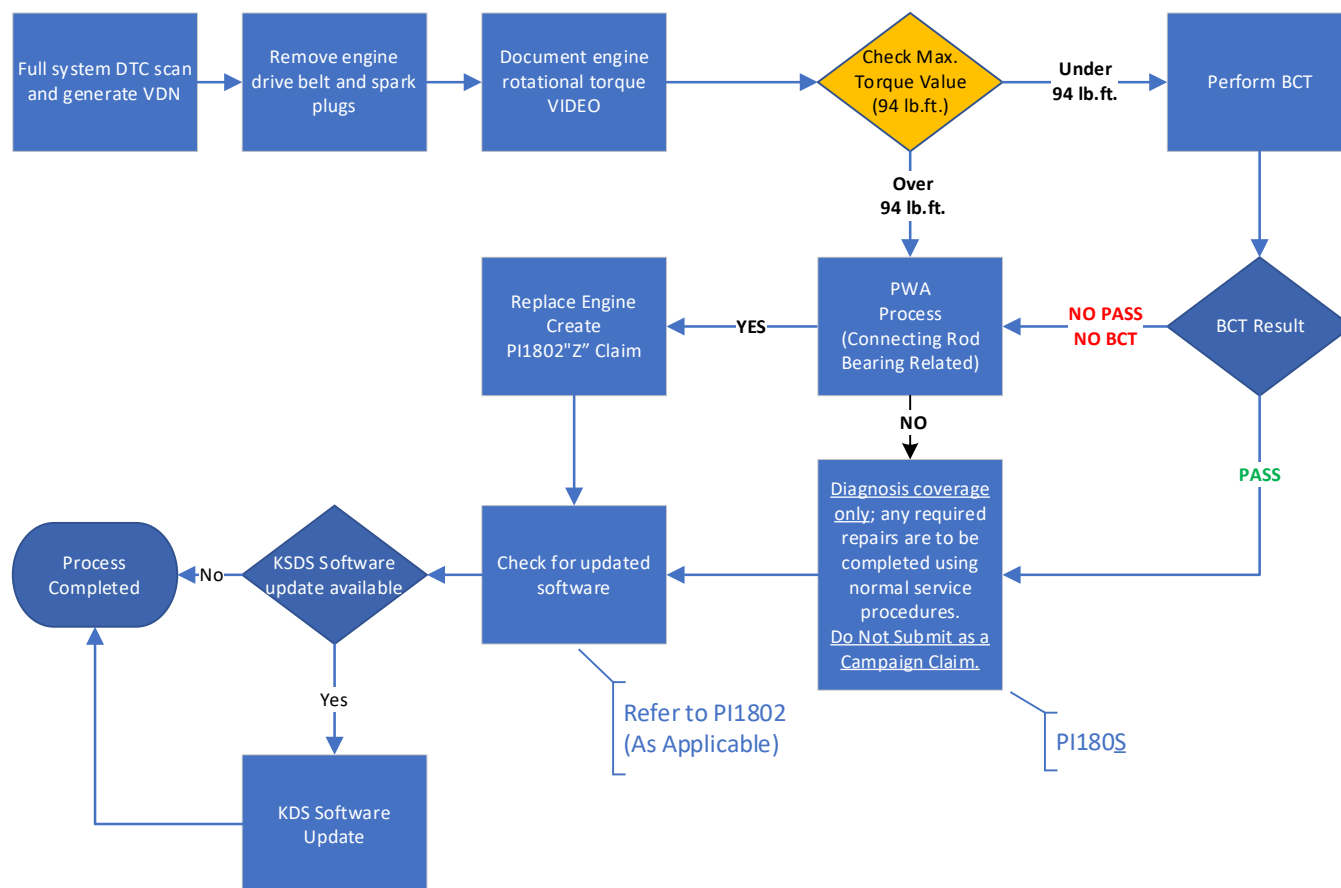
## C. Engine No Crank

Techline PWA Required; Diagnosis only Campaign Possible

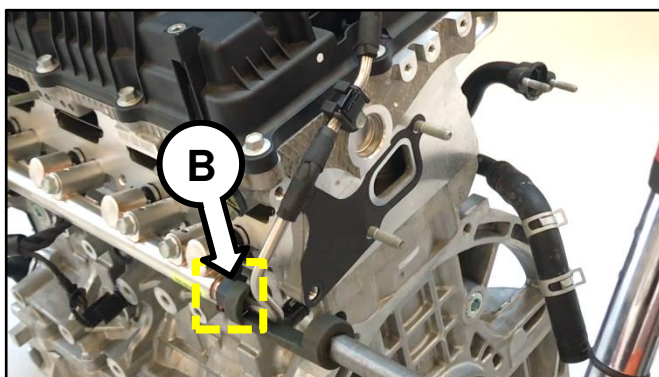
The high-pressure fuel pipe bracket and bolt must be installed AND properly torqued prior to torquing the high-pressure fuel pipe flare nuts.

3. Using a click-type/electronic torque wrench and SST 09314-3Q100, torque both flare nuts (B) to specifications.

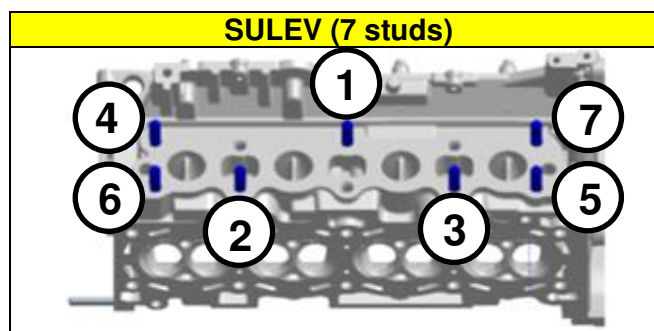
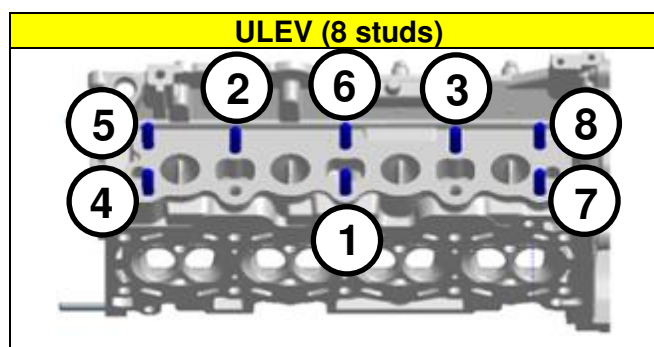
- All engines supplied under this Product Improvement Campaign have the exhaust manifold studs configured for SULEV engines.
- Using the pictures to the right, check the exhaust manifold stud location and quantity. Relocate as required for ULEV engines and obtain one (1) extra from the removed engine.
- Prior to installation, replace the exhaust manifold gasket and front muffler gasket.
- Torque nuts in the sequence shown.

**Tightening torque of nuts:**

36.2 – 39.7 lb.ft (49.0 – 53.9 N.m,  
5.0 – 5.5 kgf.m)
