NUMBER  
PI1803Y/Z (Rev 6, 12/23/2021)

### ENGINE REPLACEMENT INSTRUCTIONS FOR DTC P1326 (PI1803Y/Z)

This bulletin provides information related to the Technical Service Bulletin previously published [PI1803](#) titled "Knock Sensor Detection System - ECU Logic Improvement" equipped w/THETA II engine. Specifically, this bulletin provides instructions on which procedures to follow if, after installation of the KSDS, any one of the subject vehicles below returns to the dealer with Diagnostic Trouble Code (DTC) P1326 (Knock Signal Range/Performance).

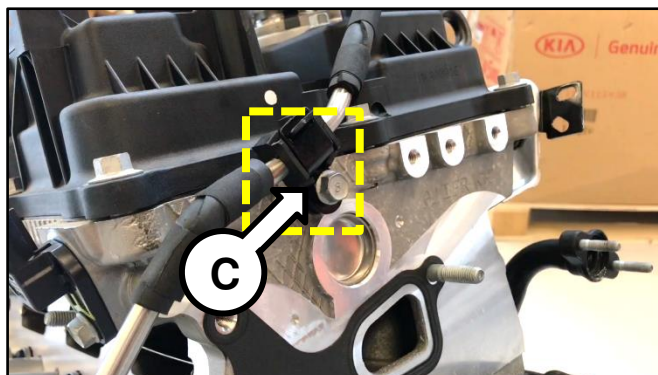
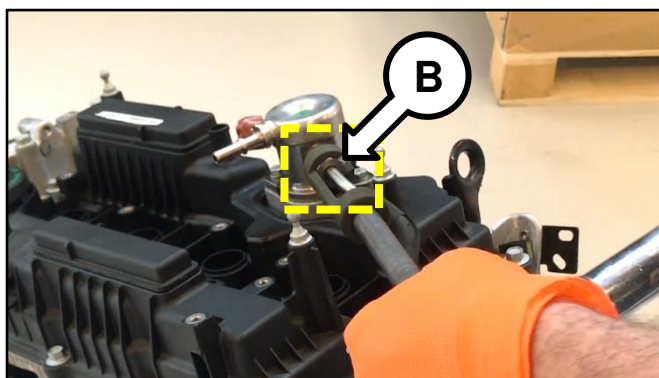
If the bracket and bolt are missing, order and install a new bracket and bolt.

2. Install the pipe retaining bracket and bolt (C) and torque to specifications.

**Tightening torque (bracket bolt):**  
 5.8 – 8.7 lb.ft (7.8 – 11.8 N.m,  
 0.8 – 1.2 kgf.m)

The high pressure fuel pipe bracket and bolt must be installed **AND** properly torqued prior to torquing the high pressure fuel pipe flare nuts.

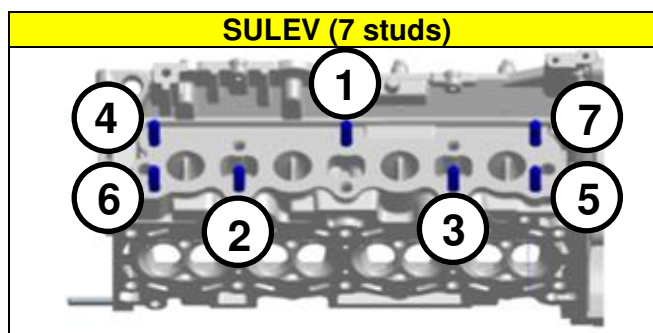
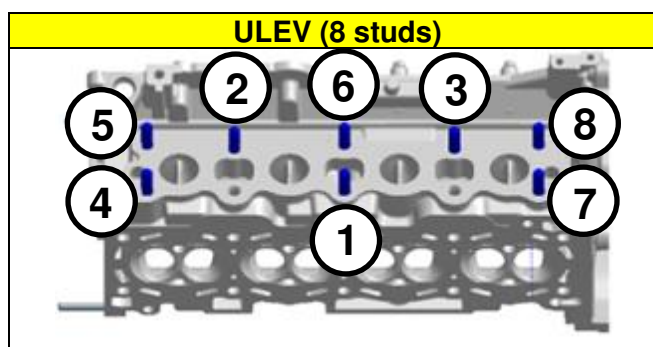
- All engines supplied under this Product Improvement Campaign have the exhaust manifold studs configured for SULEV engines.
- Using the pictures to the right, check the exhaust manifold stud location and quantity. Relocate as required for ULEV engines and obtain one (1) extra from the removed engine.
- Prior to installation, replace the exhaust manifold gasket and front muffler gasket.
- Torque nuts in the sequence shown.

**Tightening torque of nuts:**

36.2 – 39.7 lb.ft (49.0 – 53.9 N.m,  
5.0 – 5.5 kgf.m)

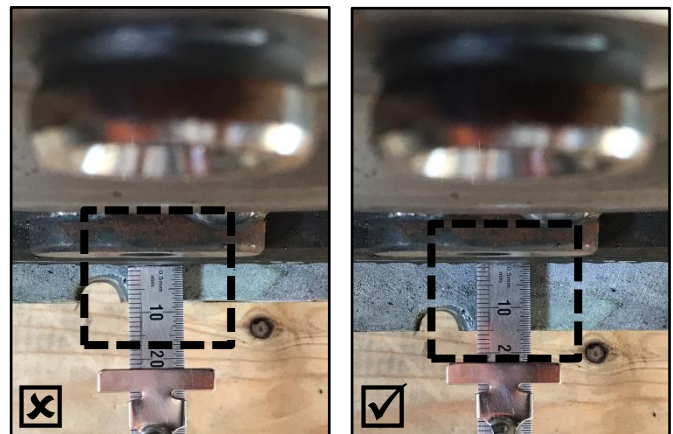
Not Fully Inserted

Fully Inserted

- If the torque converter has moved from the fully inserted position, carefully push inward while rotating the torque converter until it is recessed approximately 9/16 – 5/8" (14 – 16mm) (☑) into the transaxle case when reinstalling the automatic transaxle.
