# Preliminary Information

## PIP5826B MIL illuminated with DTC P0521

### Models

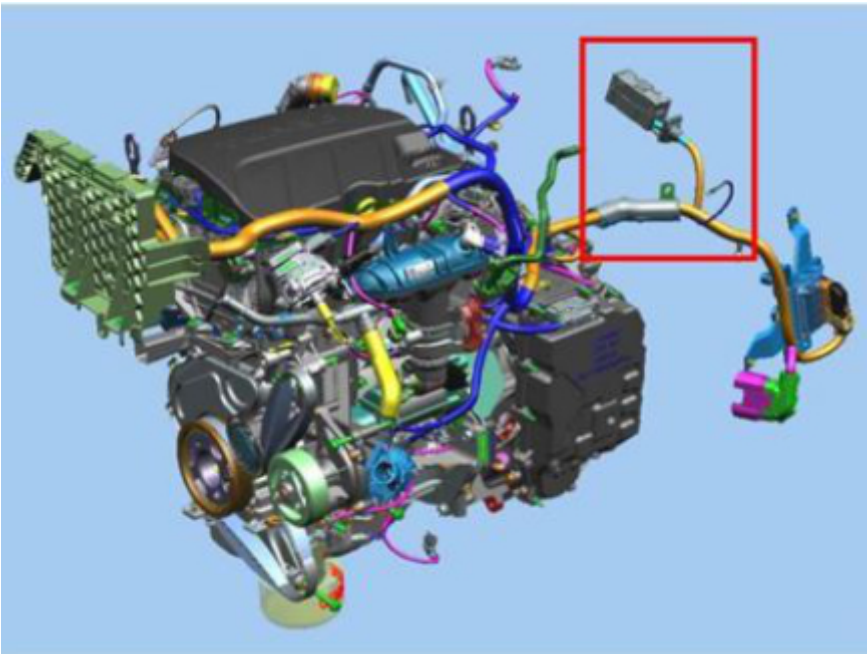
It is located on the harness branch for X50A Fuse Block - Underhood as shown below.

Branch for X50A Fuse Block - Underhood.
