Preliminary Information

PIP5791A DTC P2B60 Engine Coolant Flow Control Valve Position Sensor Circuit Performance

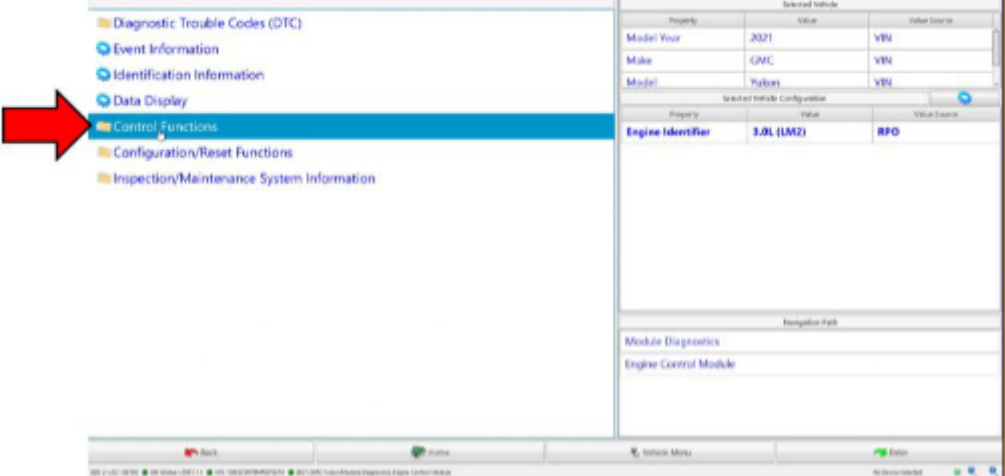
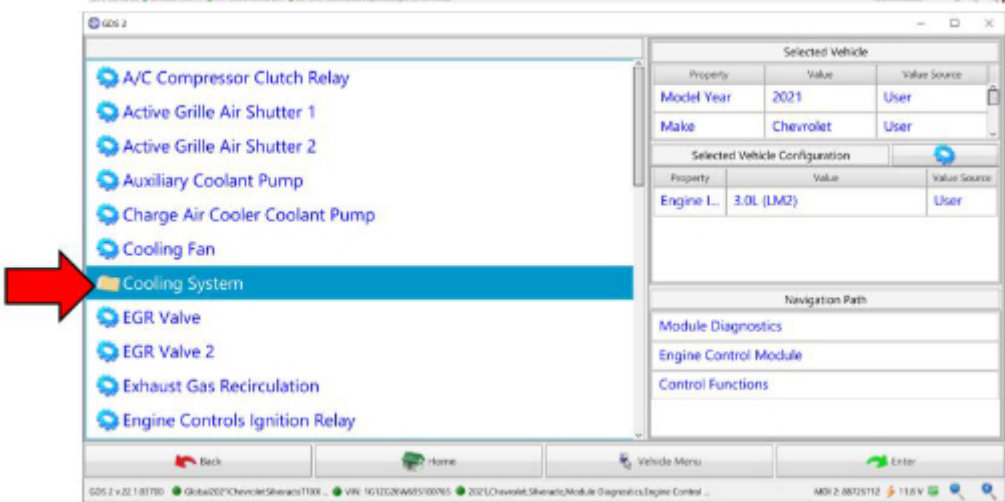
Using the GDS2 tool with software levels greater than GM Global v 2021.3.1 : Perform the following process to evaluate if the Engine Coolant Flow Control Valve is responding. With the ignition on and the engine NOT RUNNING, navigate to the Engine Coolant Flow Control Valve control function as illustrated below.

Slide the command from 25% (2) to 95% (3) (for Pickups), making sure to wait until the Engine Coolant Flow Control Position (1) indicates 95% and slide it back to 25% (2). Exercise the valve 3 times to verify it is functional. The “Engine Coolant Flow Control Valve Position” value should move to the desired value just commanded.

The GDS tool will have a slide range of only 20% - 80% (5 and 6) for an SUV. Please perform the same 3-time-slide action for SUV and verify the Coolant Flow Control Valve position parameter (4) matches the desired position you commanded.
