# Service Bulletin

Bulletin No.: 18-NA-246

**Subject:** Malfunction Indicator Lamp (MIL) Illuminated - DTC P0172, P06DE and/or P0521 Set (North America Vehicles Only)

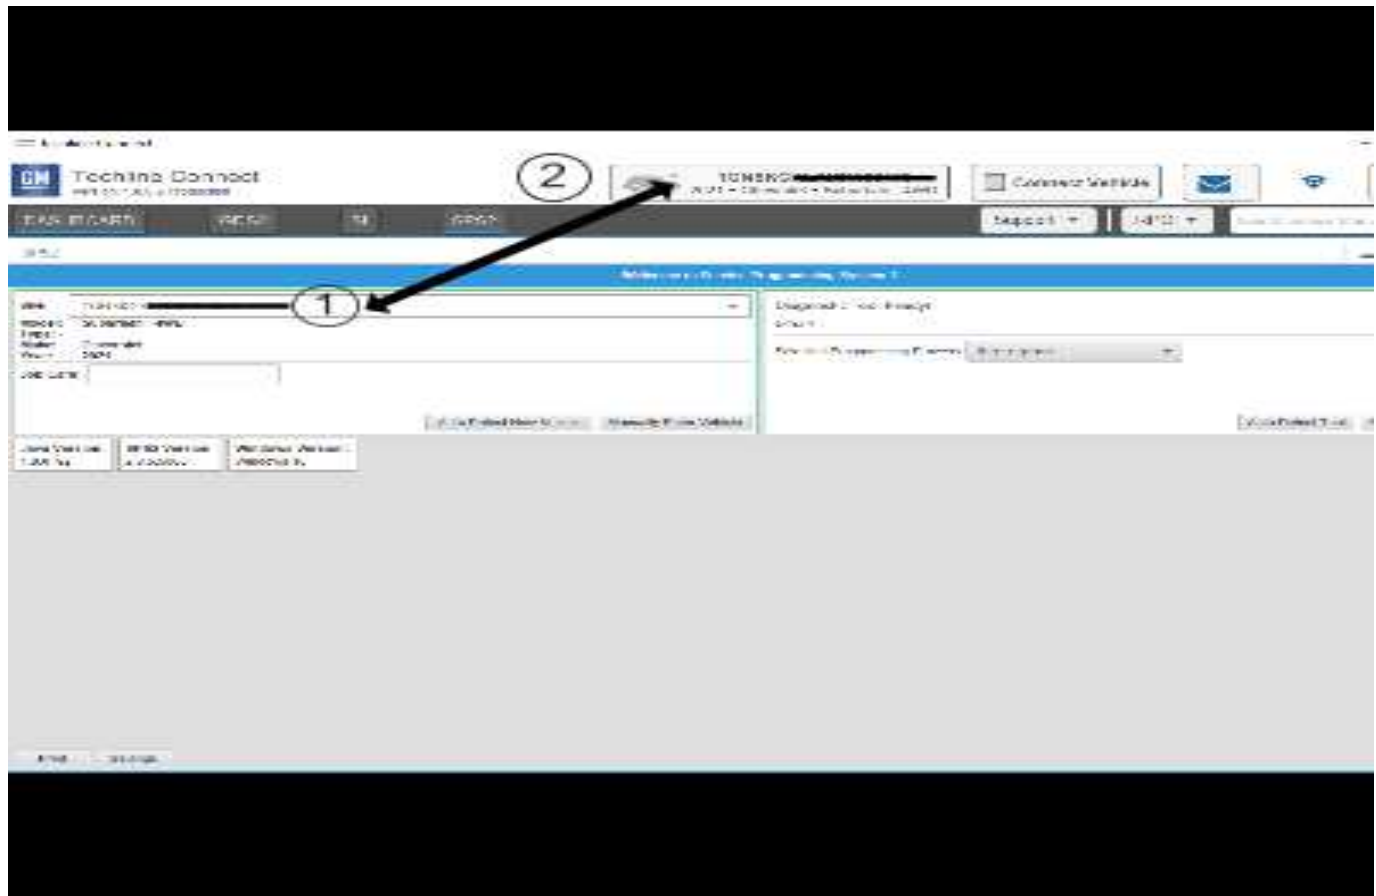
5743643

Caution: Be sure the VIN selected in the drop down menu (1) is the same as the vehicle connected (2) before beginning programming.

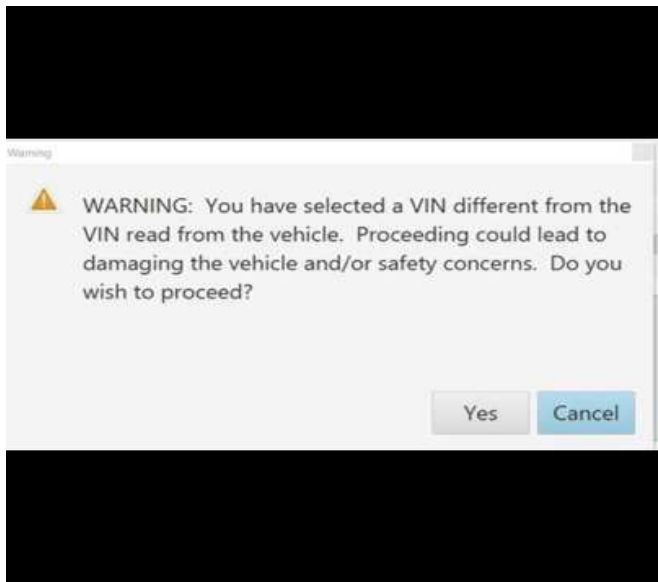
5877000

Important: If the vehicle VIN DOES NOT match, the message below will be shown.

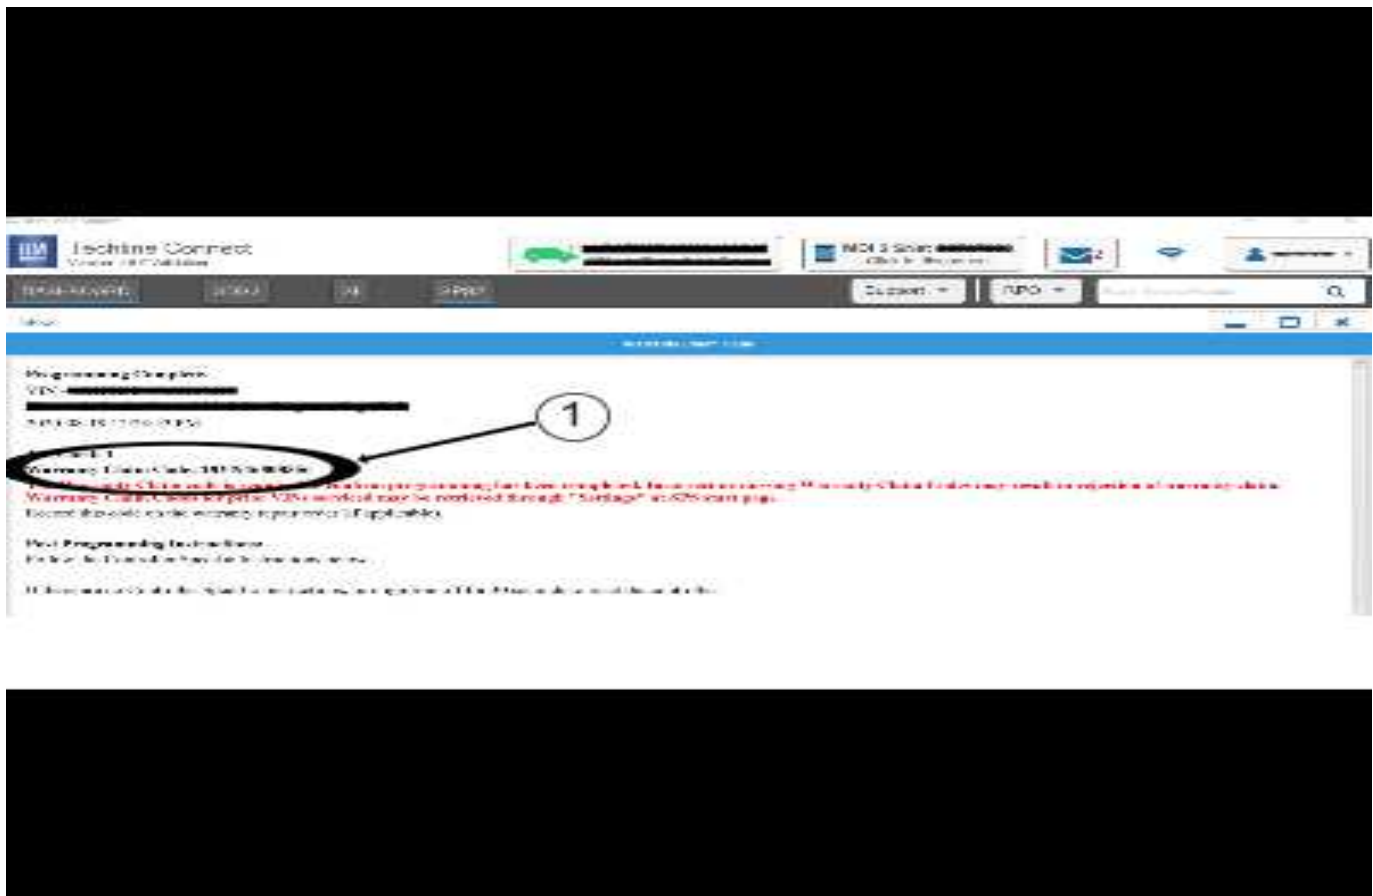
5644478

Note: The screenshot above is an example of module programming and may not be indicative of the specific module that is being programmed. Module selection and VIN information have been blacked out.

1. Reprogram the ECM. Refer to K20 Engine Control Module: Programming and Setup in the Service Manual.
