# Service Bulletin

Bulletin No.: 21-NA-024

Subject: Service Engine Soon MIL Illuminated with DTC P2B87 Set

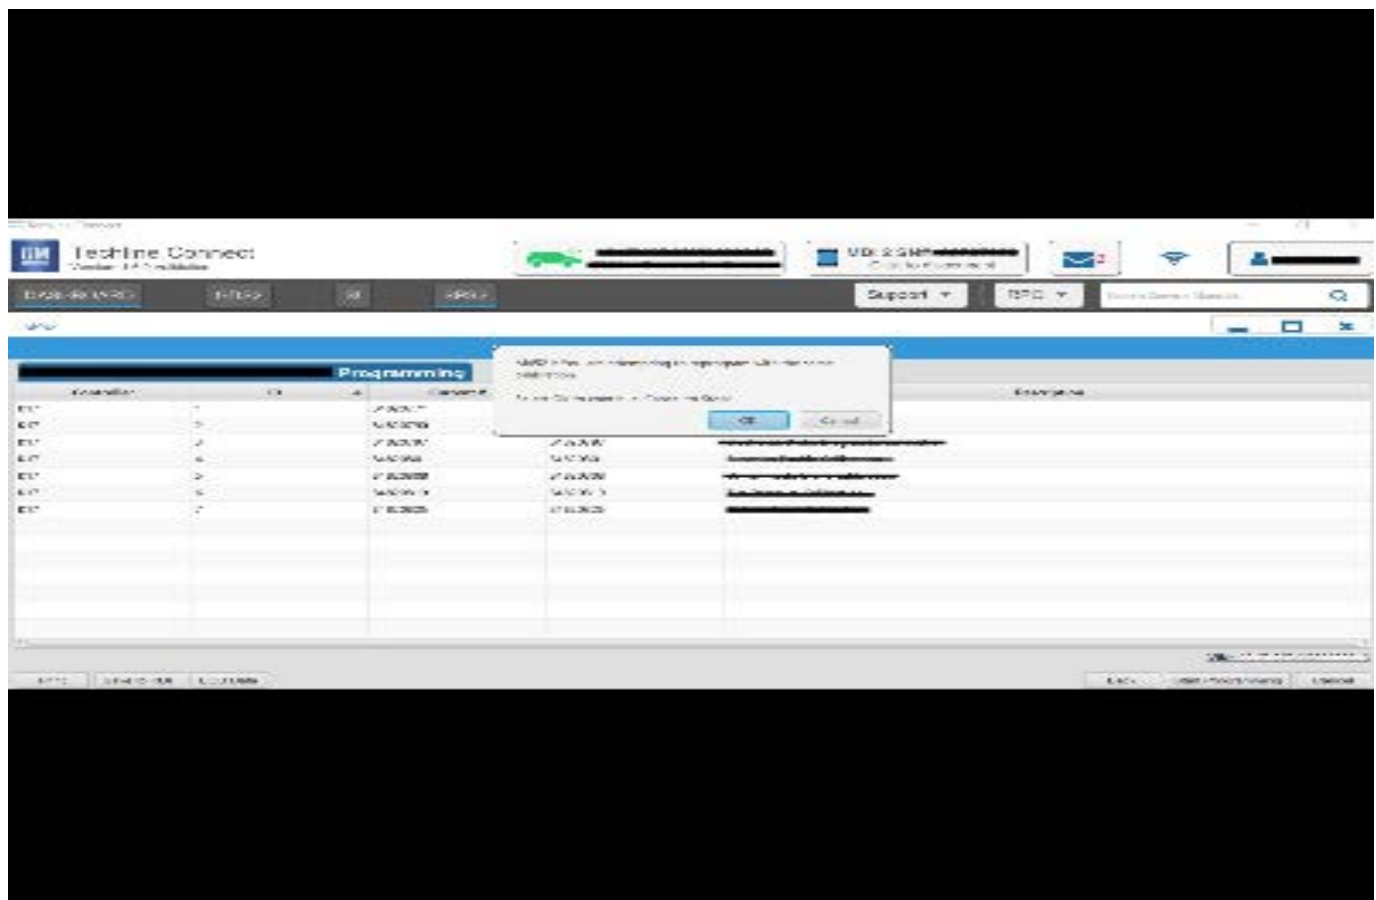
5644477

Important: Techline Connect and TIS2WEB screens shown above.

Important: If the same calibration/software warning is noted on the TLC or SPS Summary screen, select OK and follow screen instructions. After a successful programming event, the WCC is located in the Service
