2021-2022MY  
Sorento (MQ4a) w/BSD

308

July 2022

**SERVICE ACTION: REAR CORNER RADAR UNIT  
BODY SEALER INSPECTION & REPAIR (SA503)**

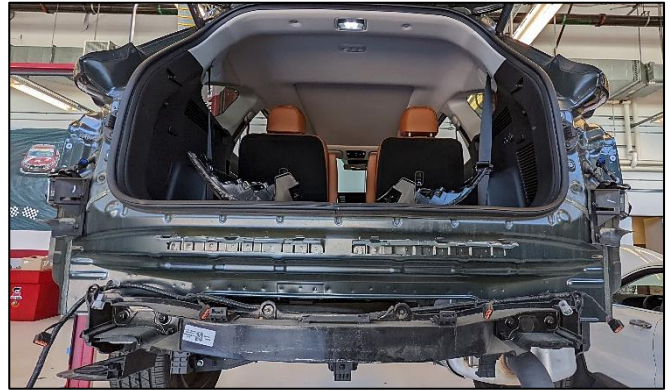
1. Remove the rear bumper cover by referring to “Body (Interior and Exterior) → Rear Bumper → Rear Bumper Assembly → Repair procedures” in the applicable Shop Manual on KGIS.

Note that the rear corner radar bracket mounting area is ‘flat’ over the body sealer. Excessive body sealer **(NG)** will cause the radar angle to aim improperly, resulting in a MIL ‘ON’ with DTC C270954.

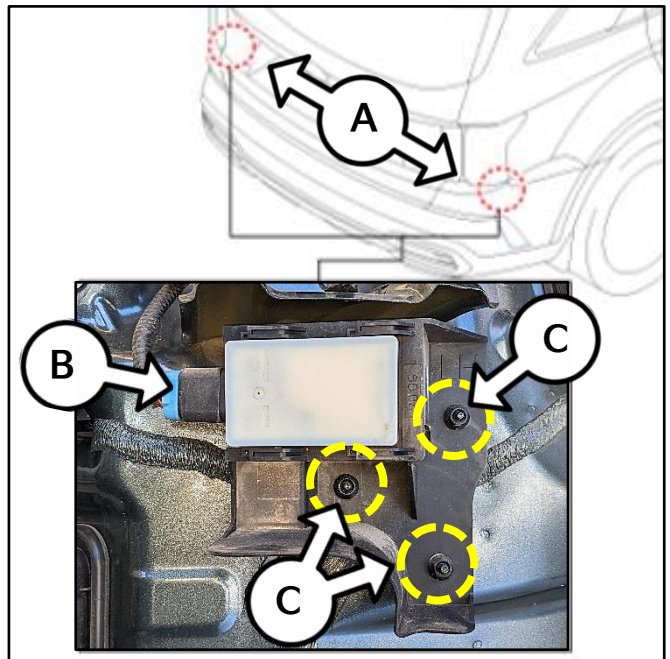
2. Remove **left** side rear corner radar units (A) by disconnecting the connector (B) and removing the three (3) retaining nuts (C).
3. Remove **right** side rear corner radar units (A) by disconnecting the connector (B) and removing the three (3) retaining nuts (C).
